REPORT ON A SURVEY
OF THE
CHICAGO SANITARY CANAL AND THE CALUMET SAG CHANNEL

Michigan Associates
Consulting Engineers
Lansing 29, Michigan

22 April 1959

REPORT ON A SURVEY OF THE
CHICAGO SANITARY CANAL AND THE CALUMET SAG CHANNEL

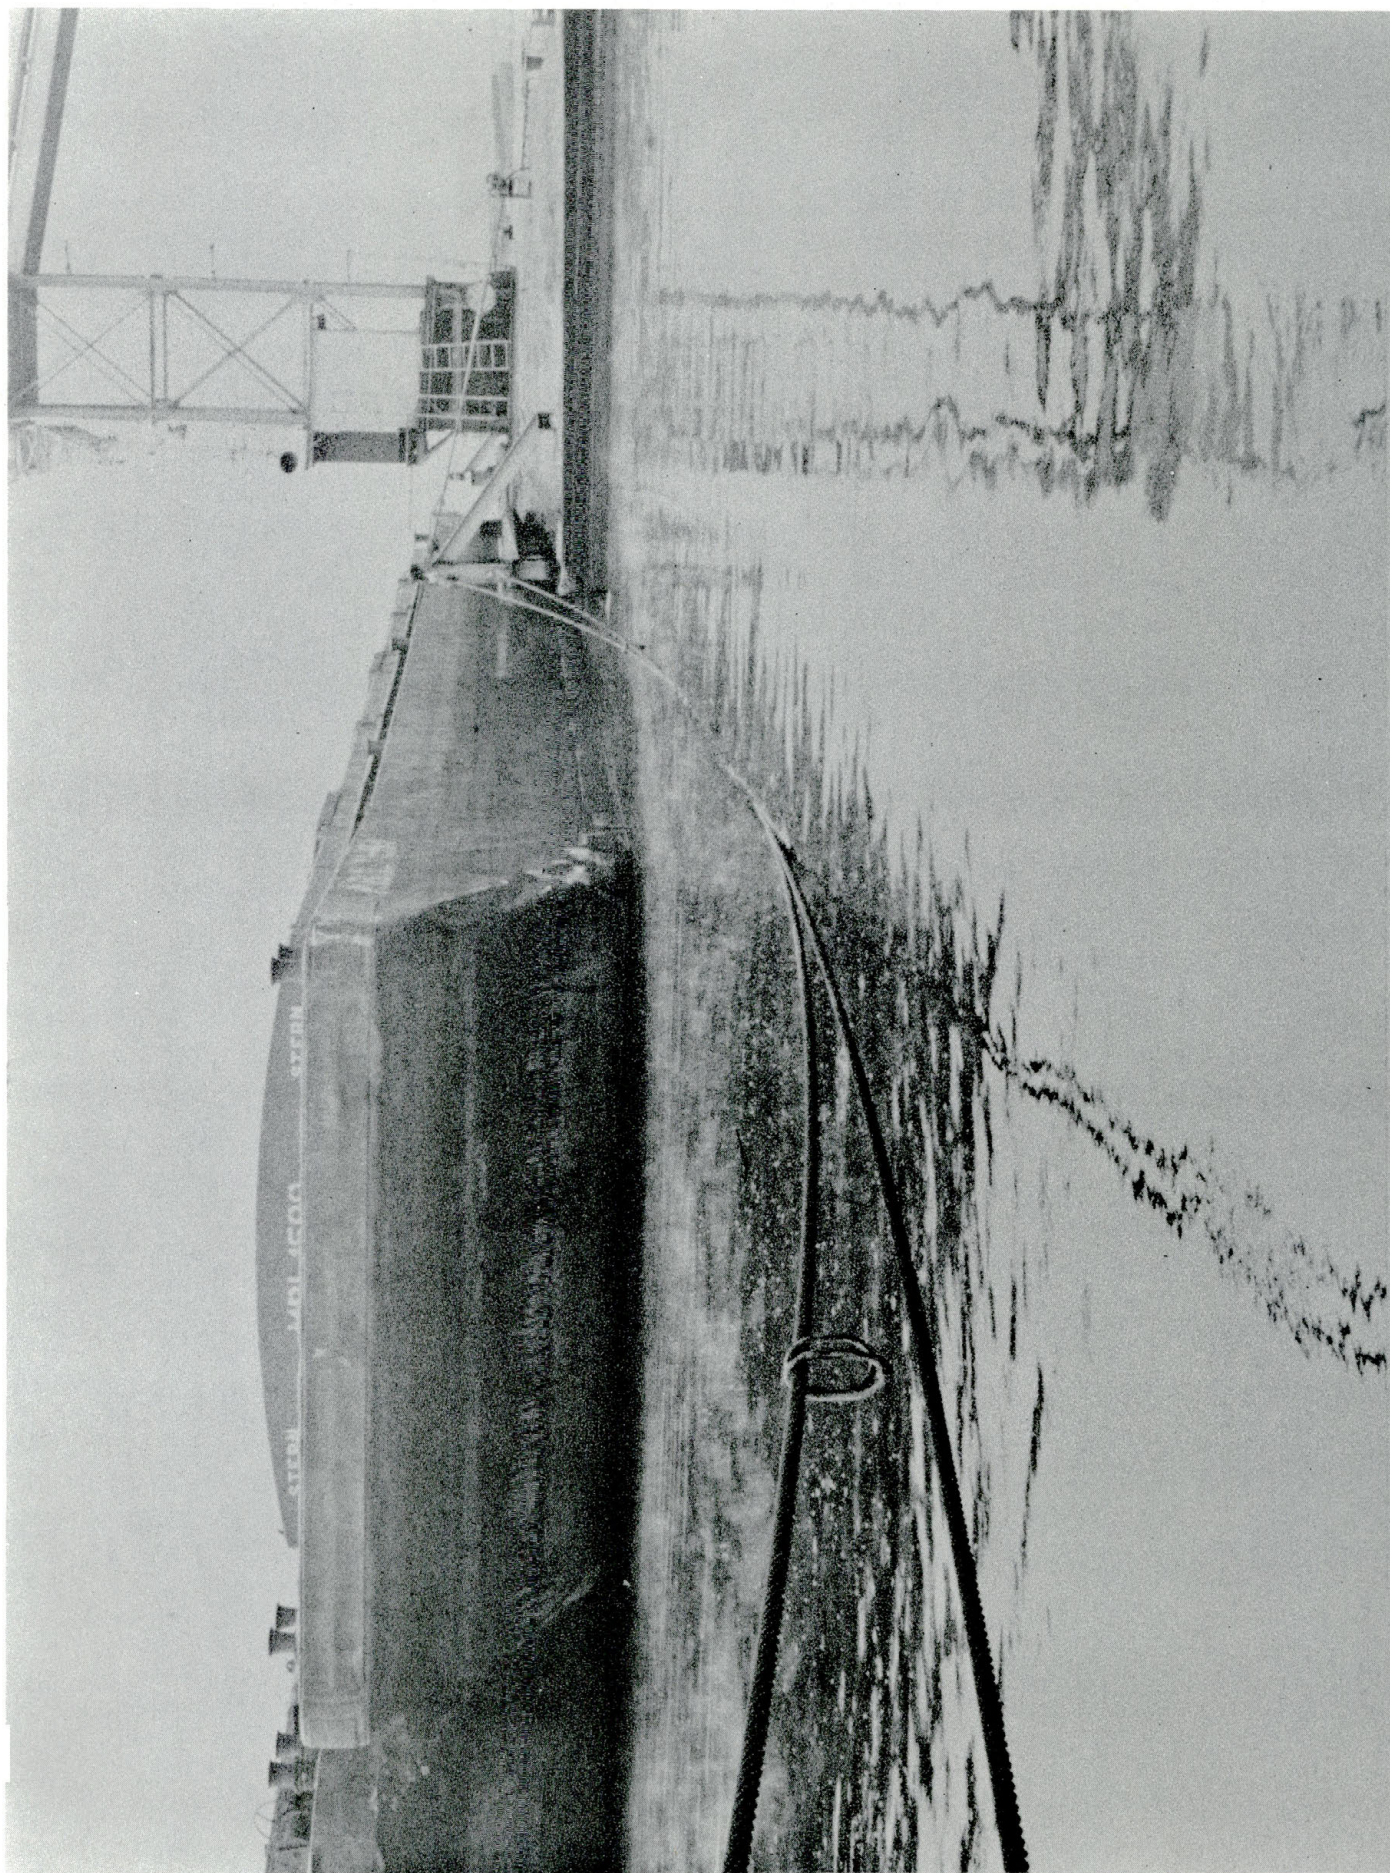
PICTURE 1 was taken at the point used to dock the motorboat at Lockport, Illinois. As can be seen, the surface of the water is covered with bubbles. Bubbles of this type are typical of heavily polluted waters and are the result of methane and carbon dioxide production in organic sludge deposits at the bottom of the canal. At this particular location, which is about 5 miles downstream from the Chicago Sanitary District boundary, the gas bubbles are most evident when water is withdrawn from the canal for operation of the locks. The sudden use of water apparently lowers the water level in the canal and the resulting reduction in water pressure releases a large quantity of gas as evidenced by the picture.

Lockport Illinois, just upstream from Locks. Note gas bubbles on surface of water which have risen from septic sludge deposits on bottom of canal.

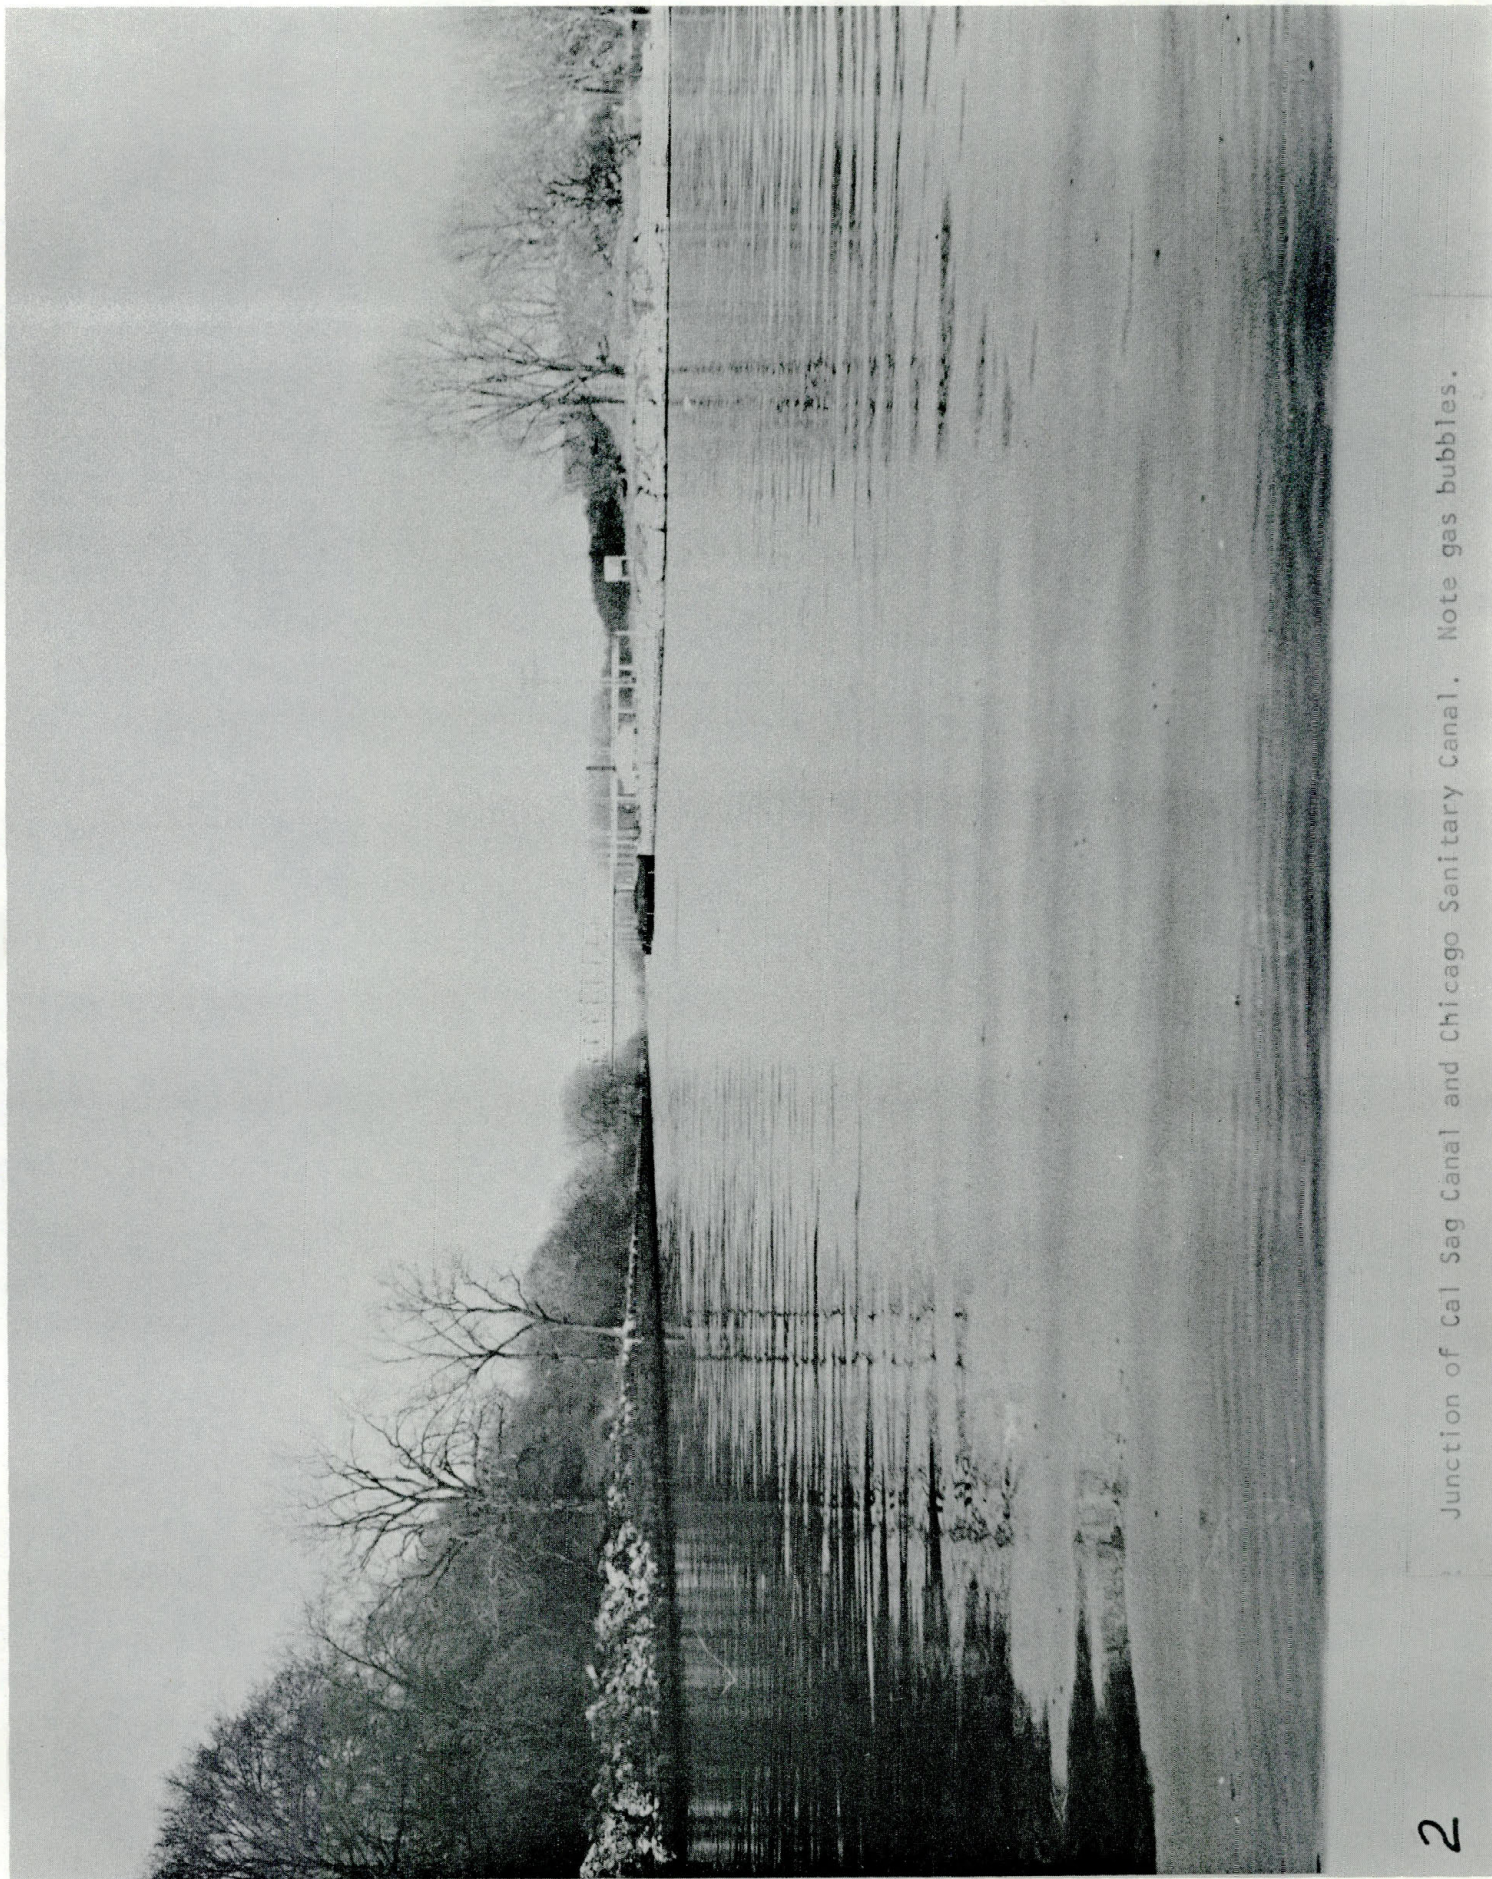
PICTURE 2 was taken at the junction of the Chicago Sanitary Canal and the Calumet Sag Channel. This picture again shows gas bubbles which have risen to the surface from organic sludge deposits. Gas bubbles of this type are tell-tale evidence of very heavily polluted waters, and these were seen on every section of the canals, except for a short distance downstream from the control works on Lake Michigan, where clean lake water entered.

Junction of Cal Sag Canal and Chicago Sanitary Canal. Note gas bubbles.

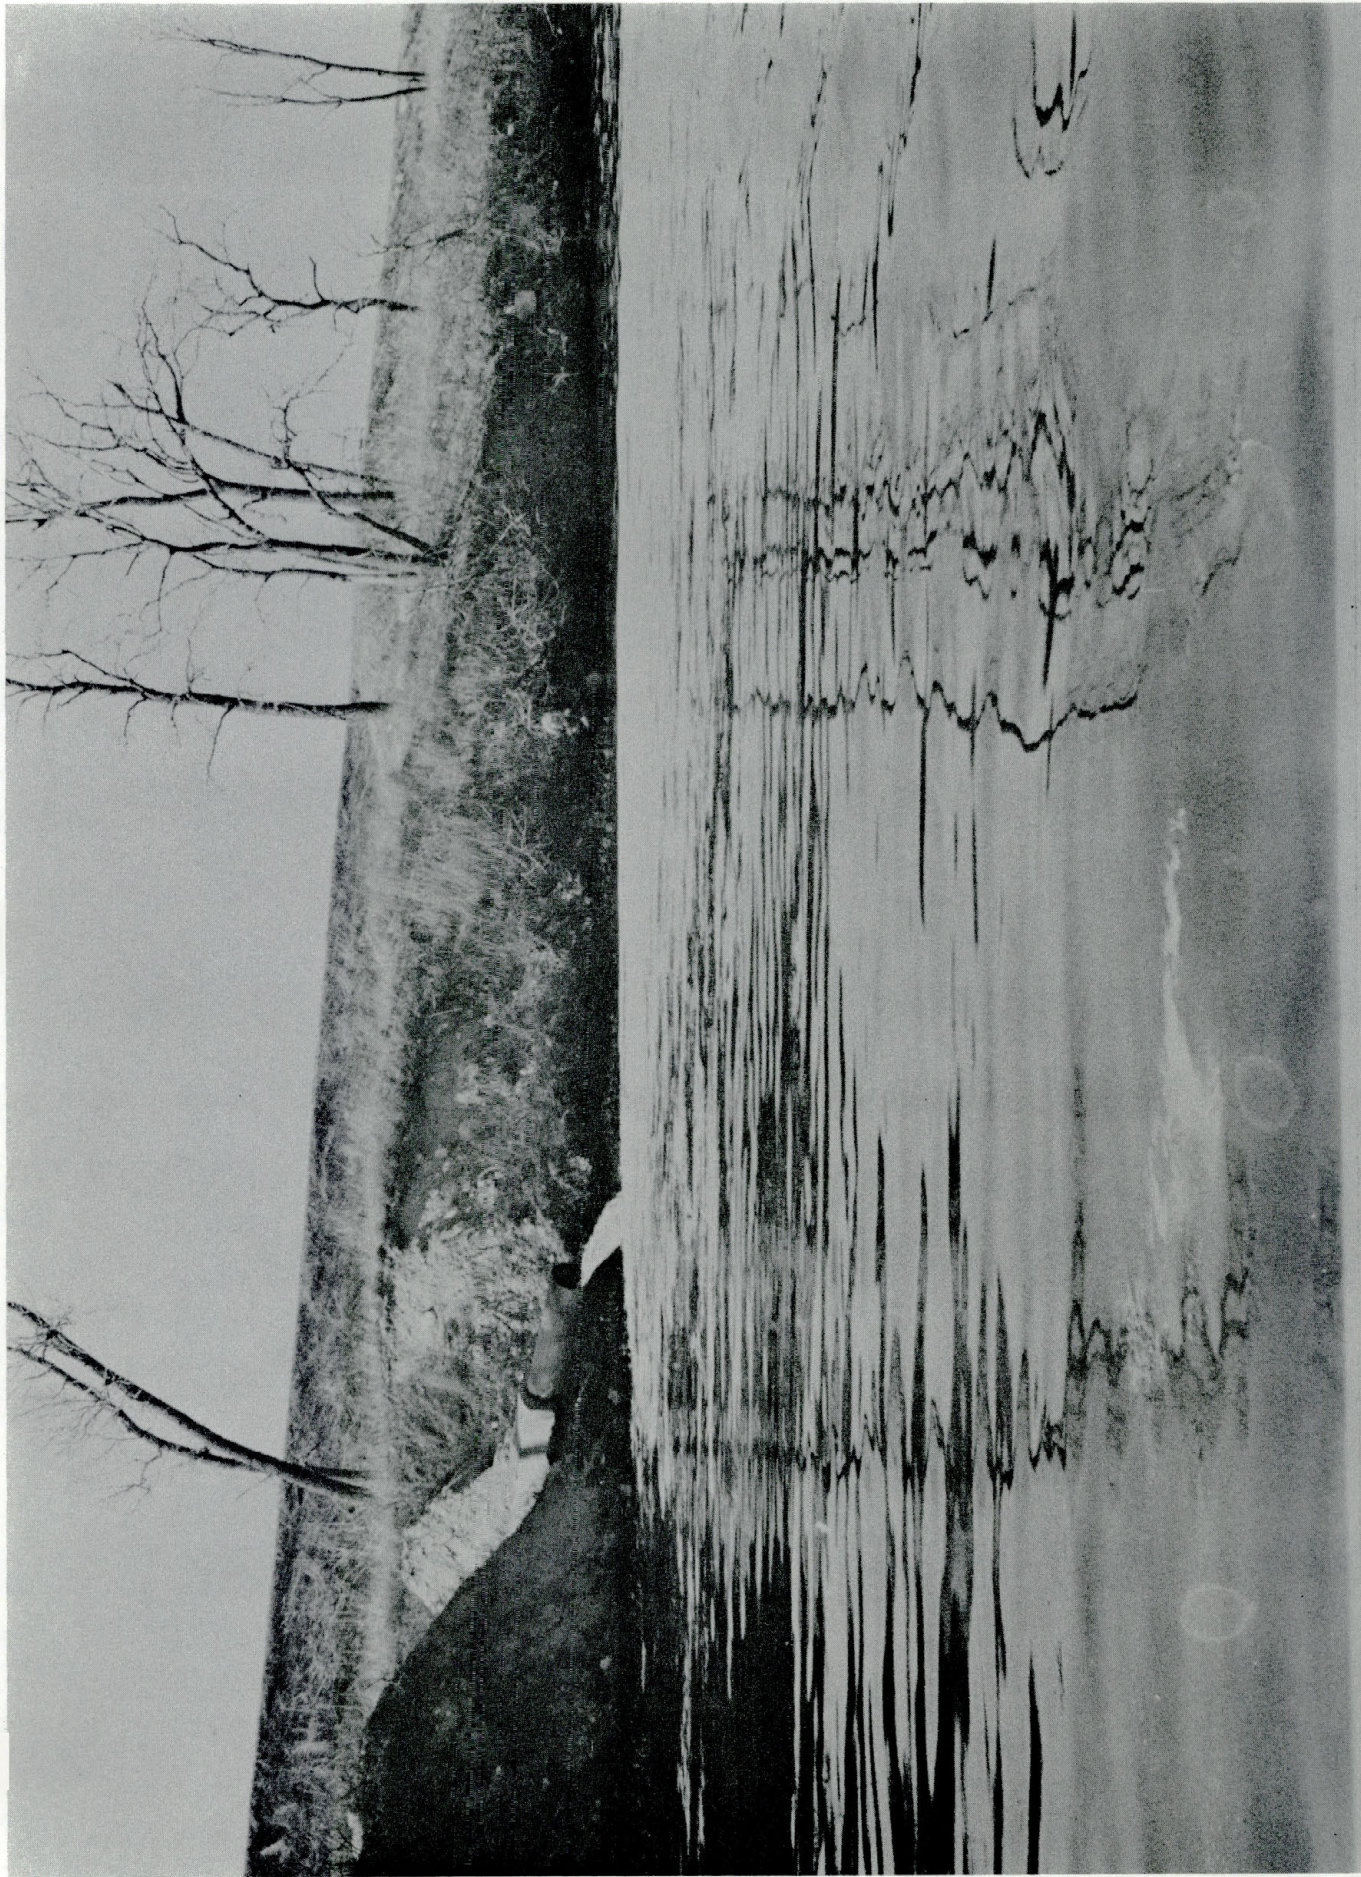
PICTURES 3, 4, 5, 6, 7 show discharging sewers along the area of the Chicago Sanitary District raw sludge lagoons. There are indications that these sewers are direct overflows from these raw sewage sludge lagoons. Samples were taken from the discharging wastes and the following results are reported:

Sample from sewer shown in picture 3	135 ppm, B.O.D.
Sample from sewer shown in picture 4	350 ppm, B.O.D.
Sample from sewer shown in picture 5	780 ppm, B.O.D.
Sample from sewer shown in picture 6	320 ppm, B.O.D.

Sewer outlet along area of Stickney Sewage Treatment Works sludge lagoons.
Discharging waste water believed to be either overflow or underdrainage
from lagoons.

The high strength of waste indicated by the above data and the quantities being discharged as shown in the pictures would normally dictate treatment of these wastes before discharge into a receiving waterway. Standard engineering practice would be to pump this waste back to the treatment plant and treat it with the incoming raw sewage.

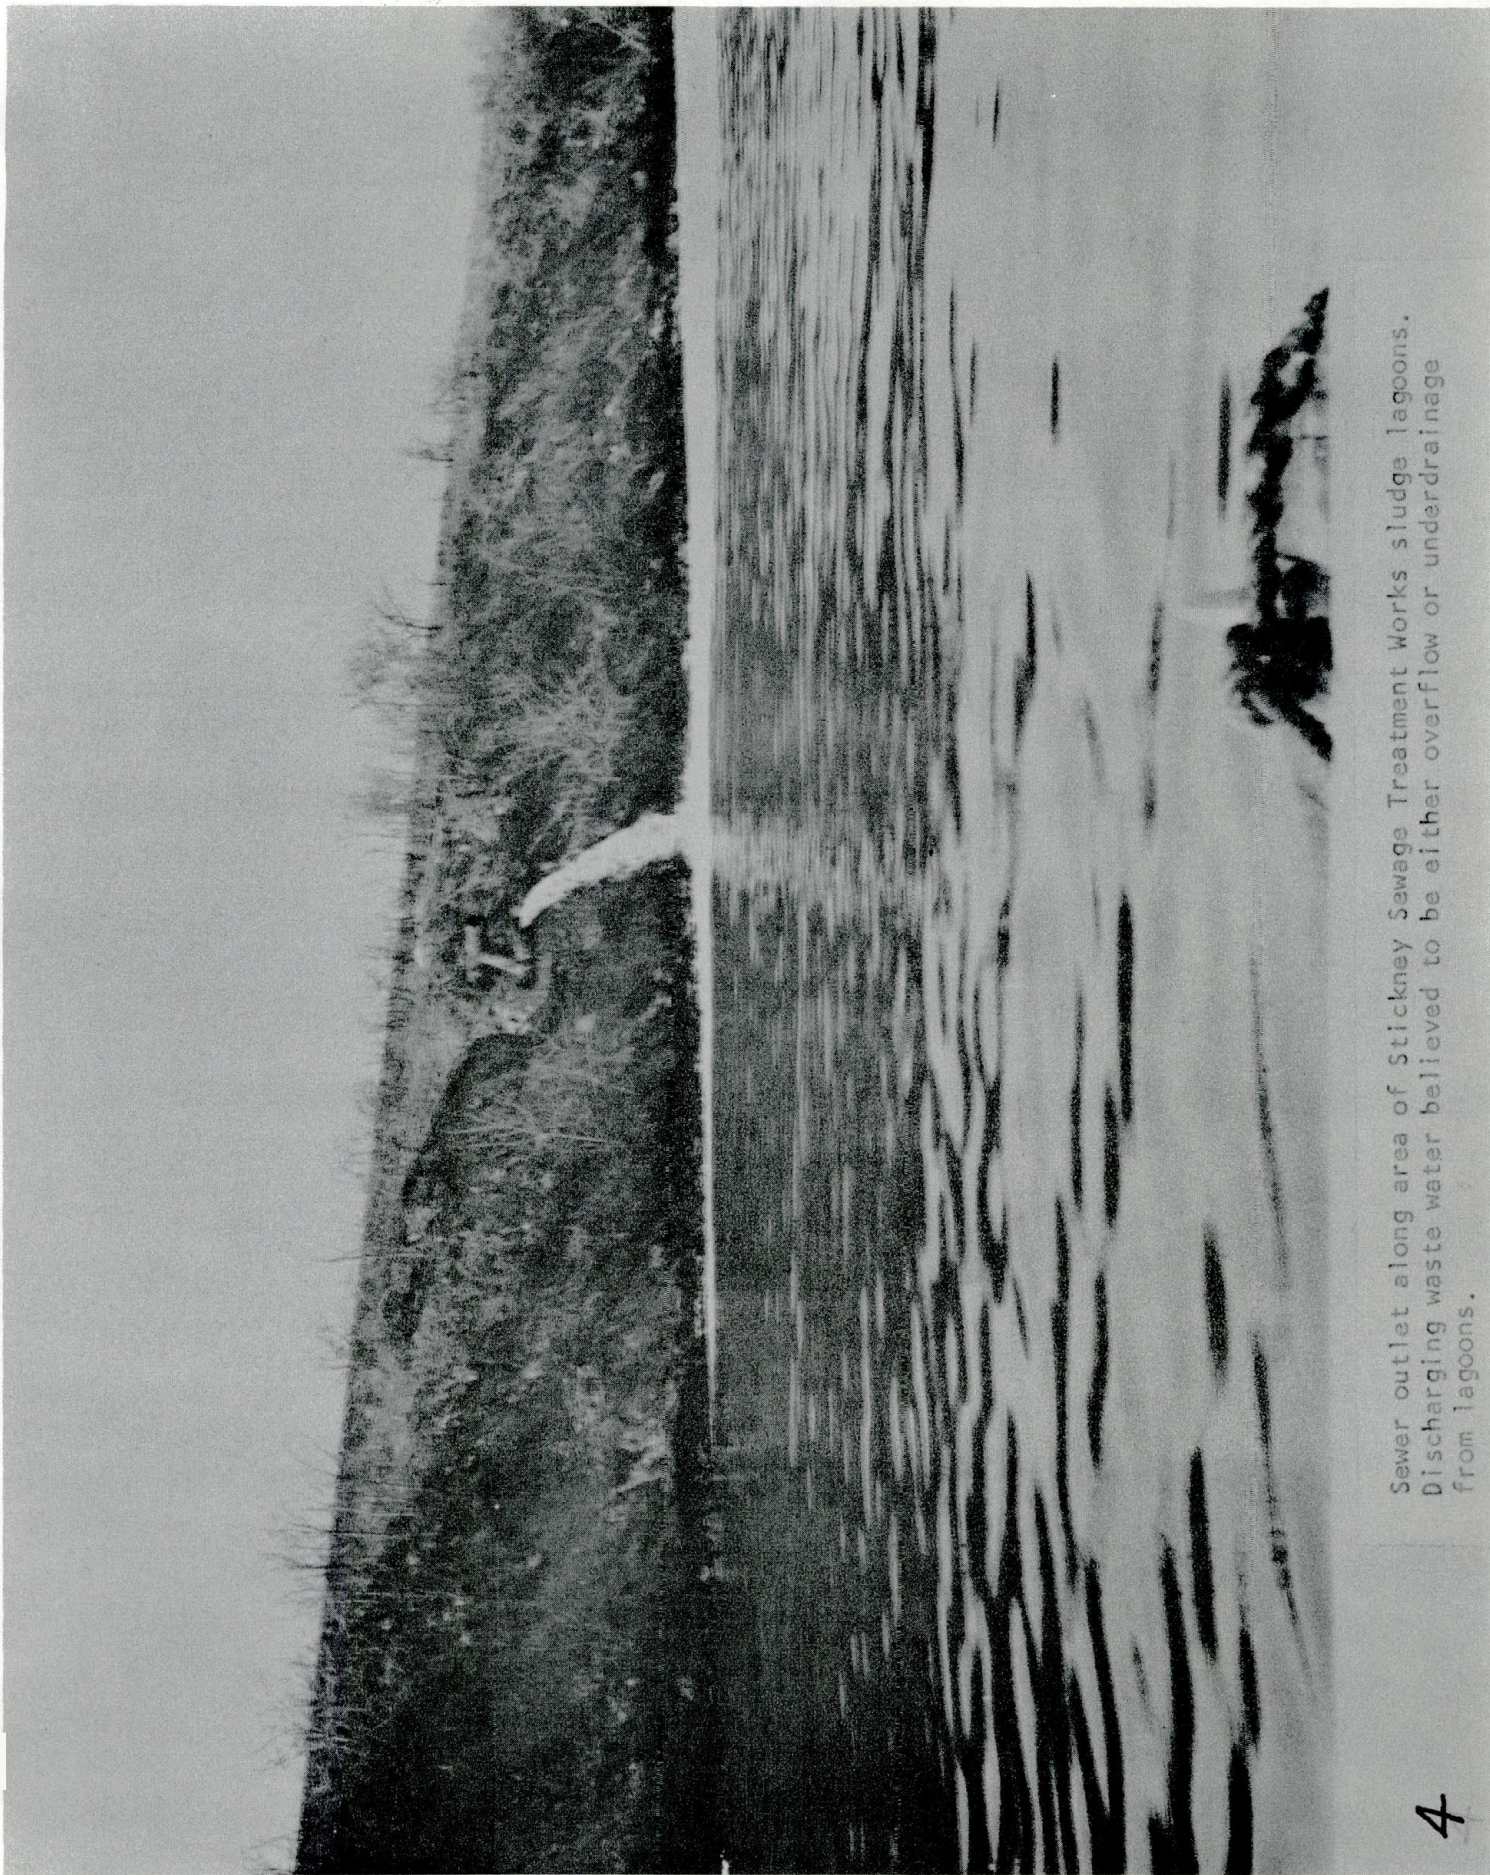
Sewer outlet along area of Stickney Sewage Treatment Works sludge lagoons.
Discharging waste water believed to be either overflow or underdrainage
from lagoons.

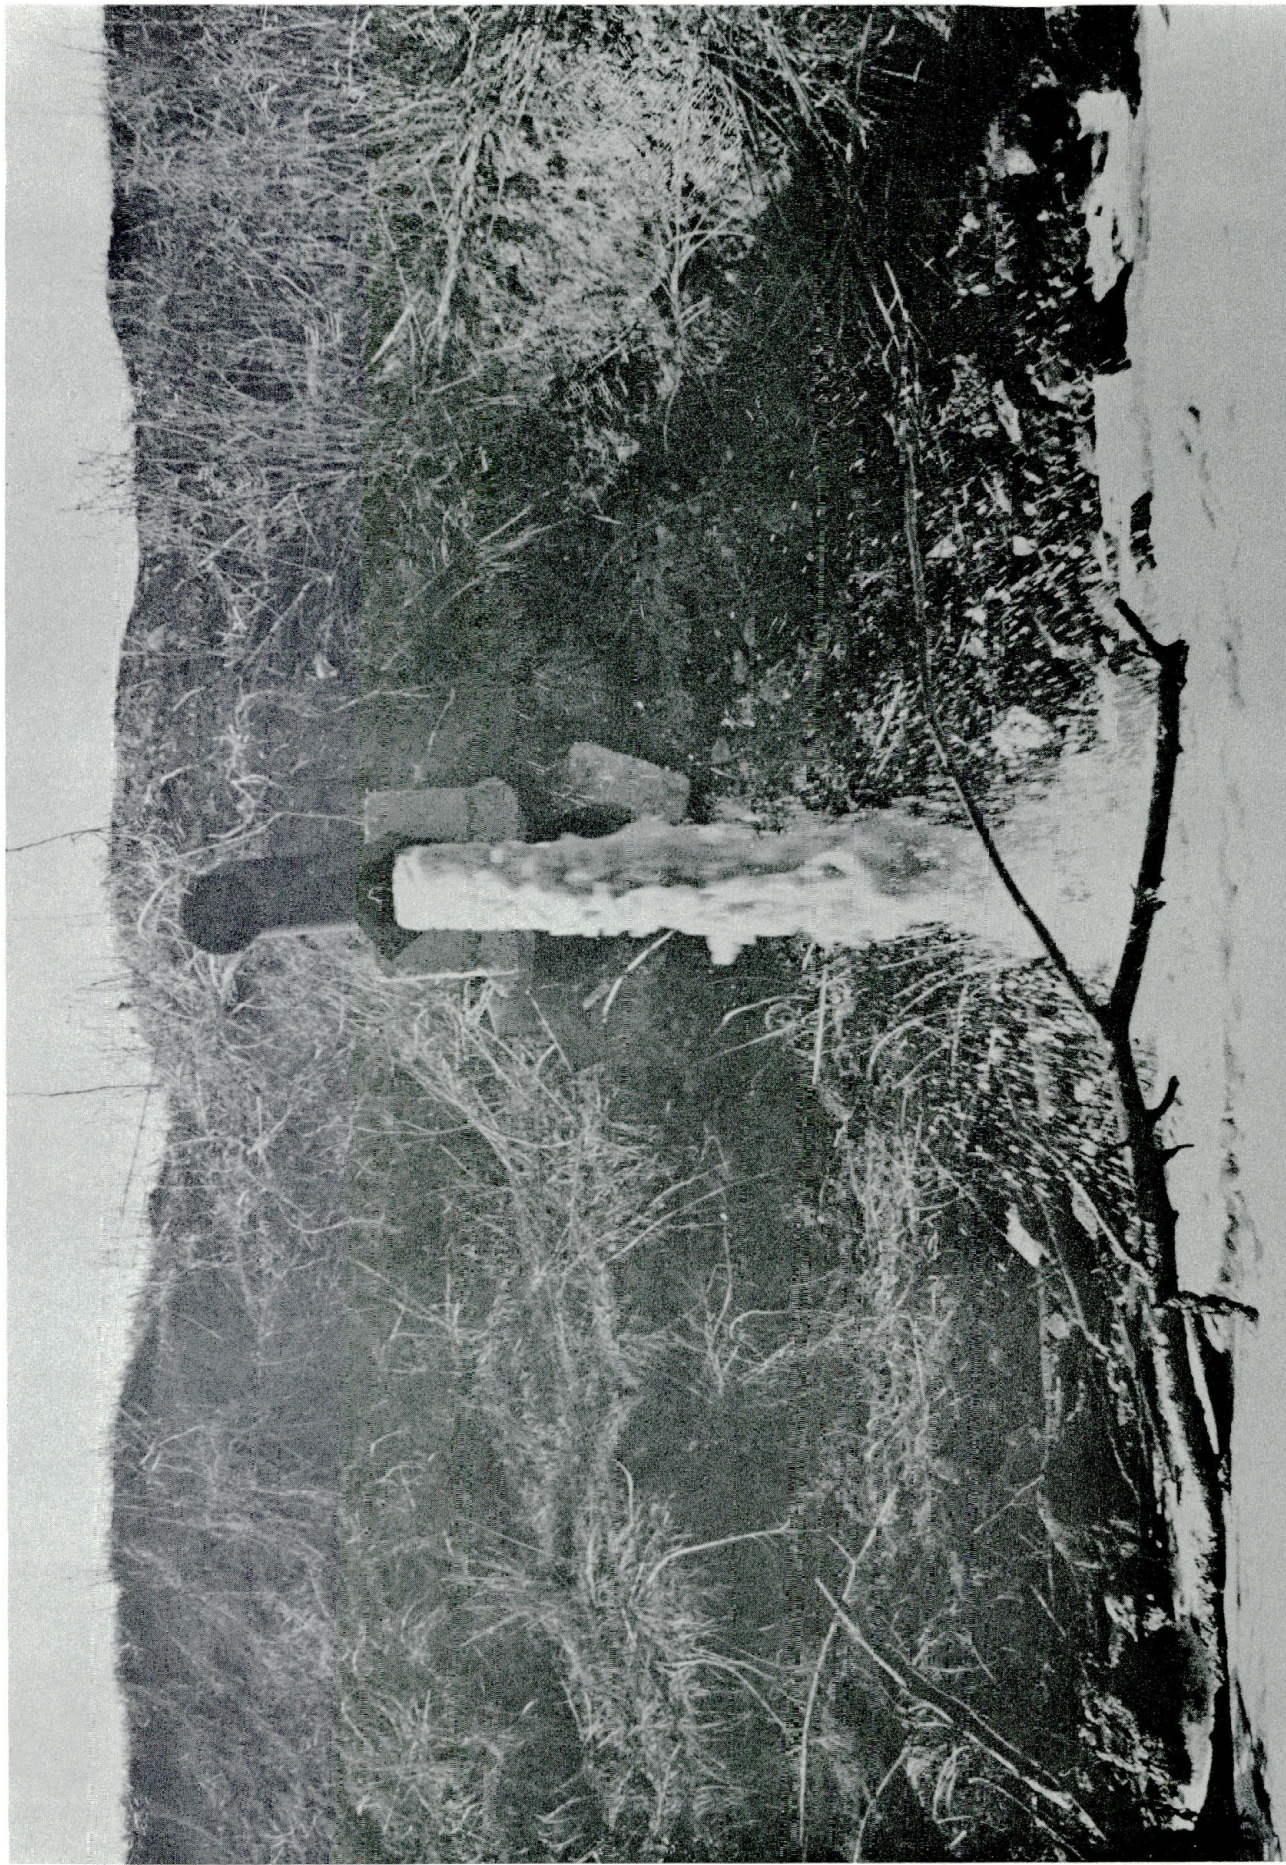
Sewer outlet along area of Stickney Sewage Treatment Works sludge lagoons. Discharging waste water believed to be either overflow or underdrainage from lagoons.

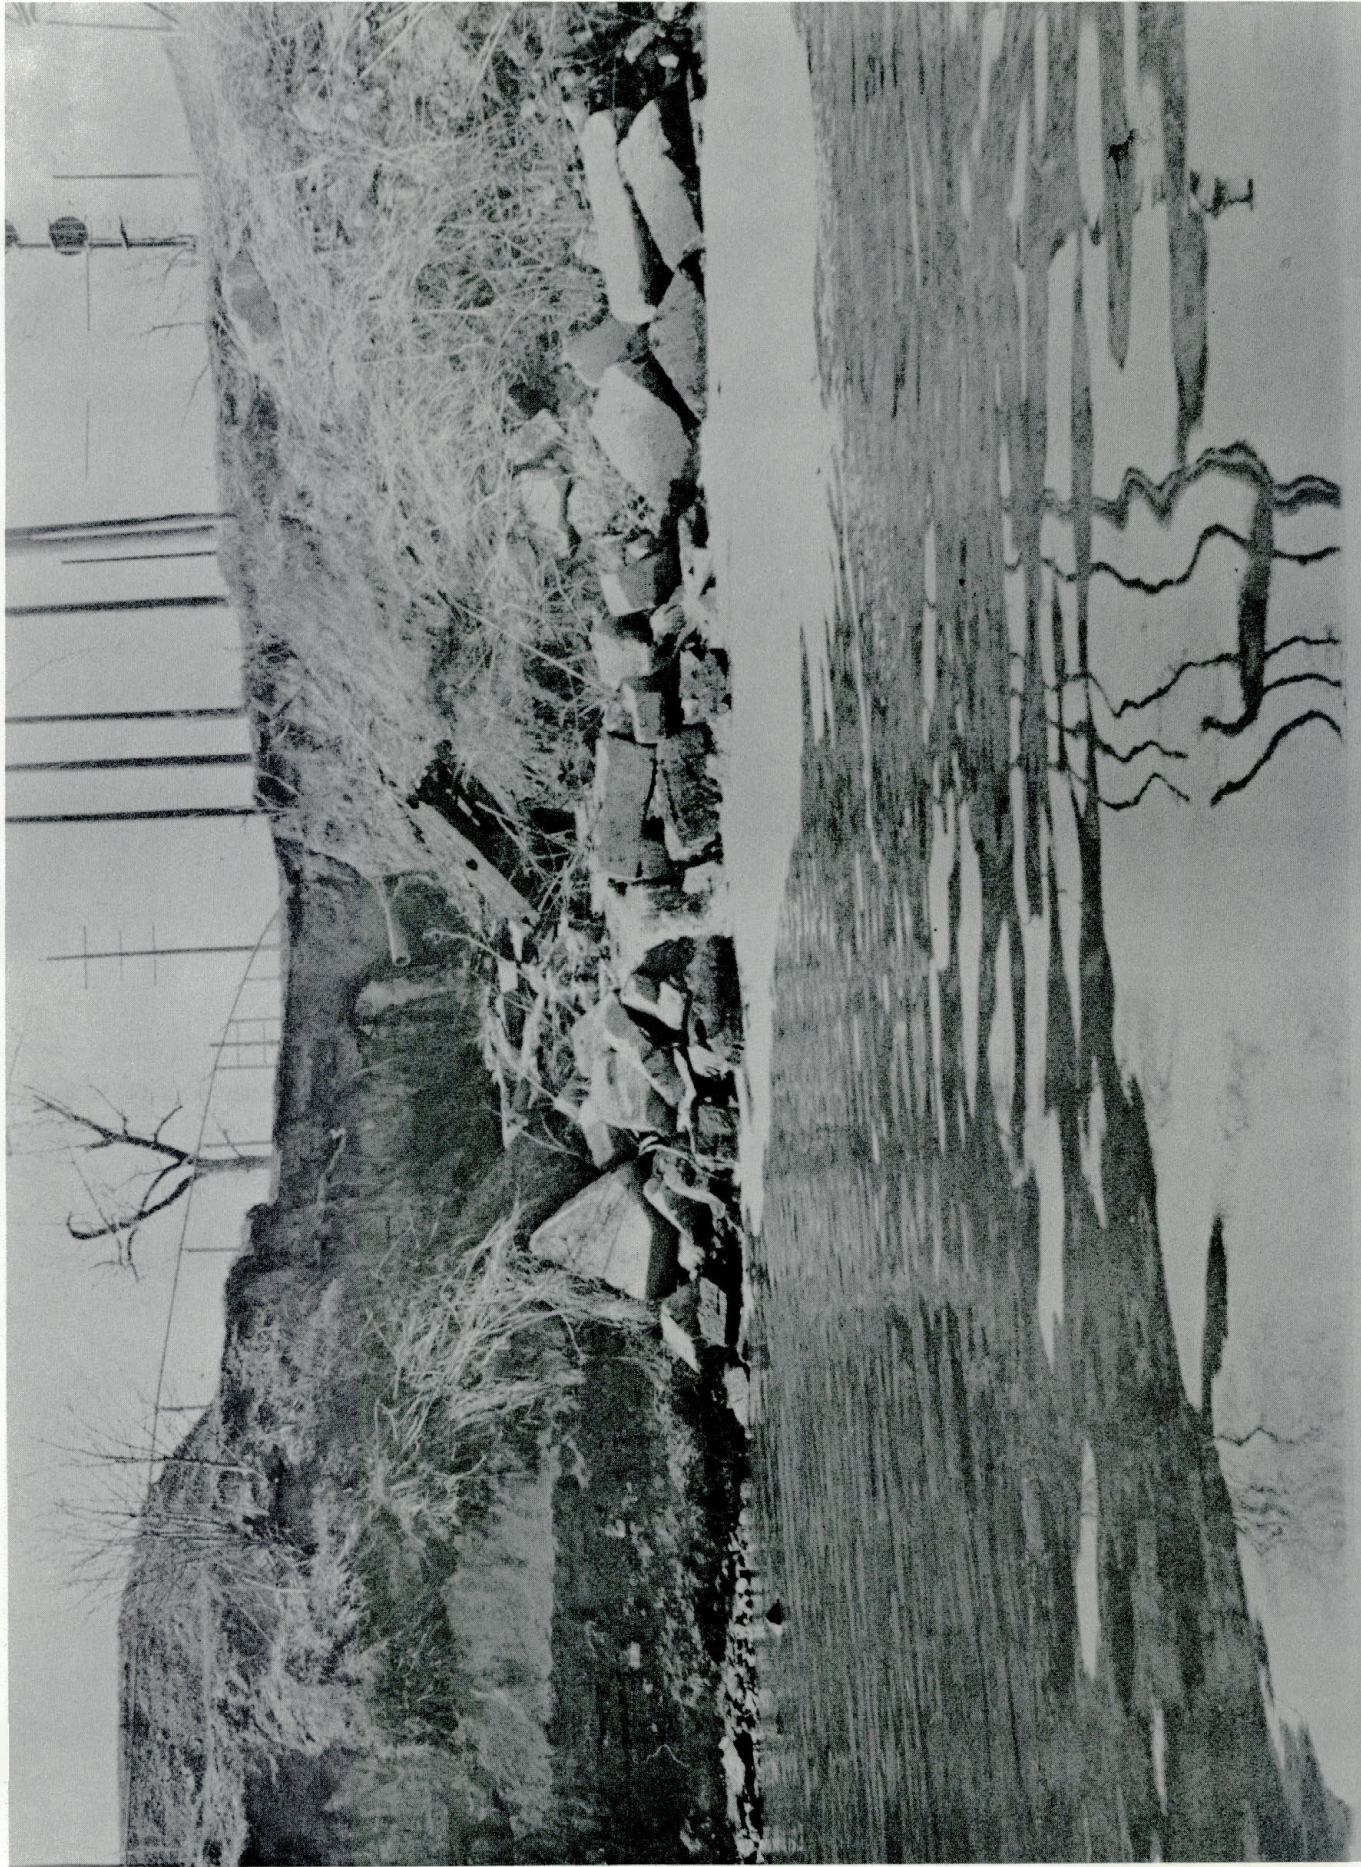
Sewer outlet along area of Stickney Sewage Treatment Works sludge lagoons. Discharging waste water believed to be either overflow or underdrainage from lagoons.

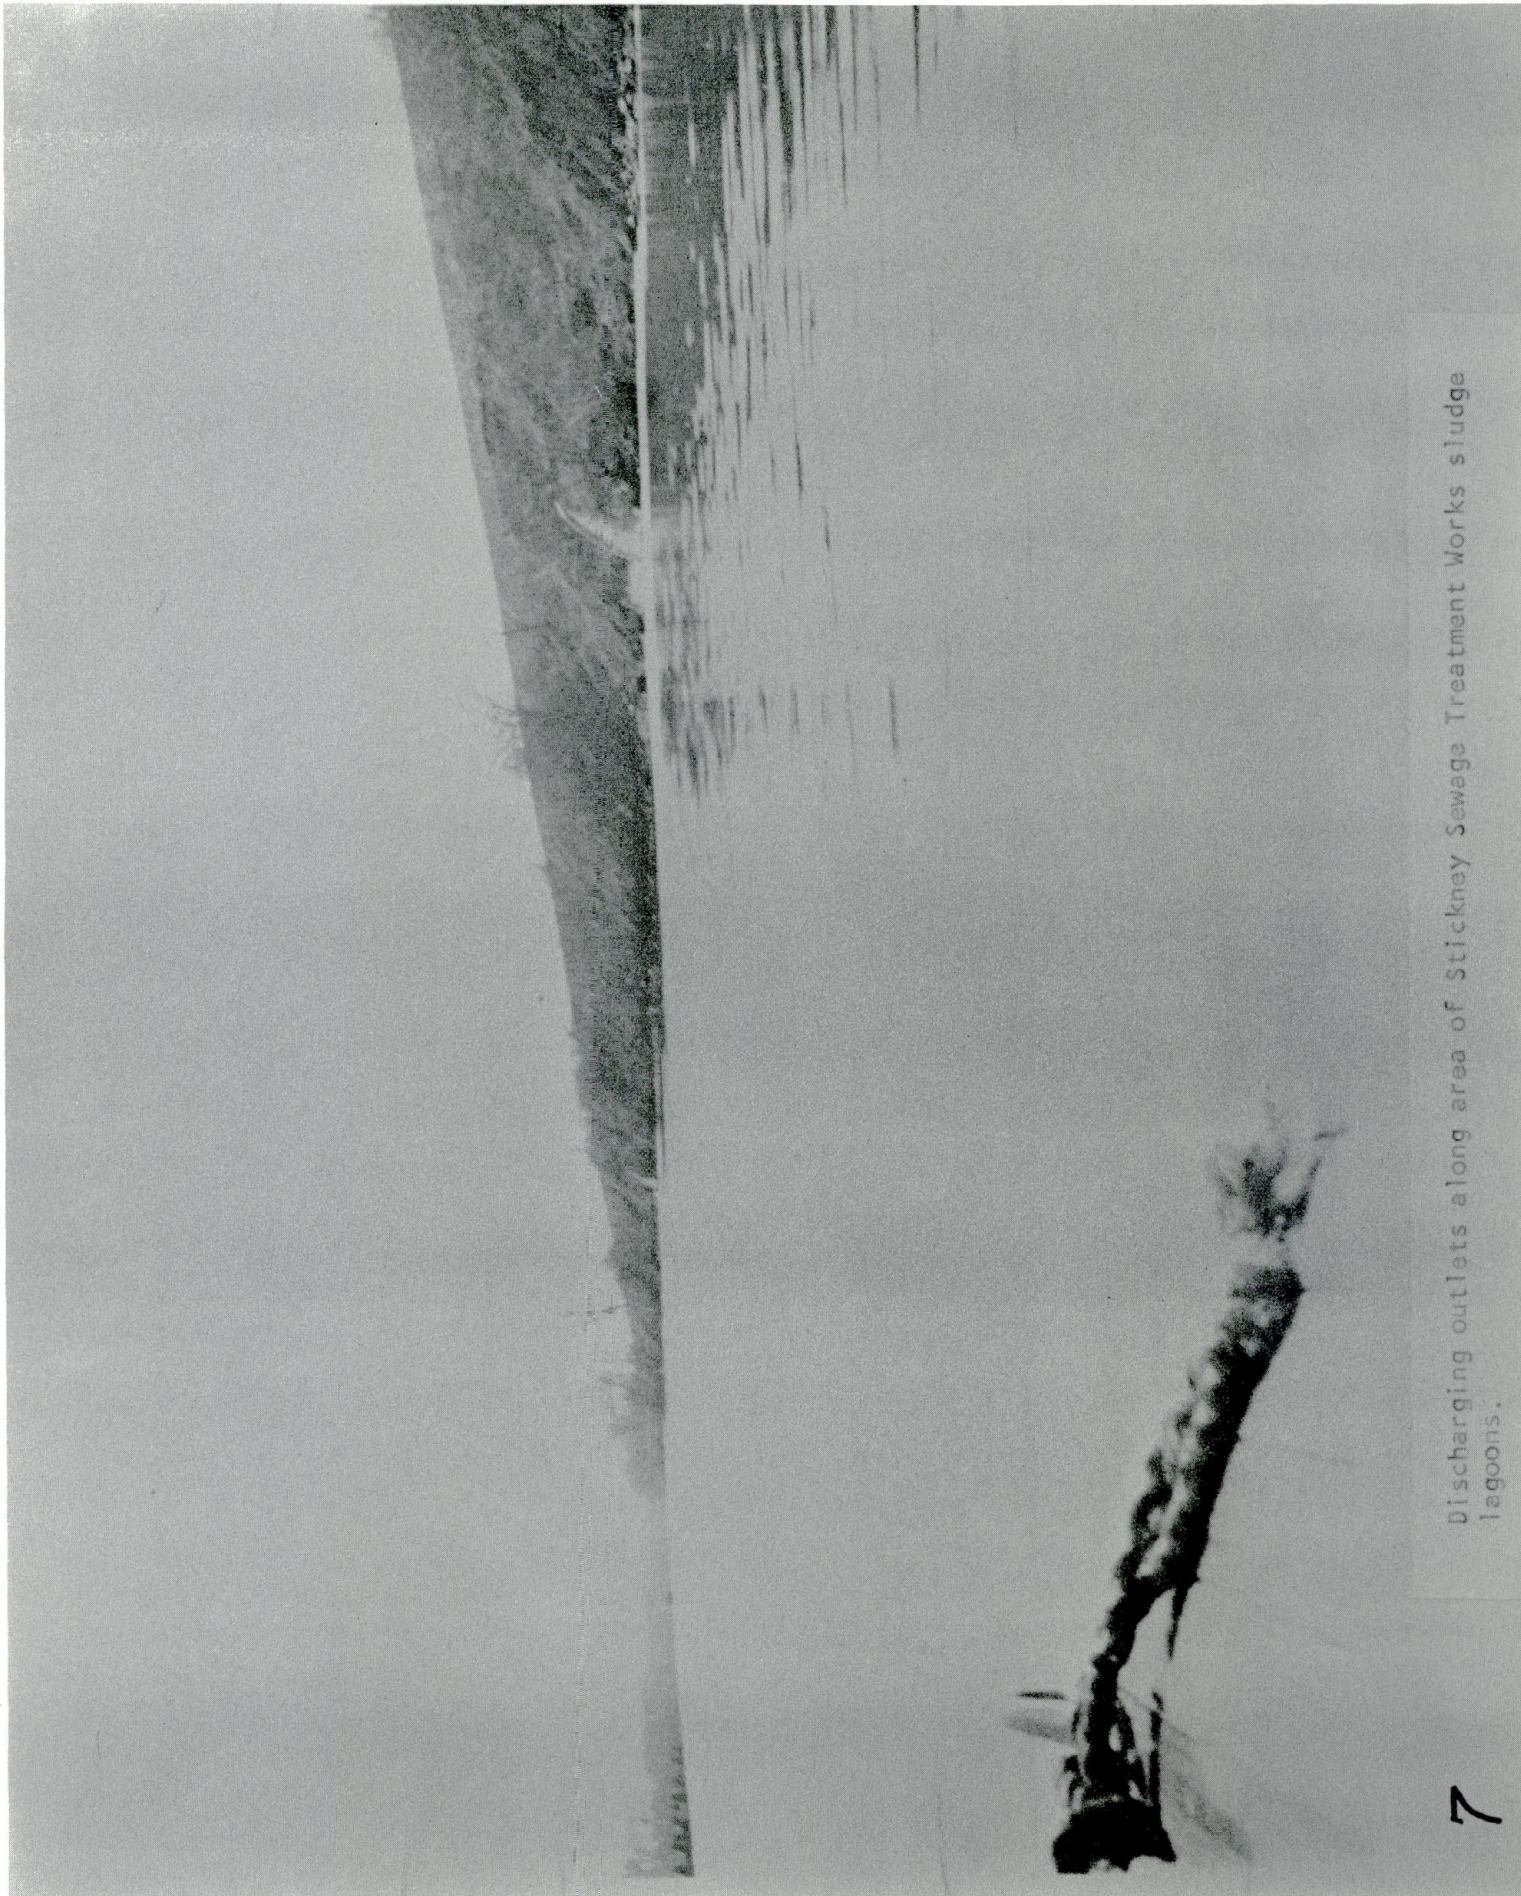
Discharging outlets along area of Stickney Sewage Treatment Works sludge lagoons.
