REPORT ON A SURVEY
OF THE
CHICAGO SANITARY CANAL AND THE CALUMET SAG CHANNEL

Michigan Associates
Consulting Engineers
Lansing 29, Michigan

22 April 1959

REPORT ON A SURVEY OF THE
CHICAGO SANITARY CANAL AND THE CALUMET SAG CHANNEL

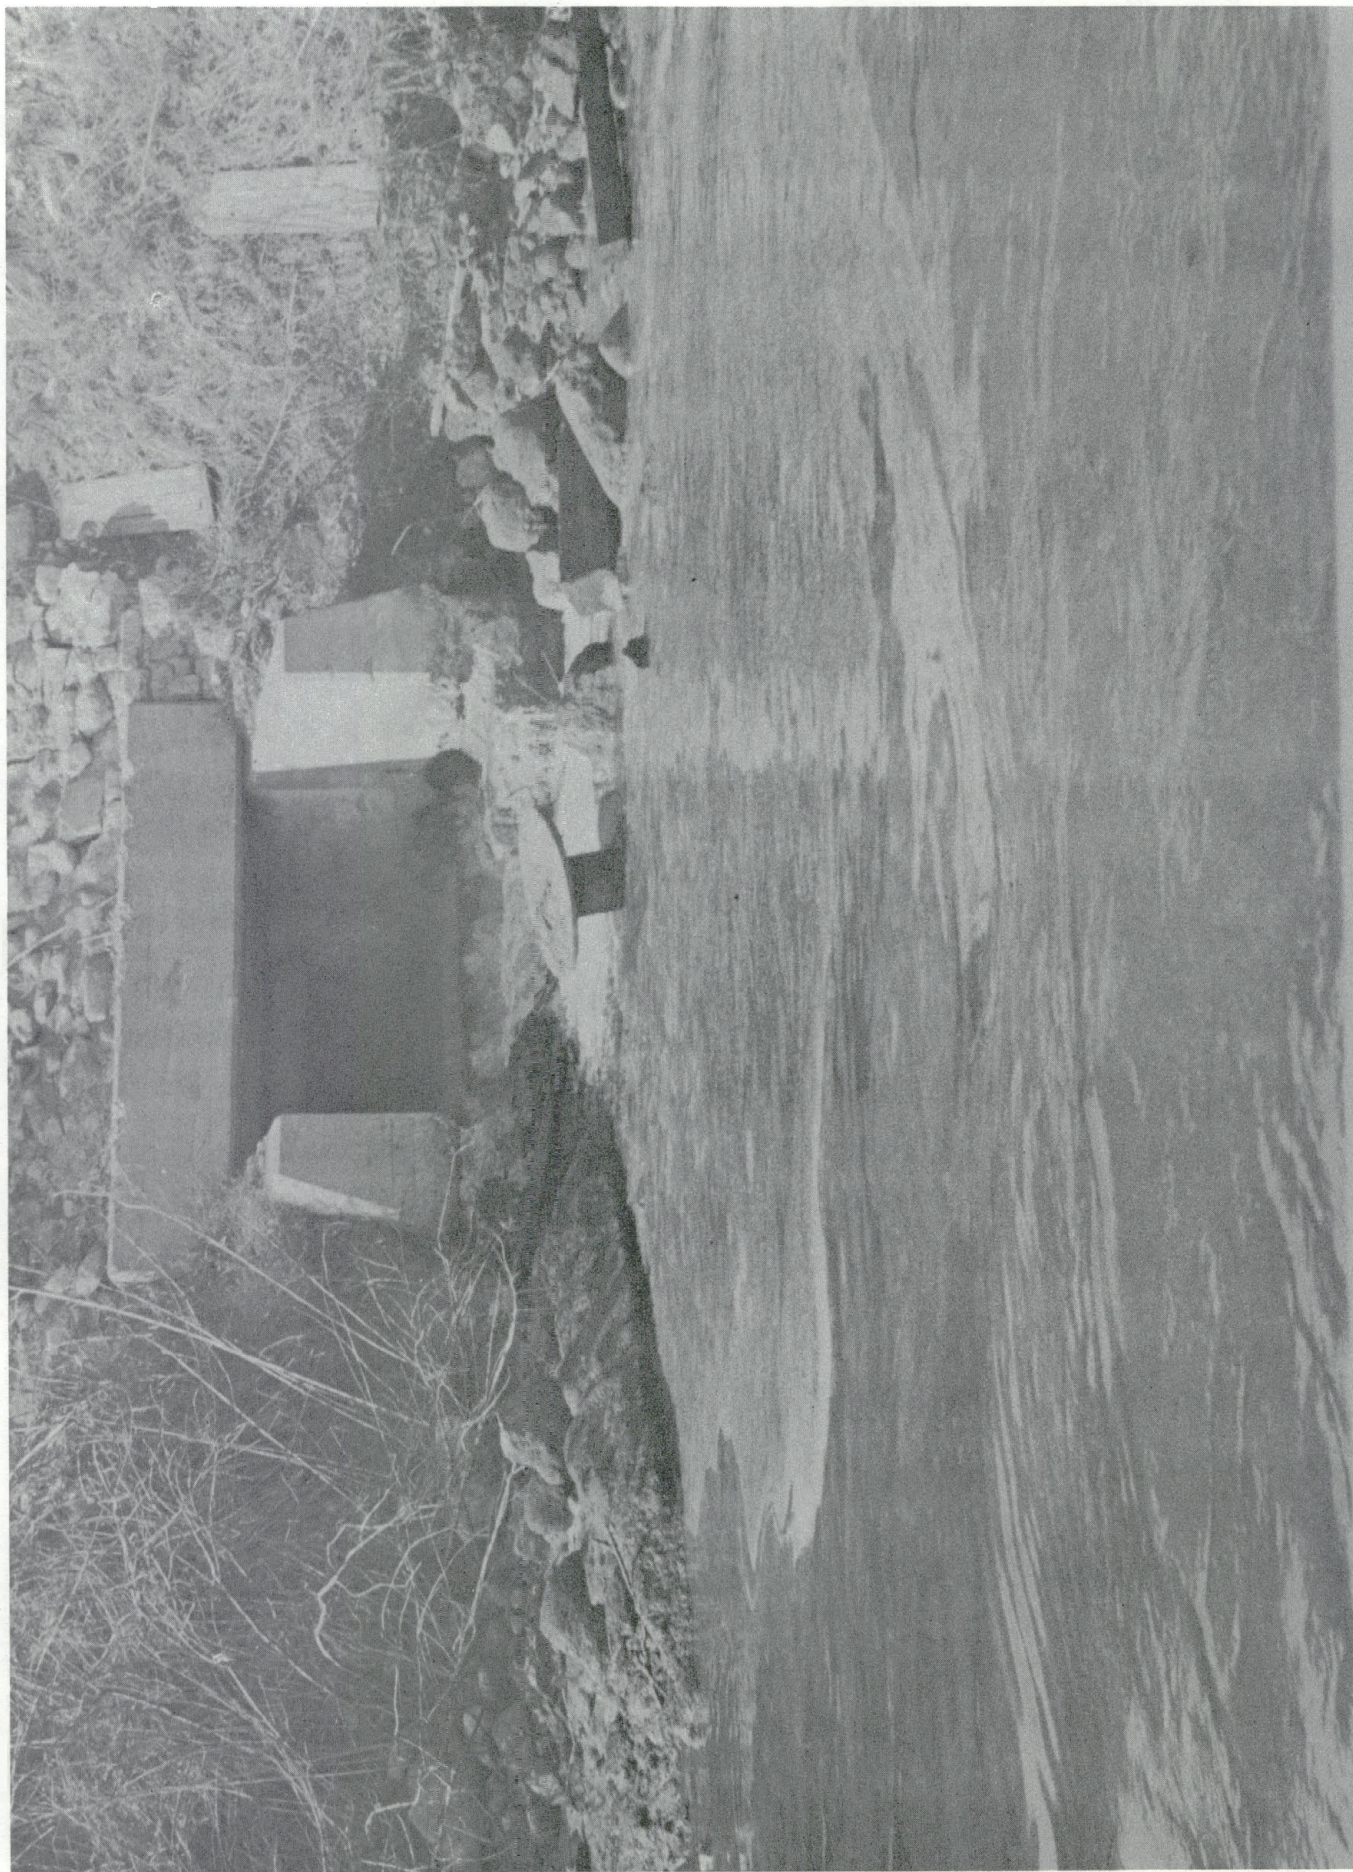
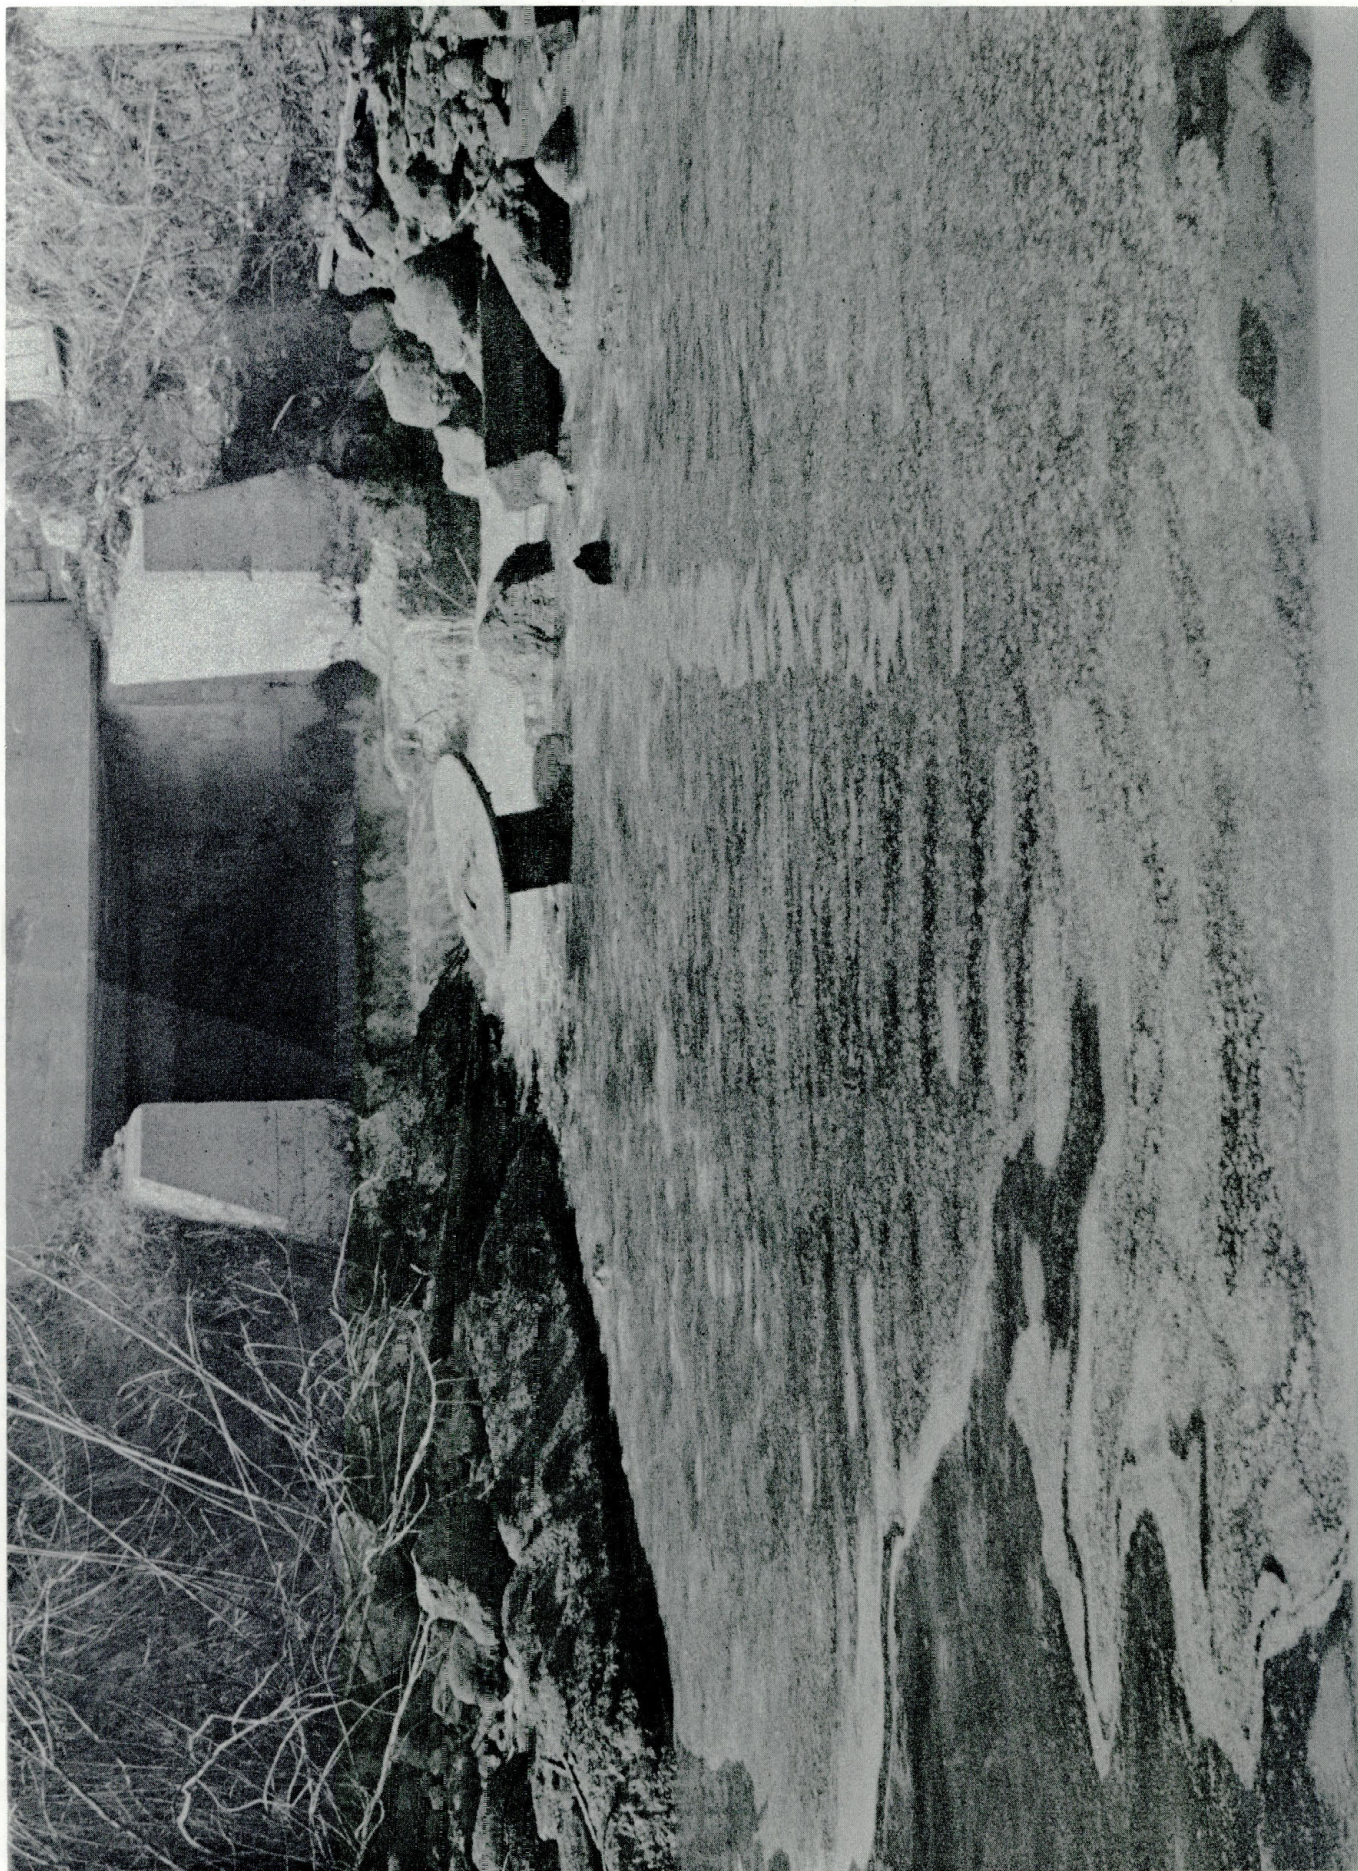
PICTURES 8 and 9 were taken just upstream from highway bridge, Route 171, and show a waste of undetermined origin heavily laden with floating solids. A B.O.D. determination of this waste showed 375 ppm B.O.D. Floating solids as seen in this picture can easily be removed from a waste by the simplest of treatment processes. The presence of these solids and the high B.O.D. indicate that no treatment is given to this very strong waste prior to discharge into the Chicago Sanitary Canal.

Sewer outlet just upstream from highway bridge, route 171. See sample #12.

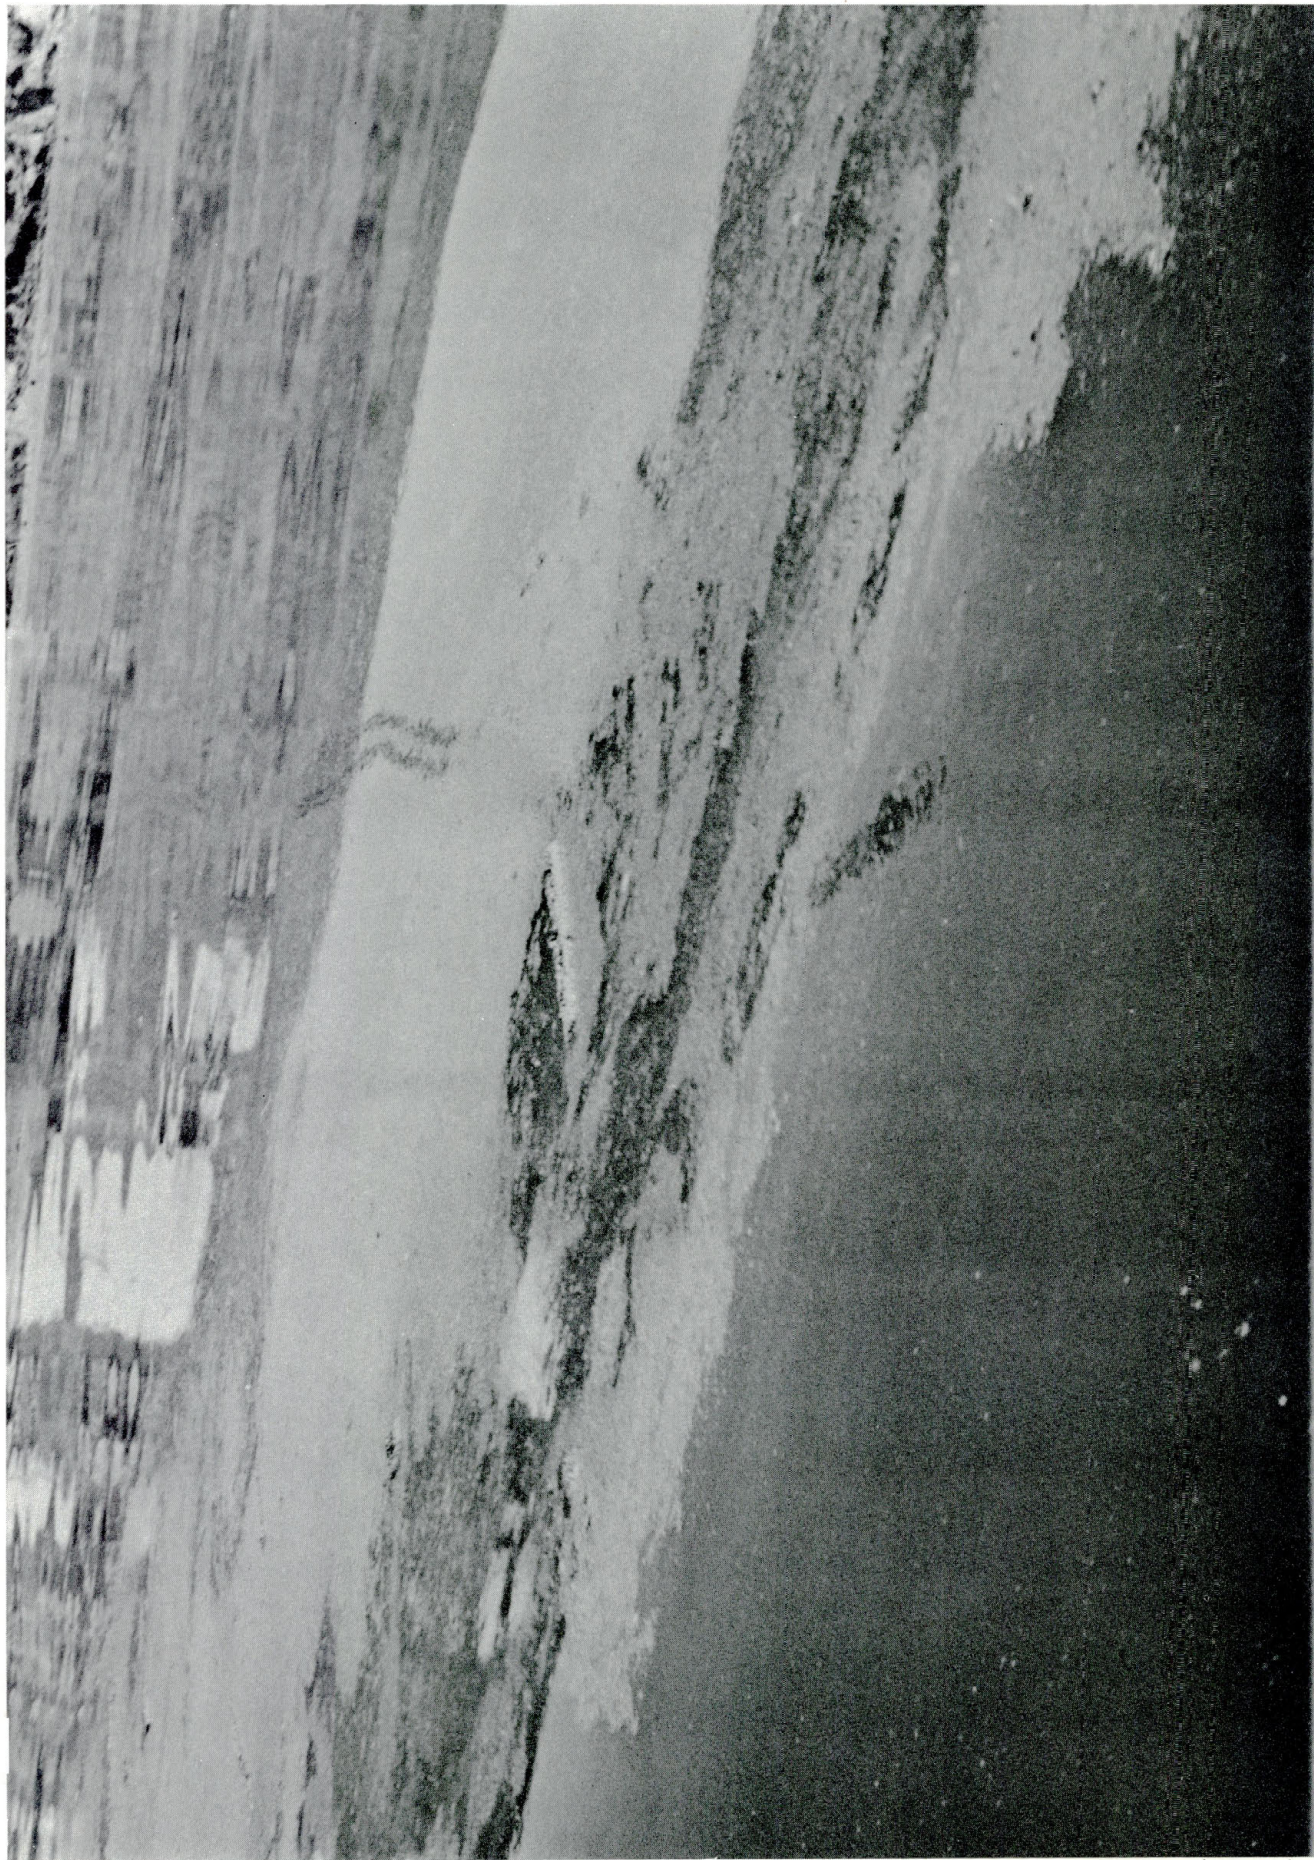
PICTURES 10, 11, 12, 13 show raw ground garbage floating on the surface. These pictures were taken just downstream from the Stickney Sewage Treatment Plant discharge sewer. No garbage could be found floating on the upstream side of this sewage plant outfall, and it is therefore concluded that this material is being discharged from the plant itself. If this is the case, one can only conclude that a percentage of Chicago's raw sewage is being bypassed around the plant without treatment. The floating solids, as shown in the pictures, were found in concentrated form for about one-quarter of a mile downstream from the sewage plant outfall. It should be pointed out that the portion of ground garbage that would be seen floating is probably only a small percentage of the original untreated sewage being discharged. It should also be pointed out that the crudest methods of sewage treatment are capable of removing the solids that are shown in these pictures.

Floating fresh ground garbage. Condition found just downstream from Stickney Sewage Treatment Plant outfall. Floating garbage prevalent for about one quarter of a mile from outfall. See sample #11.

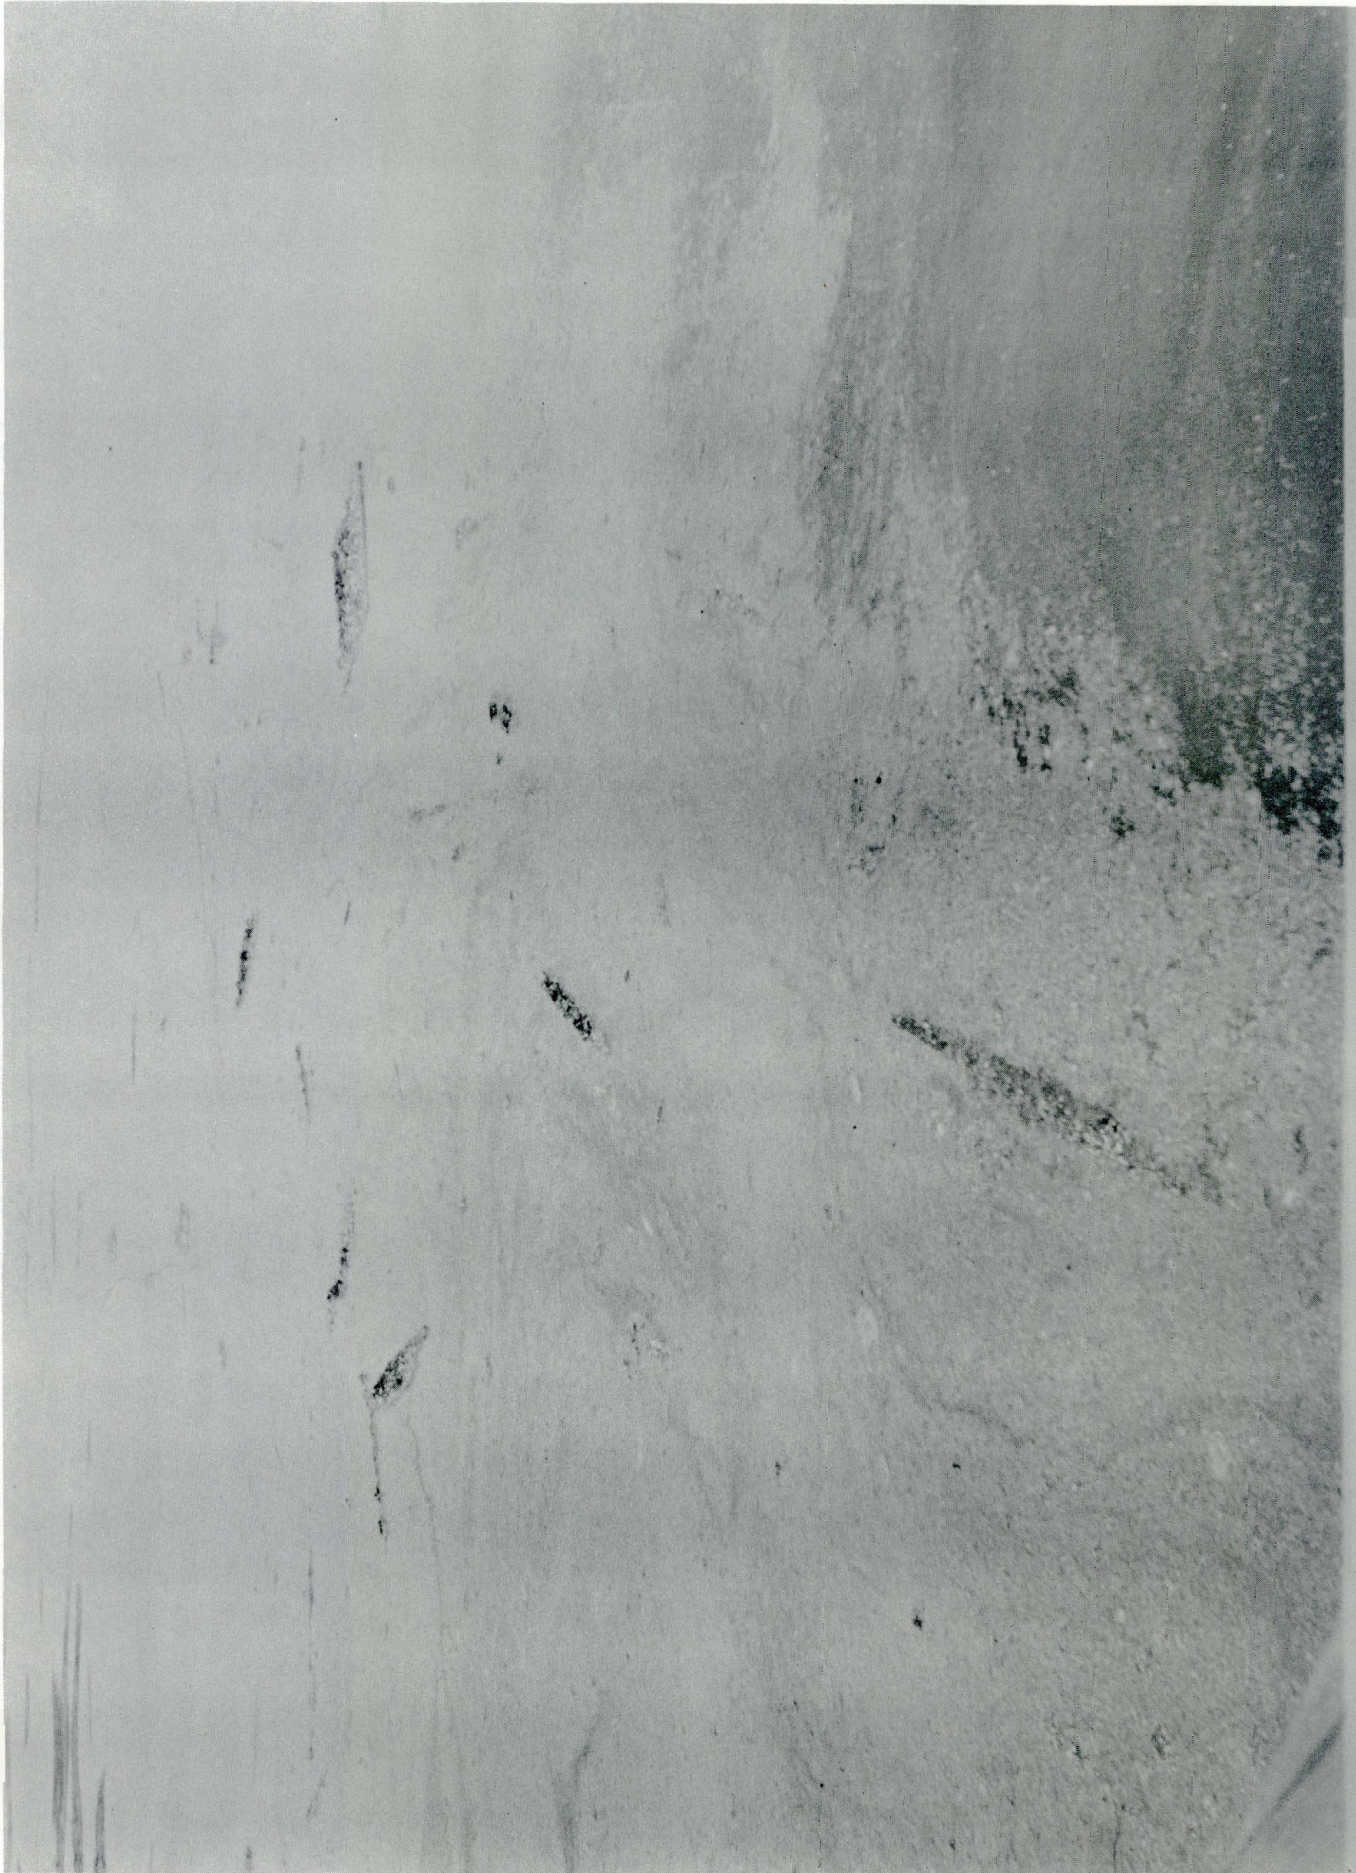
Floating fresh ground garbage. Condition found just downstream from Stickney Sewage Treatment Plant outfall. Floating garbage prevalent for about one quarter of a mile from outfall. See sample #11.

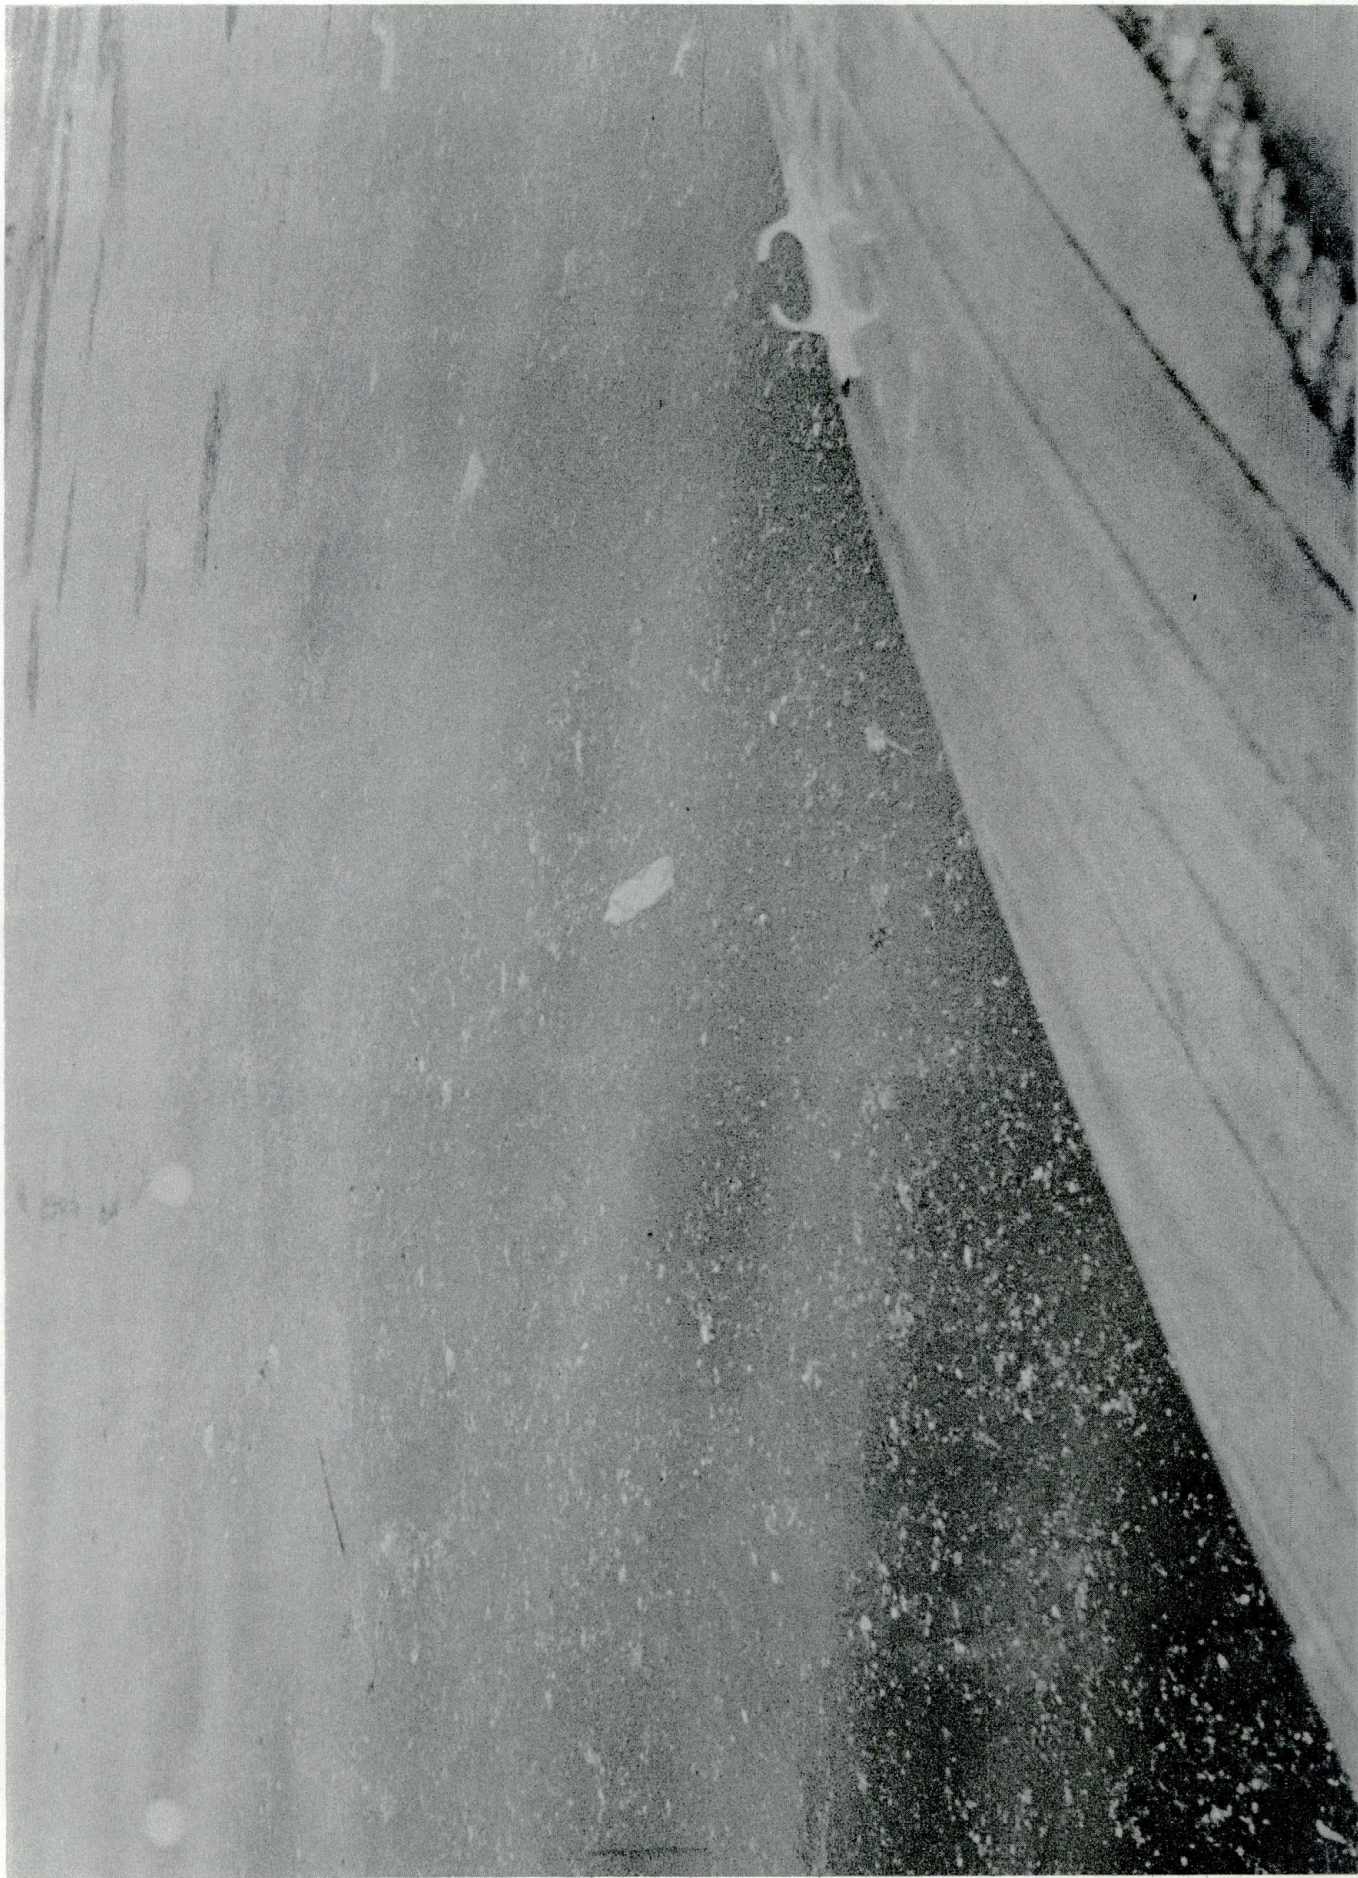
Floating fresh ground garbage. Condition found just downstream from Stickney Sewage Treatment Plant outfall. Floating garbage prevalent for about one quarter of a mile from outfall. See sample #11.

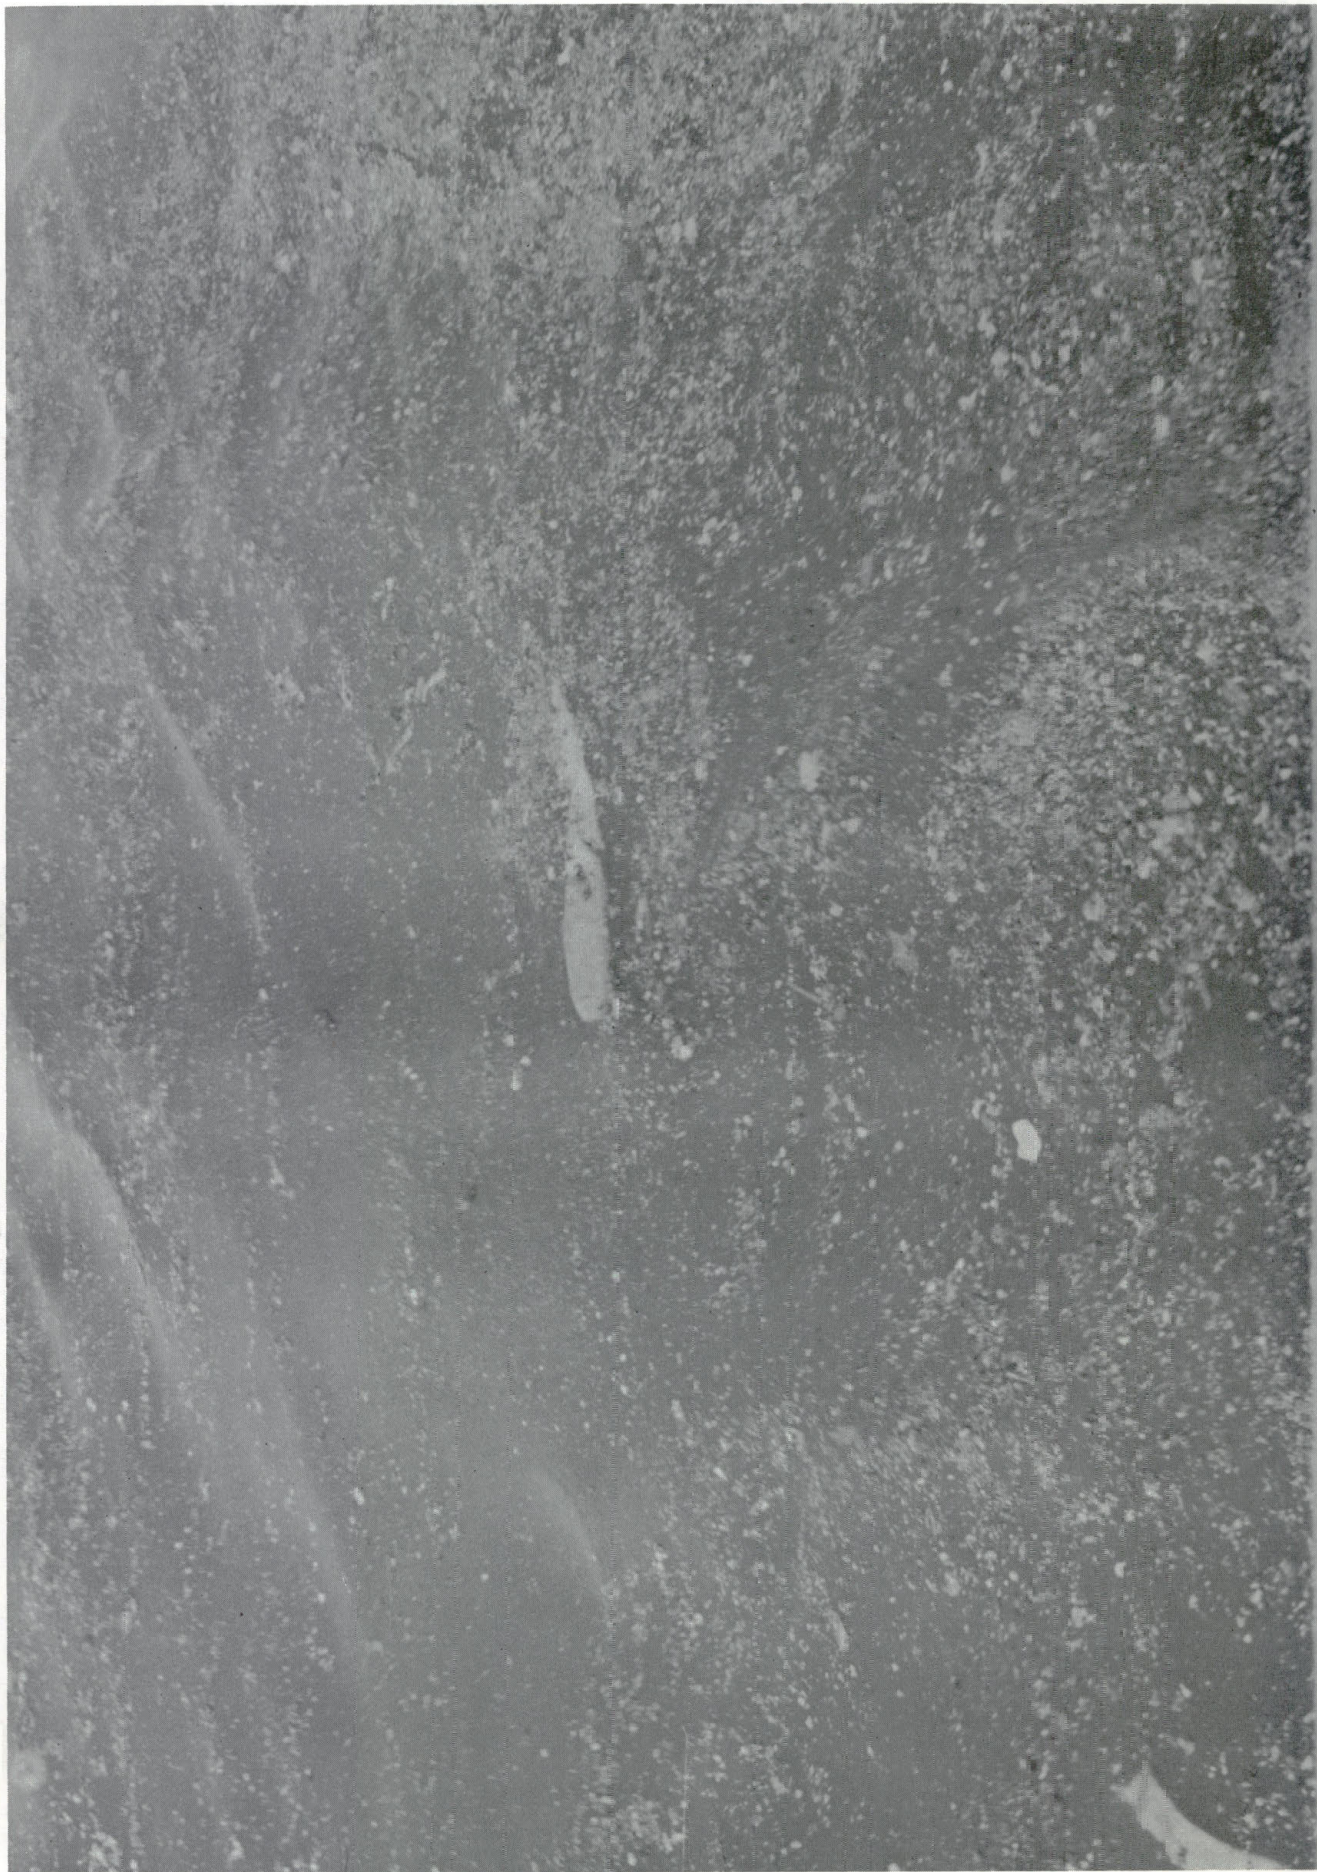
Floating fresh ground garbage. Condition found just downstream from Stickney Sewage Treatment Plant outfall. Floating garbage prevalent for about one quarter of a mile from outfall. See sample #11.

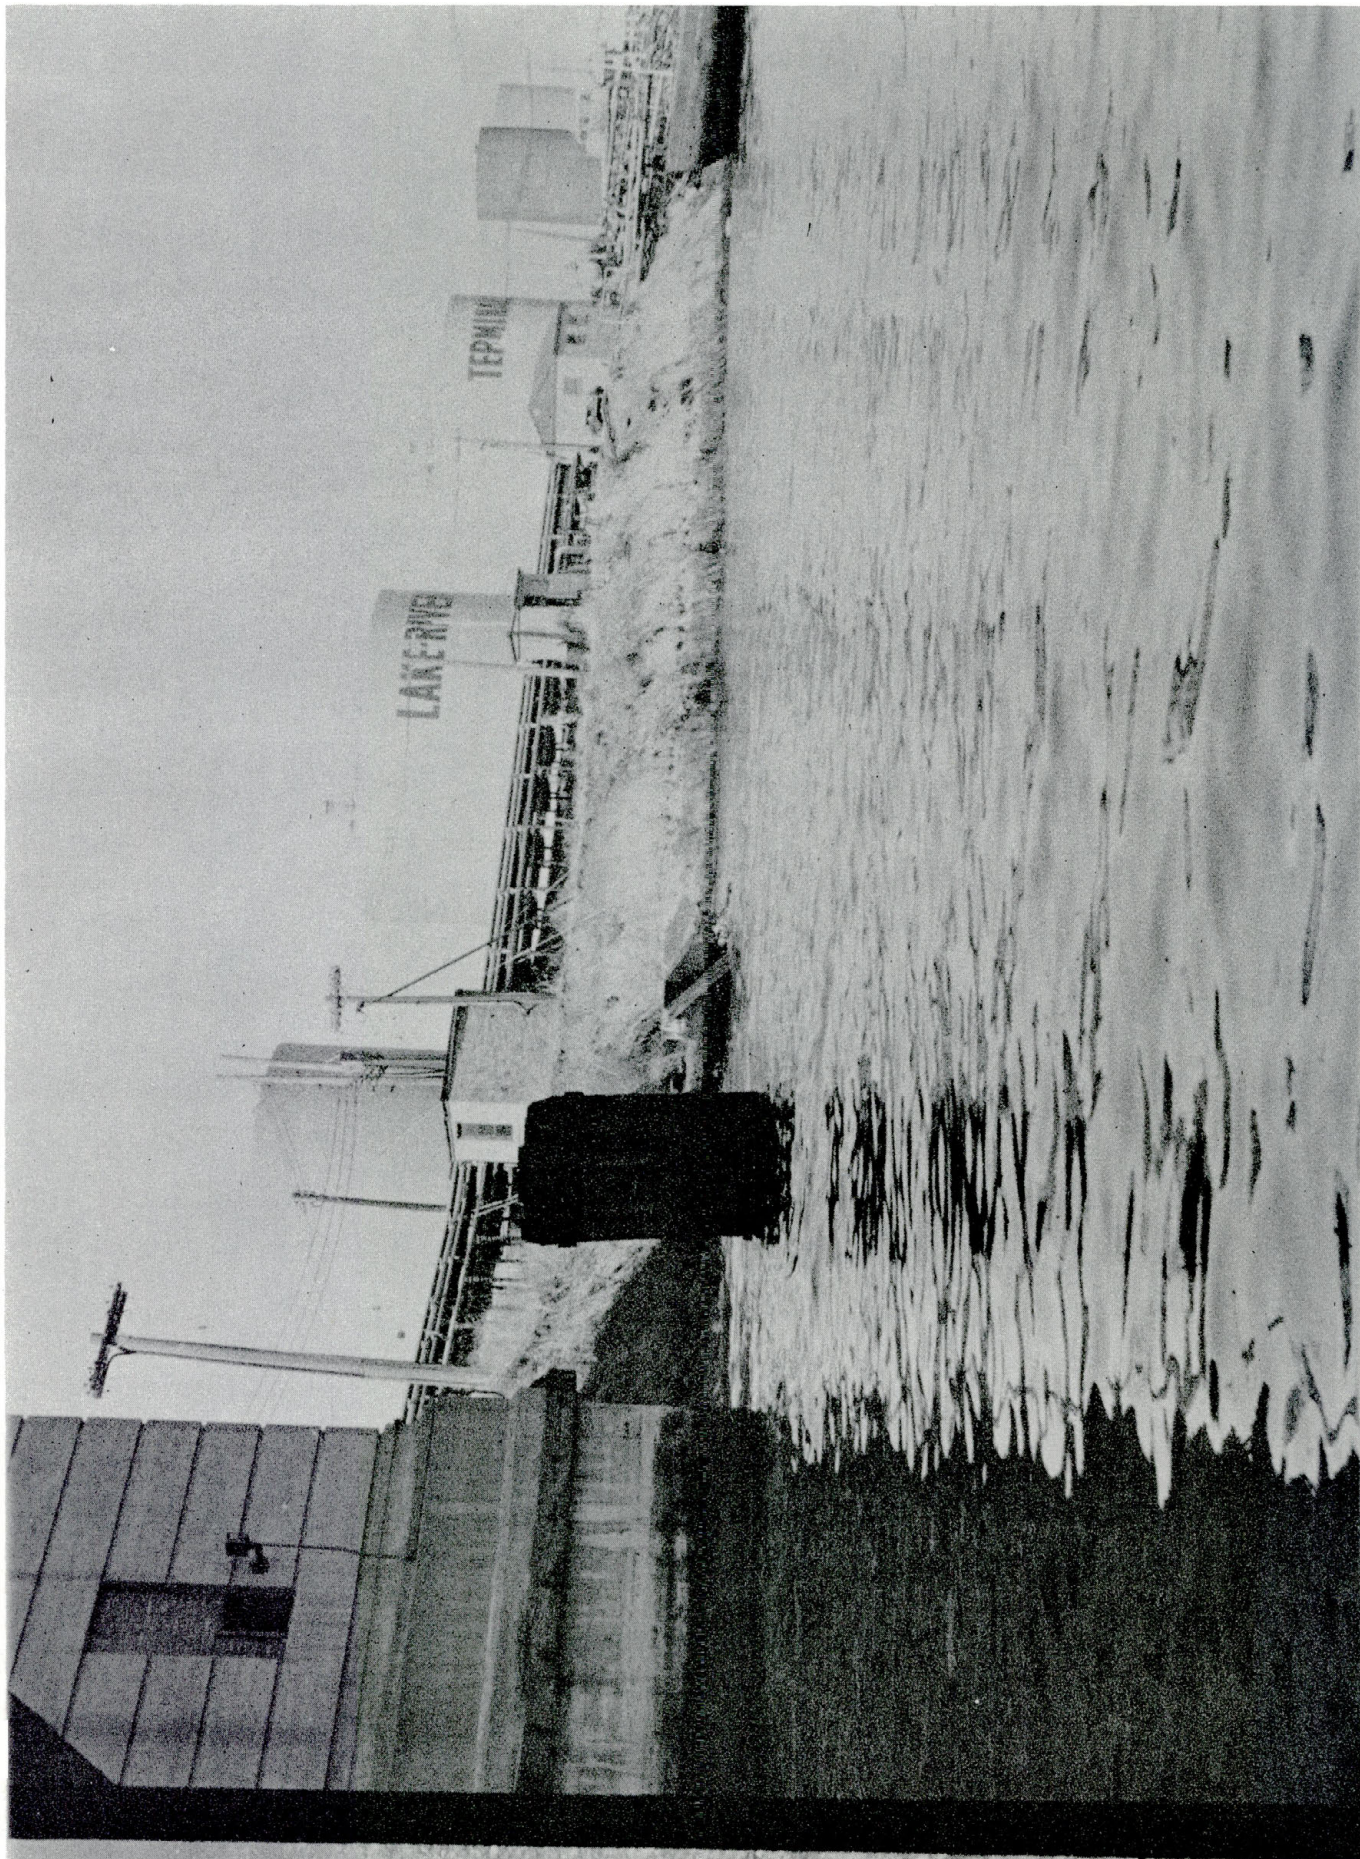
PICTURES 14, 15, 16, 17 were taken upstream from the Stickney Sewage Plant in the area of numerous oil works. The pictures show oil slicks on the surface of the canal, and thick oil scum deposits along the banks. Heavy oil slicks, as shown in picture 16, inhibit the transfer of atmospheric oxygen into the canal

Sewer outlet by Lake-River Terminal Oil Co. Note heavy oil slicks around sewer opening.

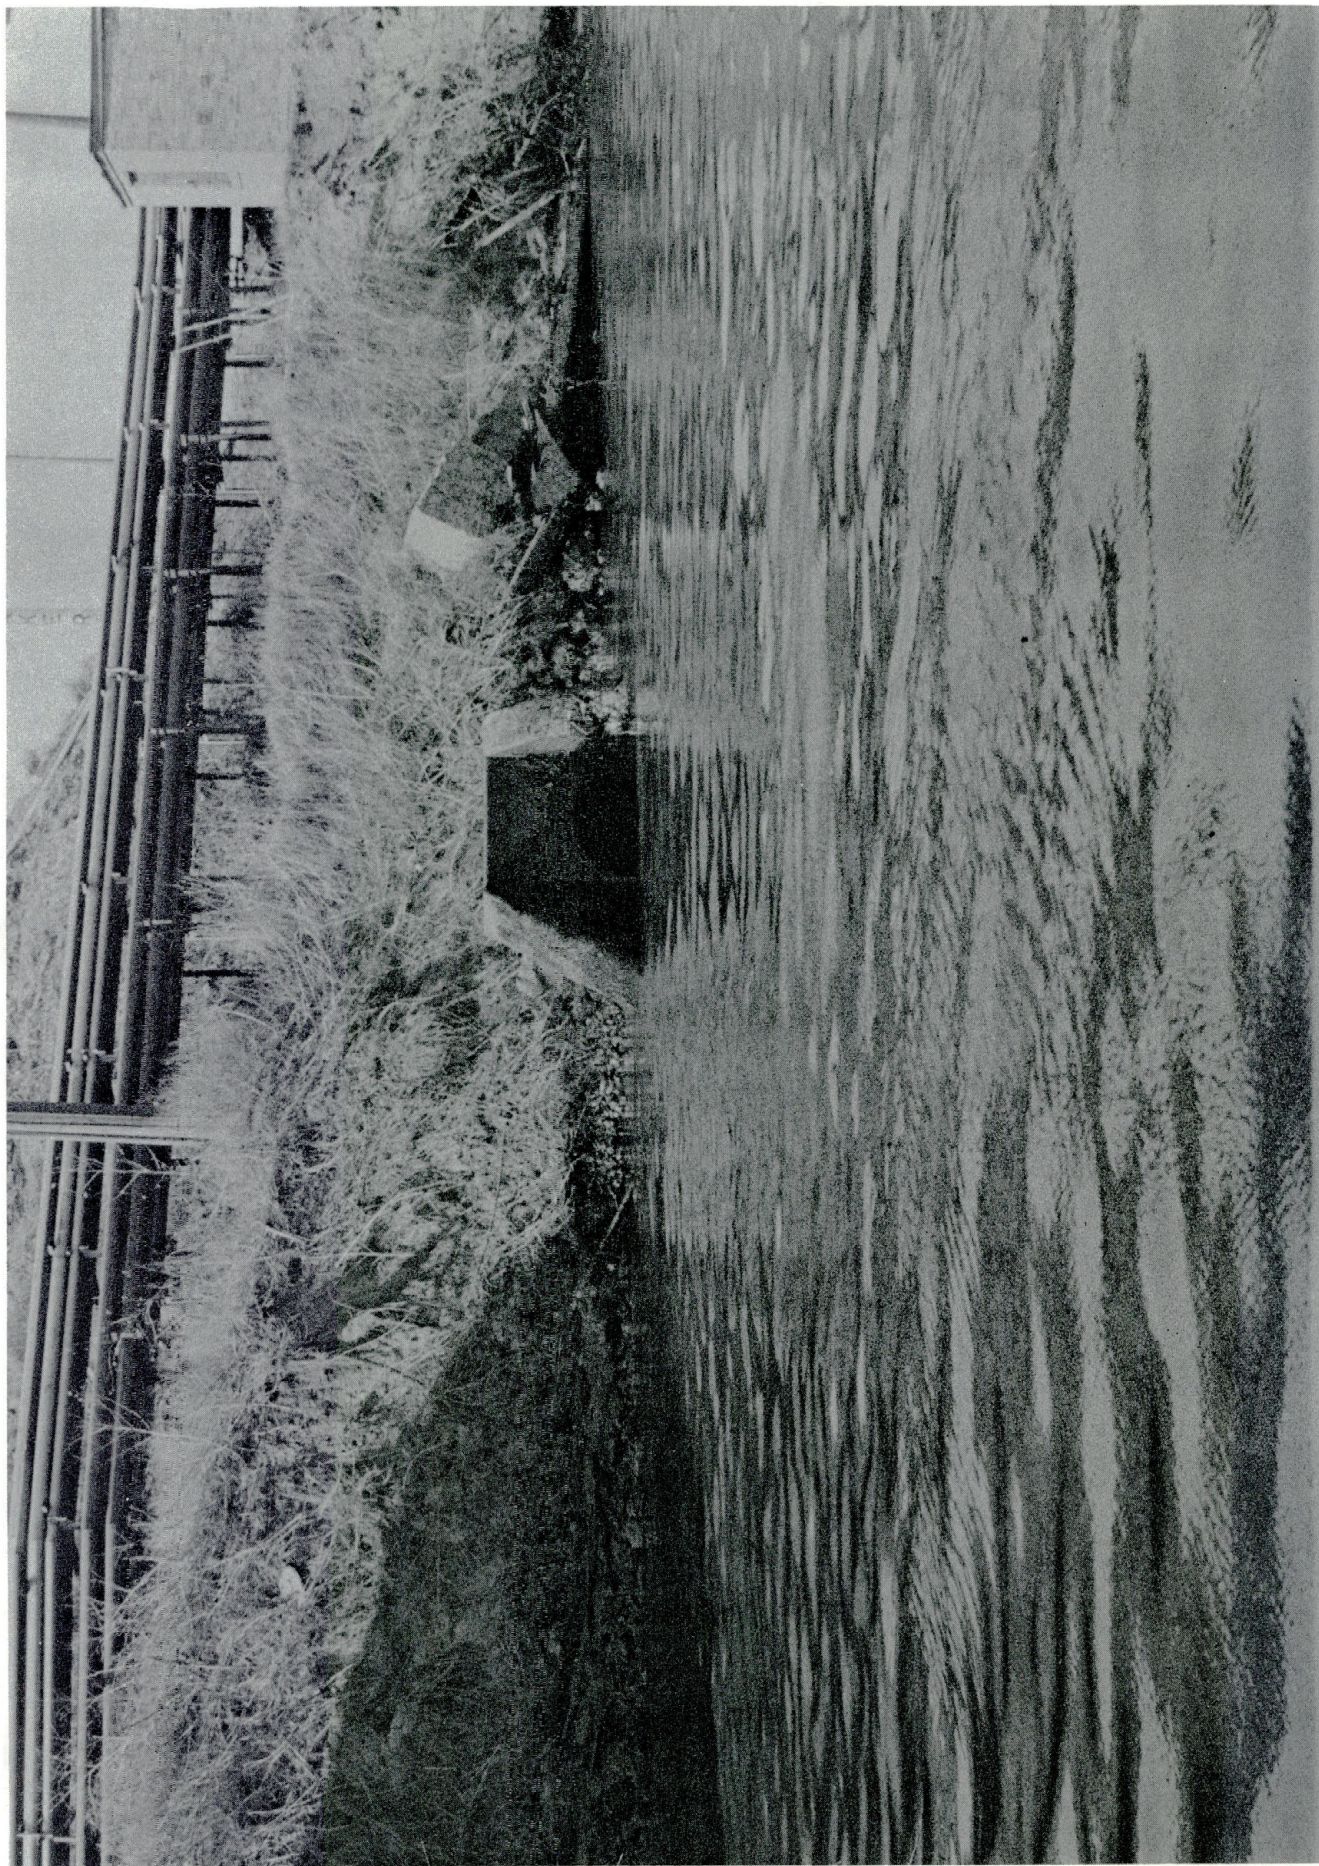
Sewer outlet by Lake-River Terminal Oil Co. Note heavy oil slicks around sewer opening.
