REPORT ON A SURVEY
OF THE
CHICAGO SANITARY CANAL AND THE CALUMET SAG CHANNEL

Michigan Associates
Consulting Engineers
Lansing 29, Michigan

22 April 1959

REPORT ON A SURVEY OF THE
CHICAGO SANITARY CANAL AND THE CALUMET SAG CHANNEL

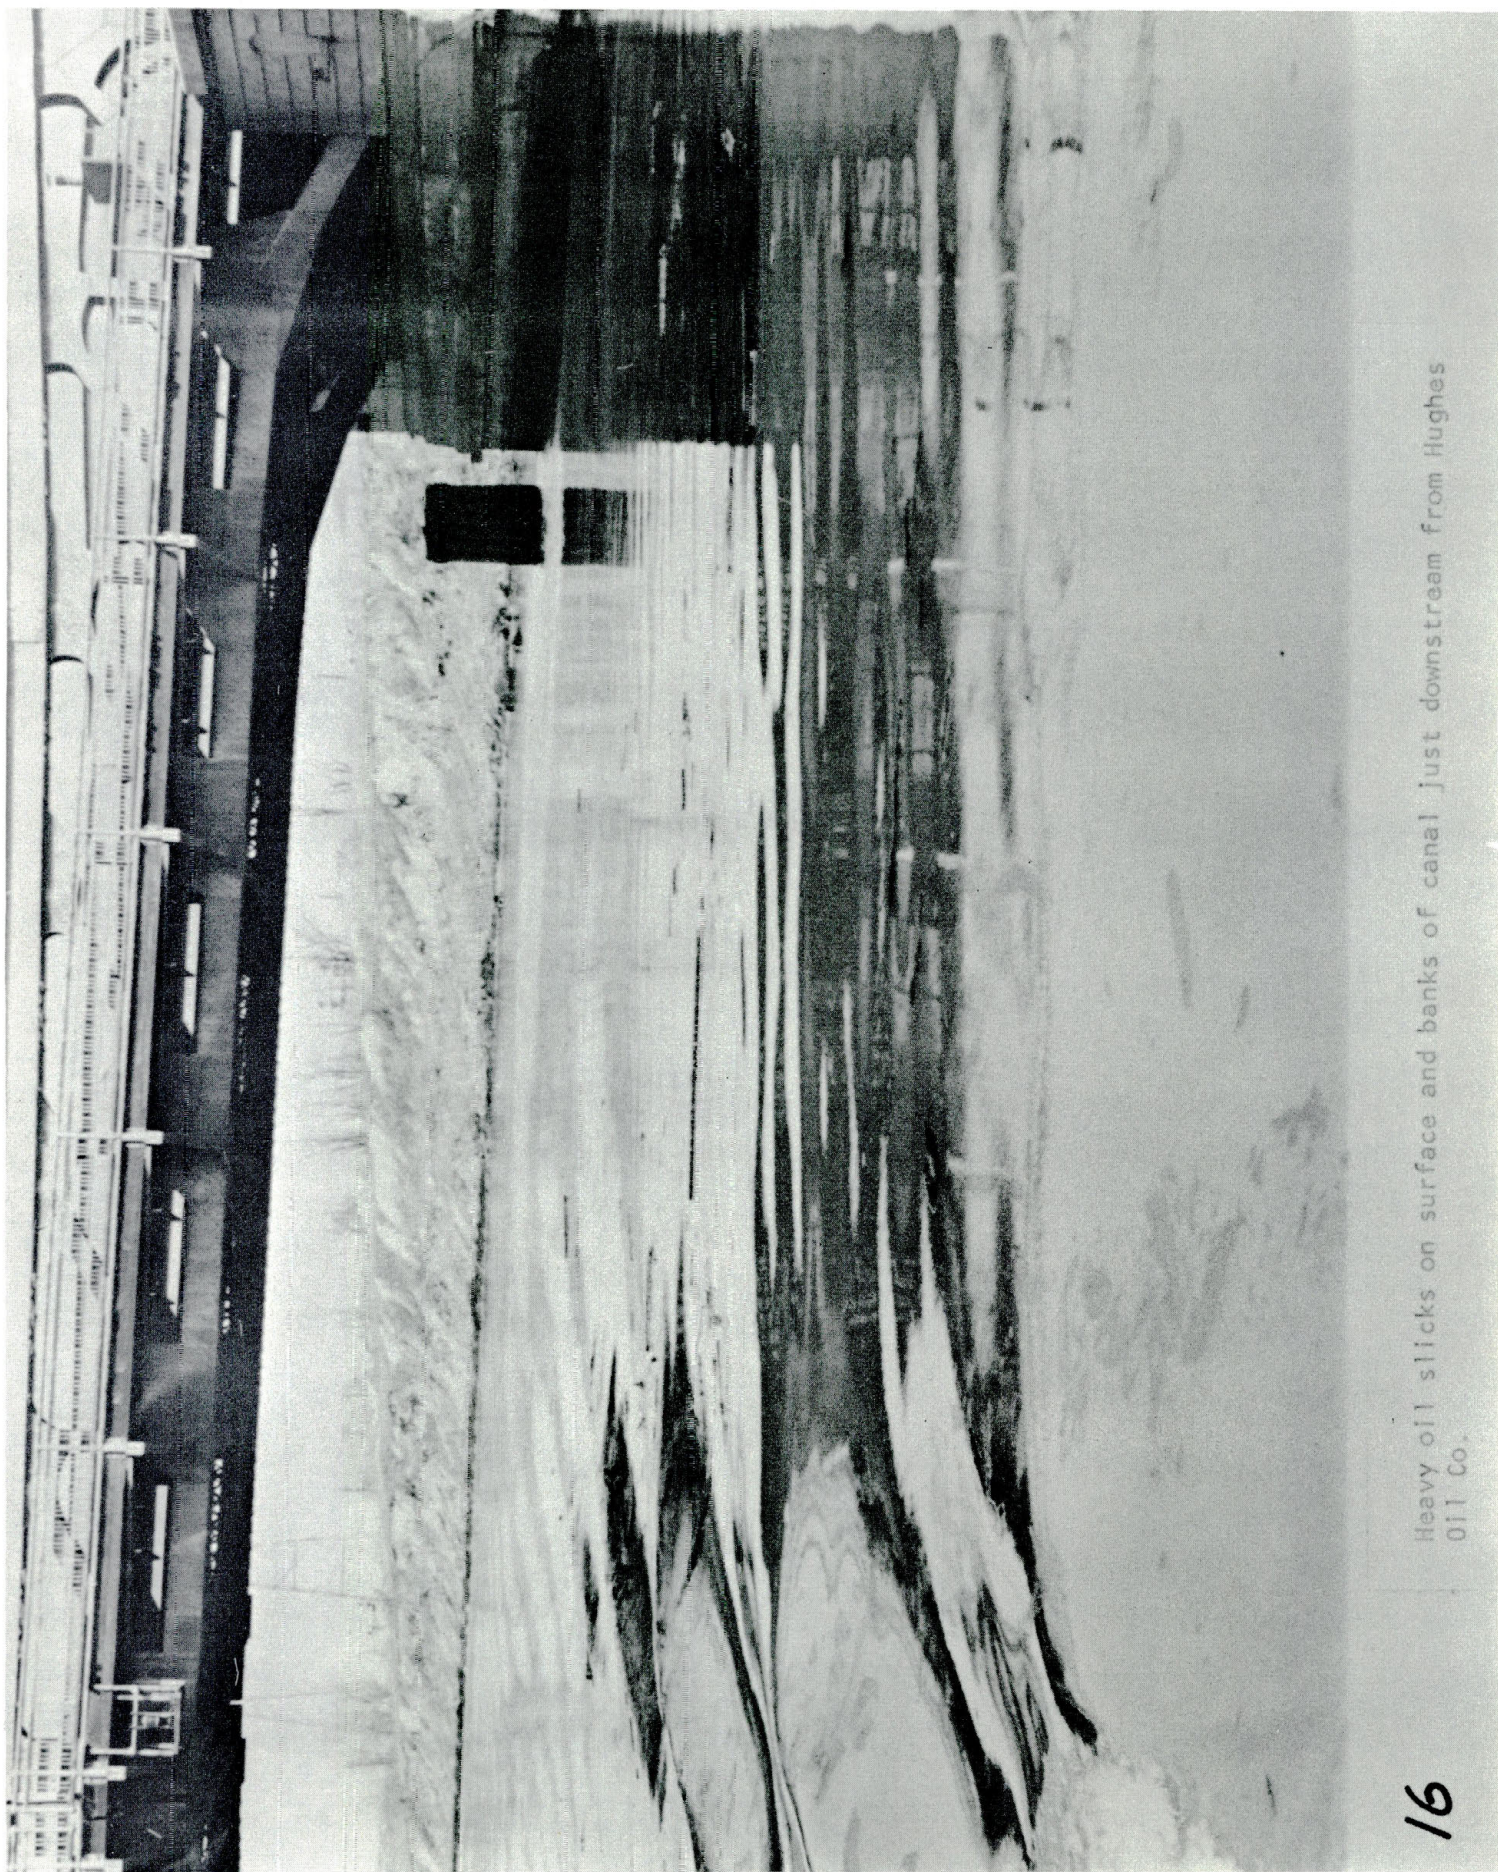
PICTURES 14, 15, 16, 17 were taken upstream from the Stickney Sewage Plant in the area of numerous oil works. The pictures show oil slicks on the surface of the canal, and thick oil scum deposits along the banks. Heavy oil slicks, as shown in picture 16, inhibit the transfer of atmospheric oxygen into the canal

water, and thereby, reduce the ability of the water to purify itself through natural biological processes.

Heavy oil slicks on surface and banks of canal just downstream from Hughes Oil Co.

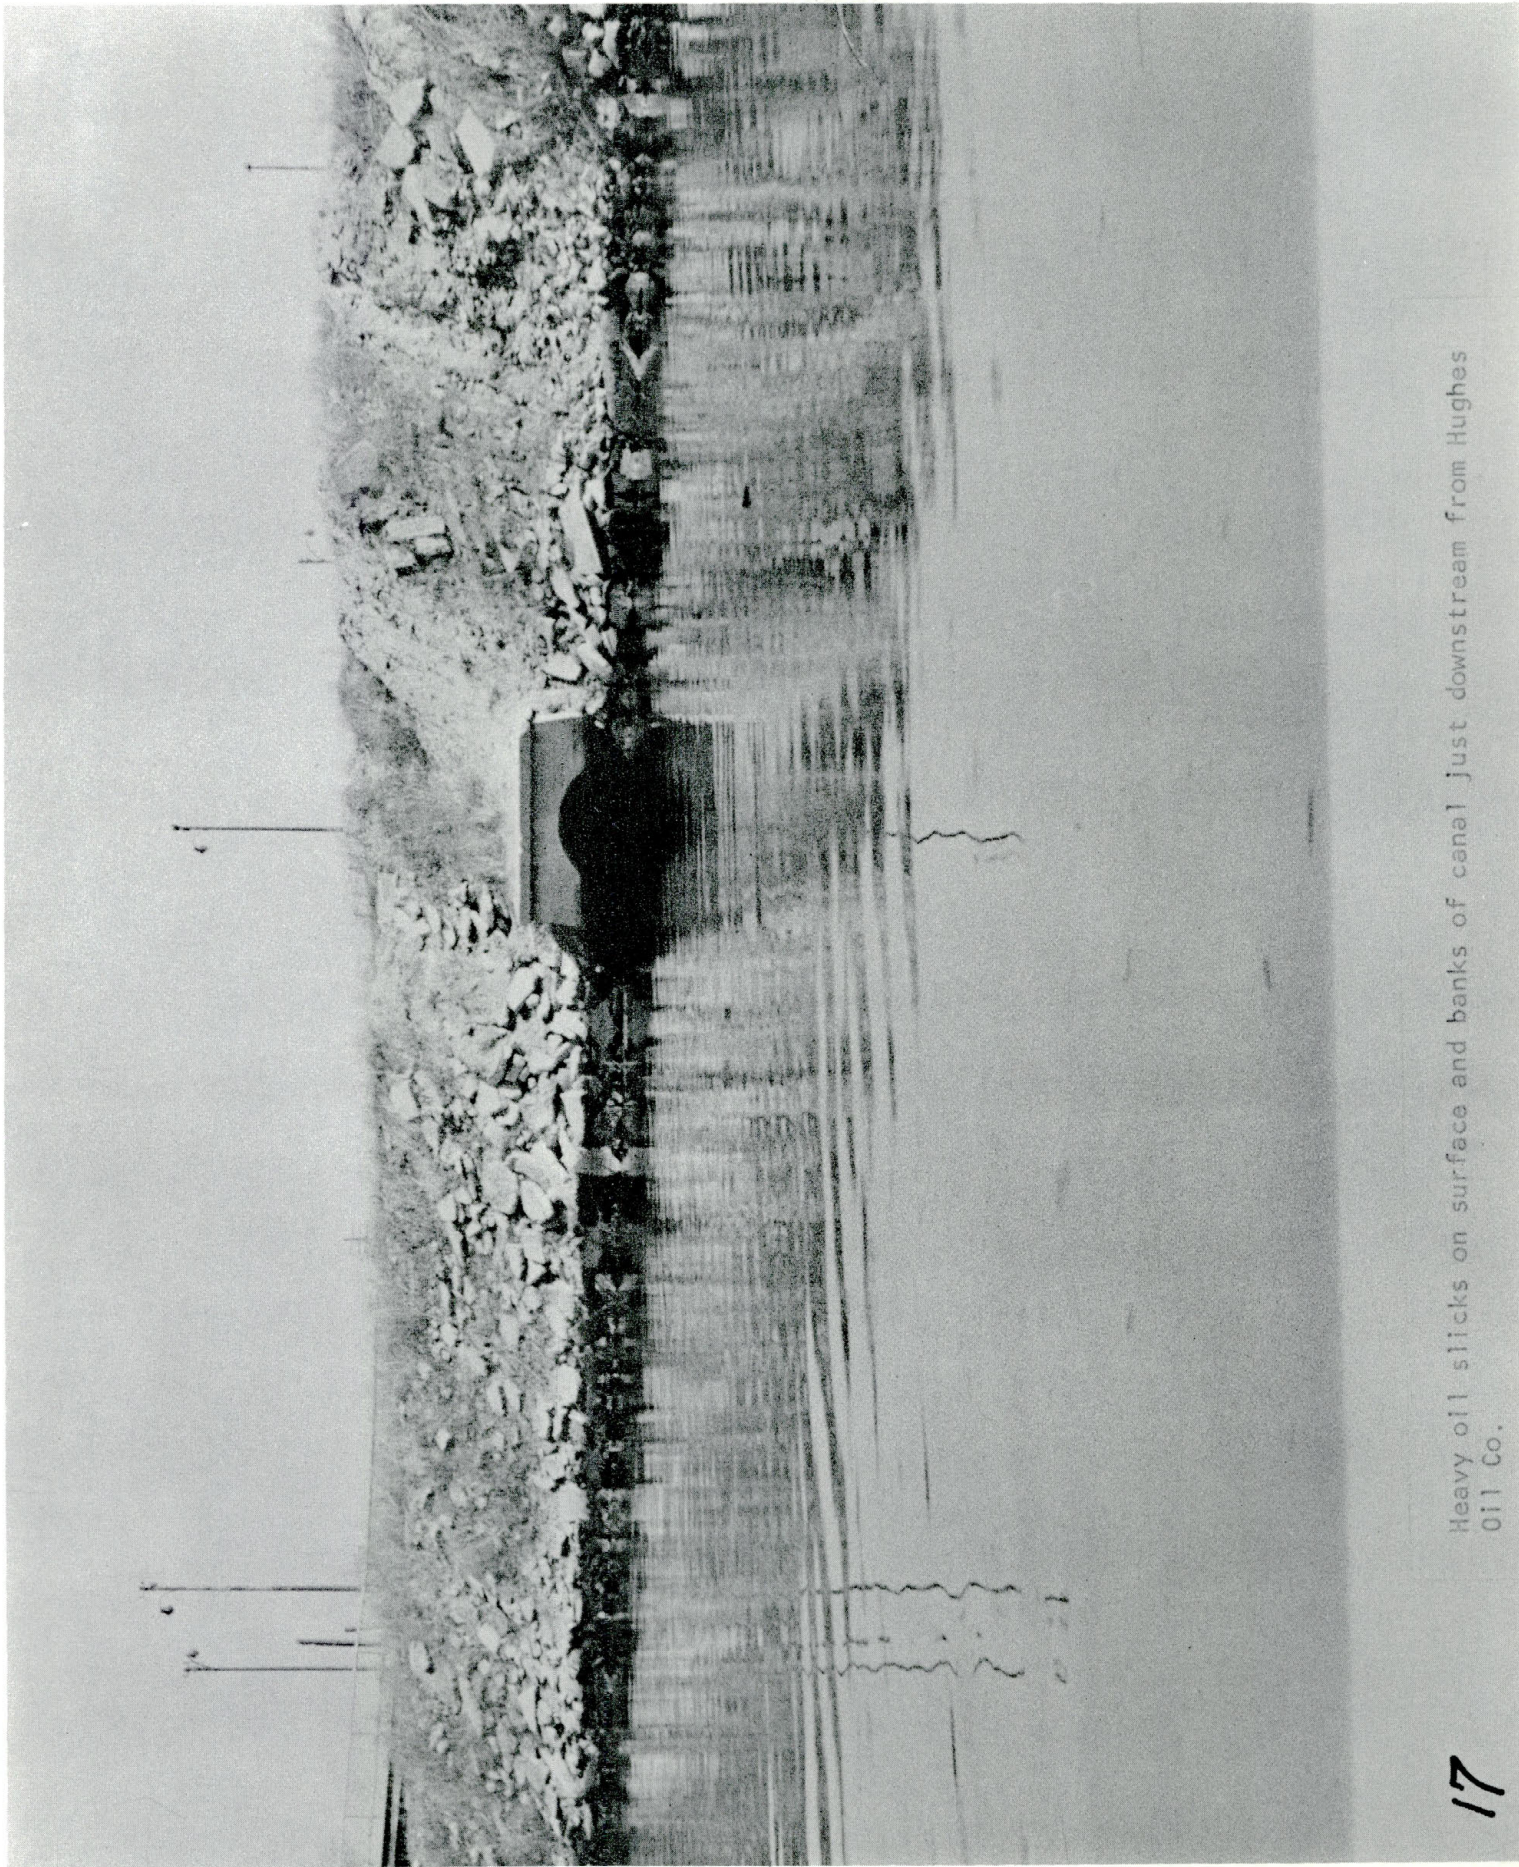
Heavy oil slicks on surface and banks of canal just downstream from Hughes
Oil Co.

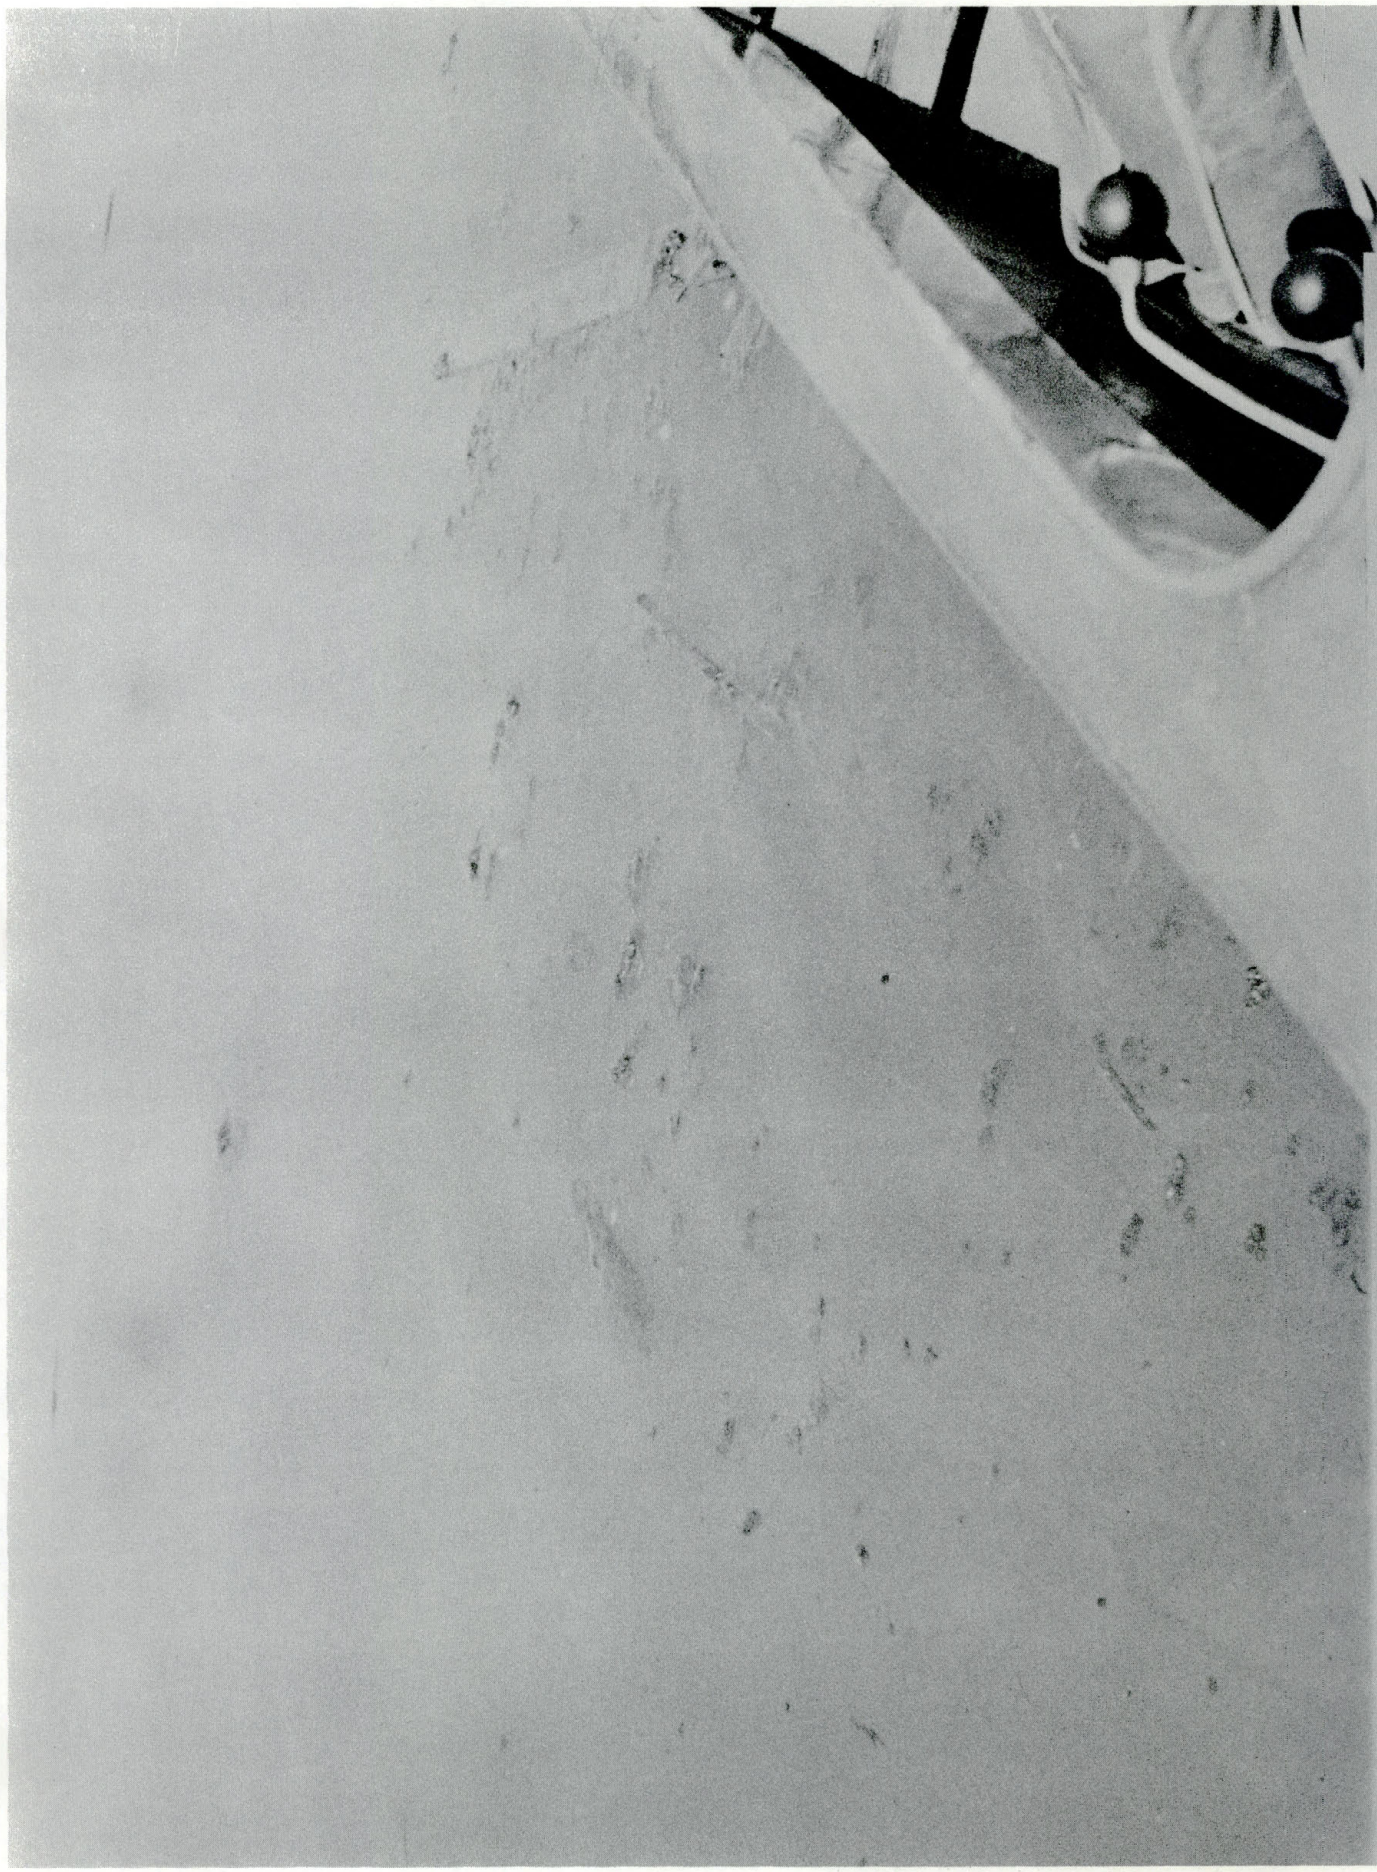
PICTURE 18 was taken at the junction of the Chicago Sanitary Canal and the canal leading to the Union Stock Yard area. These solids were composed of grease, scum, organic solids and debris, and is typical of many areas along the entire length of canal that was traveled.

Floating grease, scum and debris typical of many areas along Chicago Sanitary Canal. Picture taken at Junction of Chicago Sanitary Canal and canal leading to Union Stock Yard area. See sample #7

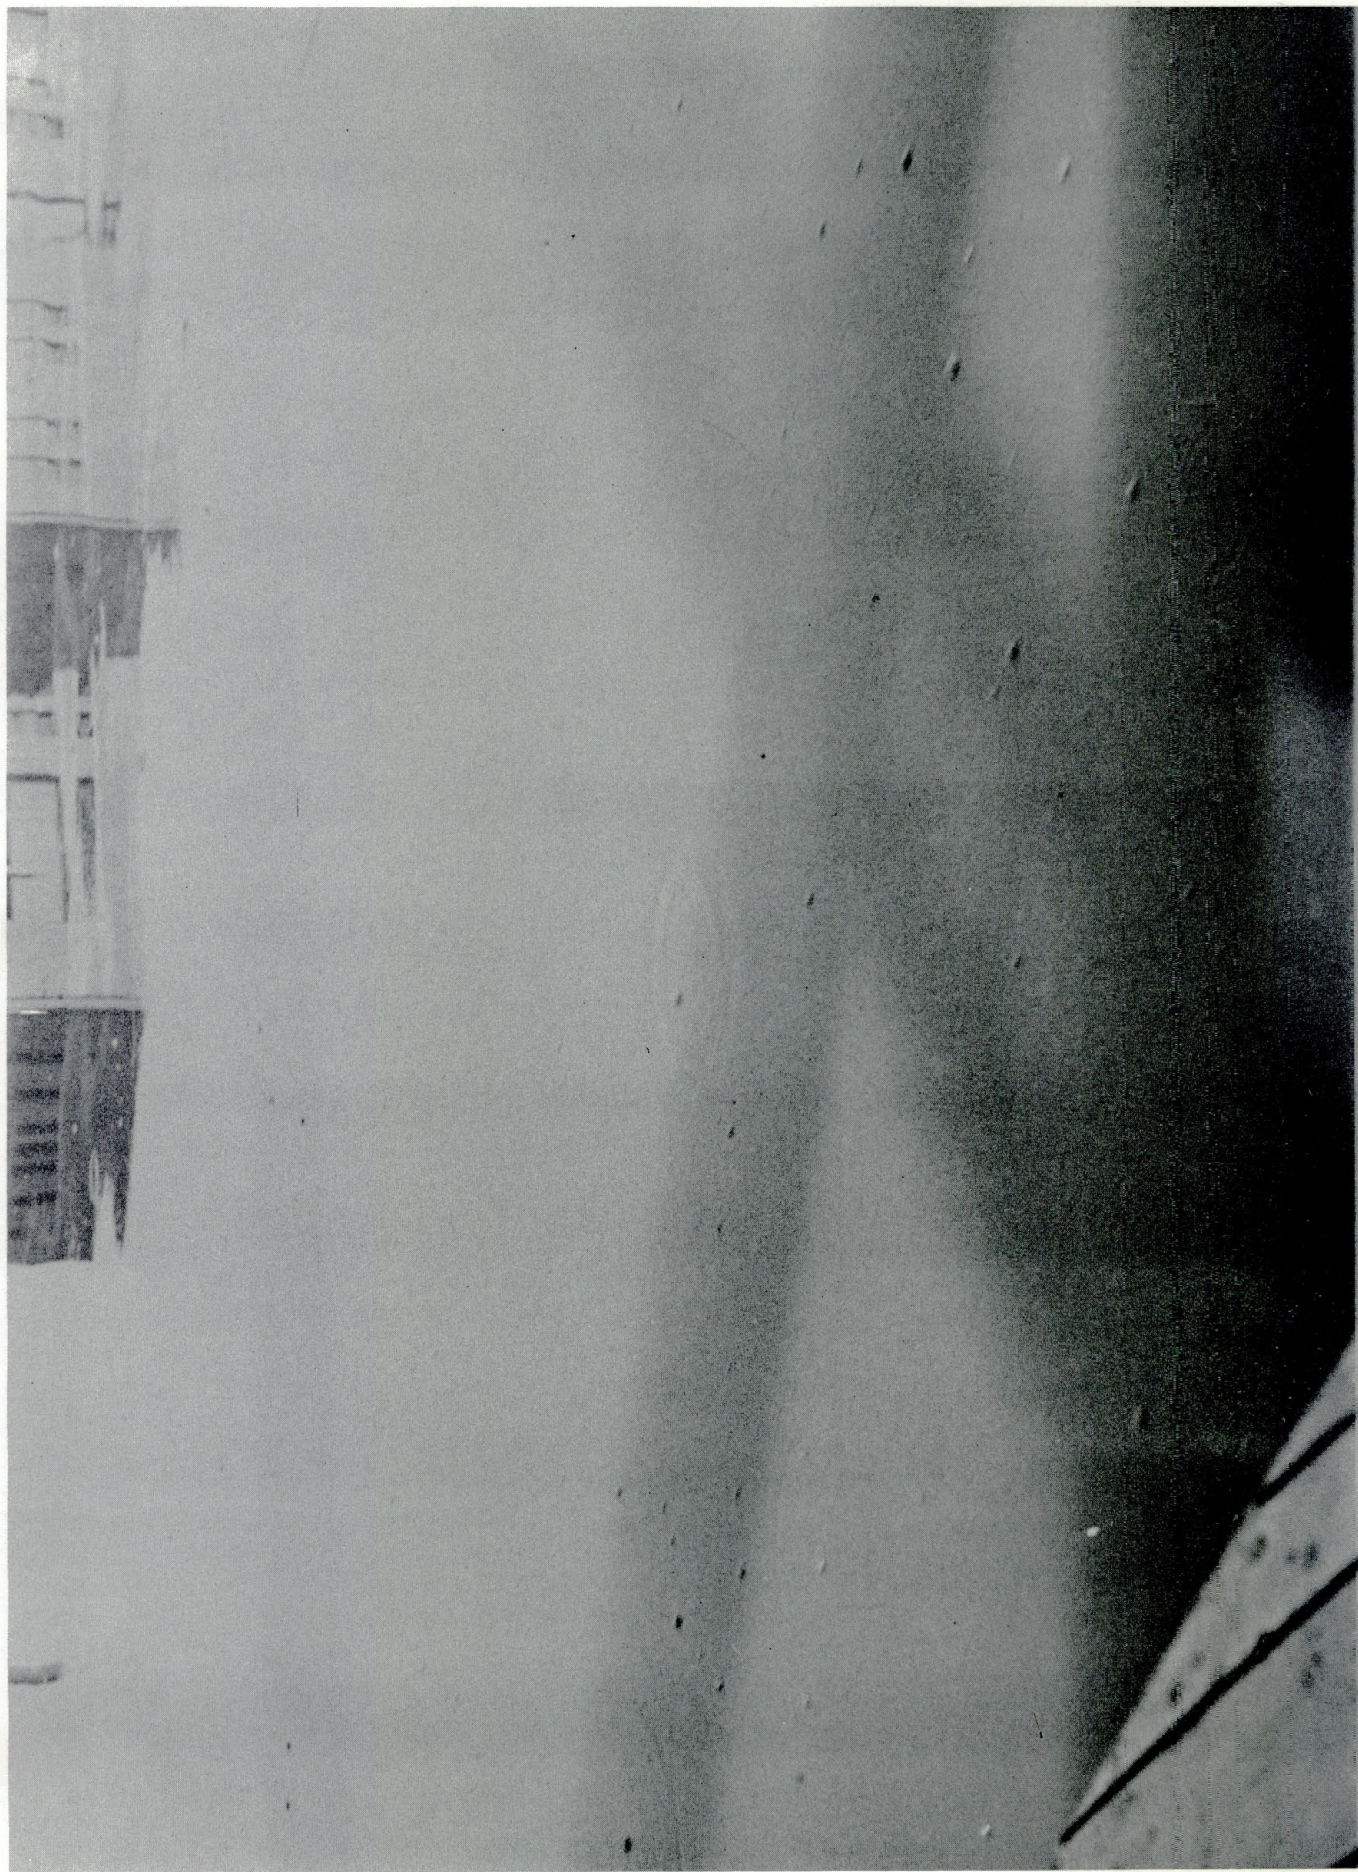
PICTURE 19 was taken in the canal leading to the Union Stock Yard area, and shows the gas bubbles rising from the sludge deposits on the bottom of the canal. A representative sample taken from the canal water near the surface at the end of this canal showed a B.O.D. of 205 ppm. Our boat followed a barge tug about half way up this canal. The tug's large screw churned the water considerably and stirred up the bottom sludge deposits. A sample of the stirred up water was taken and can best be described by saying that it was black as ink, and had a very foul and nauseating odor. In fact, the general impression while traveling this canal was that of boating in a septic tank. The upper end of this canal is too shallow for barge traffic, and as a result, the sludge deposits are not kept stirred up. While we were in this area, large chunks of organic sludge, 3 and 4 feet long, would periodically break loose from the bottom and come boiling to the surface. The putrid nature of this water and the heavy sludge deposits are conclusive indications that strong sewage is discharged into this canal.

Canal leading to Union Stock Yard area. Note gas bubbles from heavy septic sludge deposits along bottom of Canal. See Sample #8

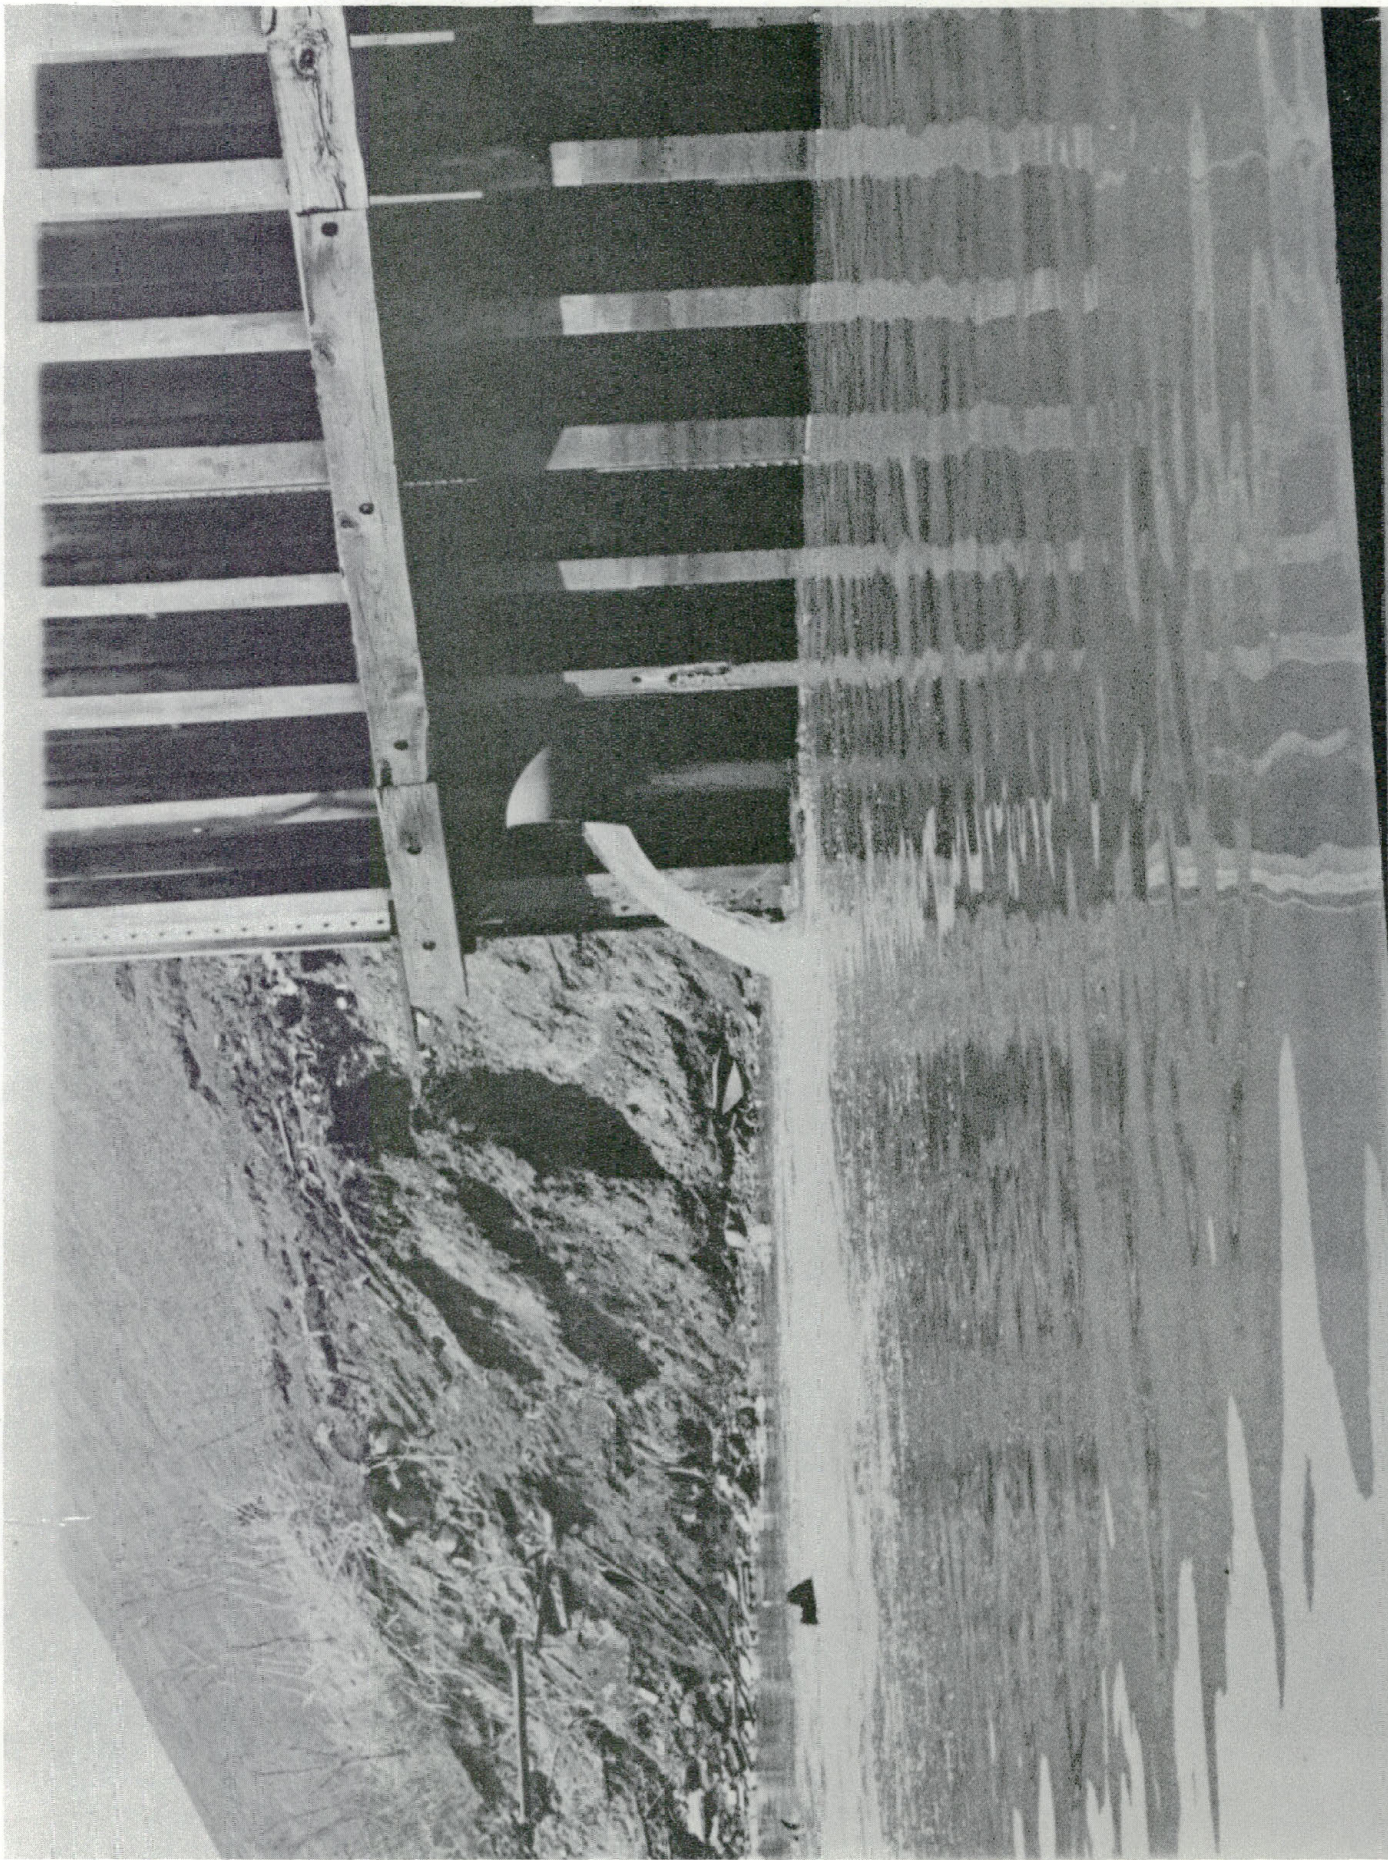
Sewer outlet under Railroad bridge just upstream from Canal Street in
Chicago Sanitary Canal.

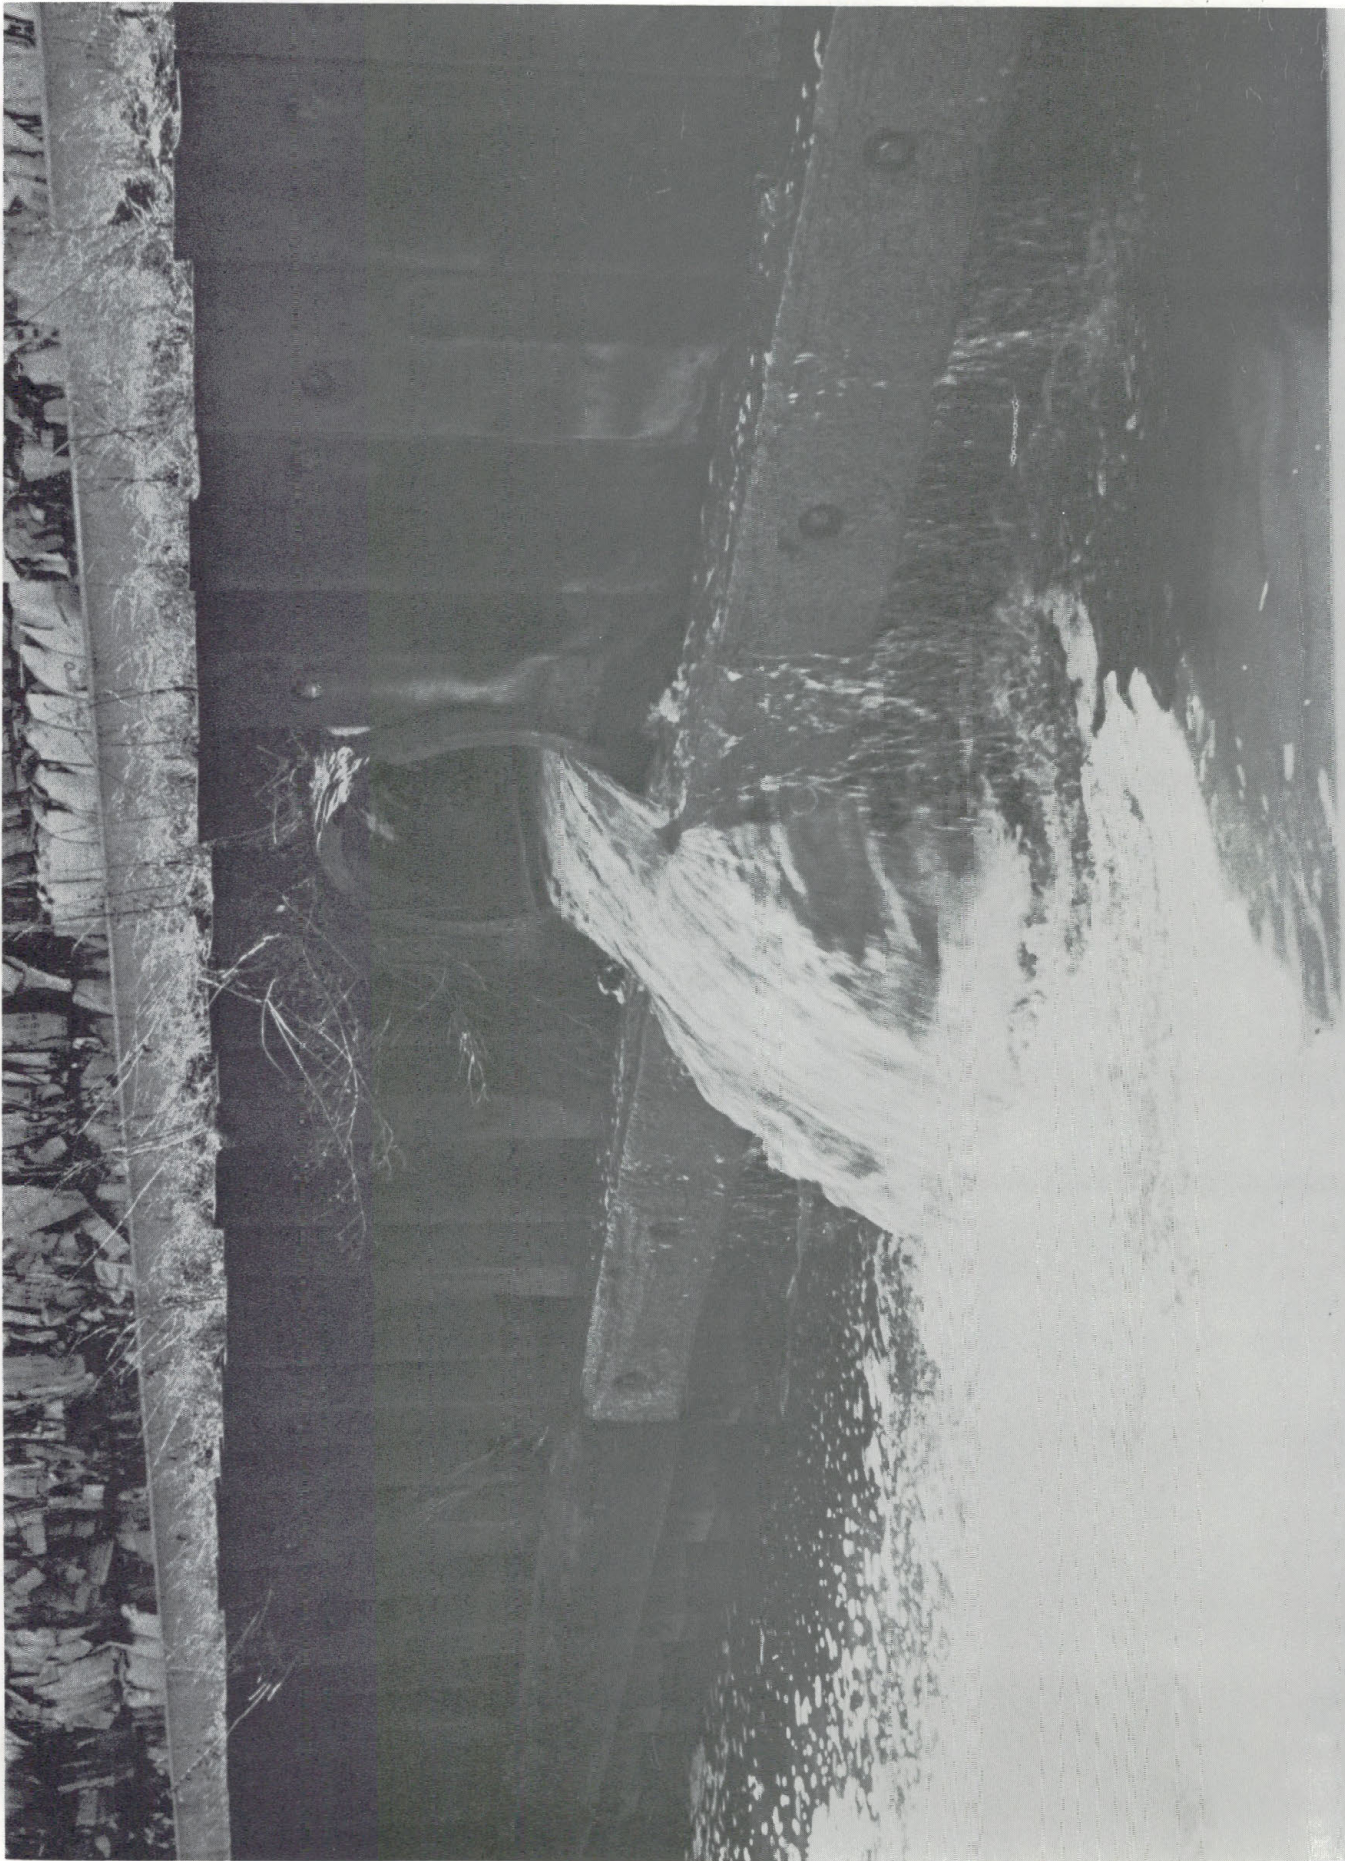
PICTURE 21 is a sewer outlet discharging from the property of a manufacturing plant. A sample from this waste water showed a B.O.D. of 230 ppm. This strength of waste is comparable to the strength of raw, untreated domestic sewage.

1 Sewer Outlet by Container Company situated in North branch loop just above Chicago Avenue.

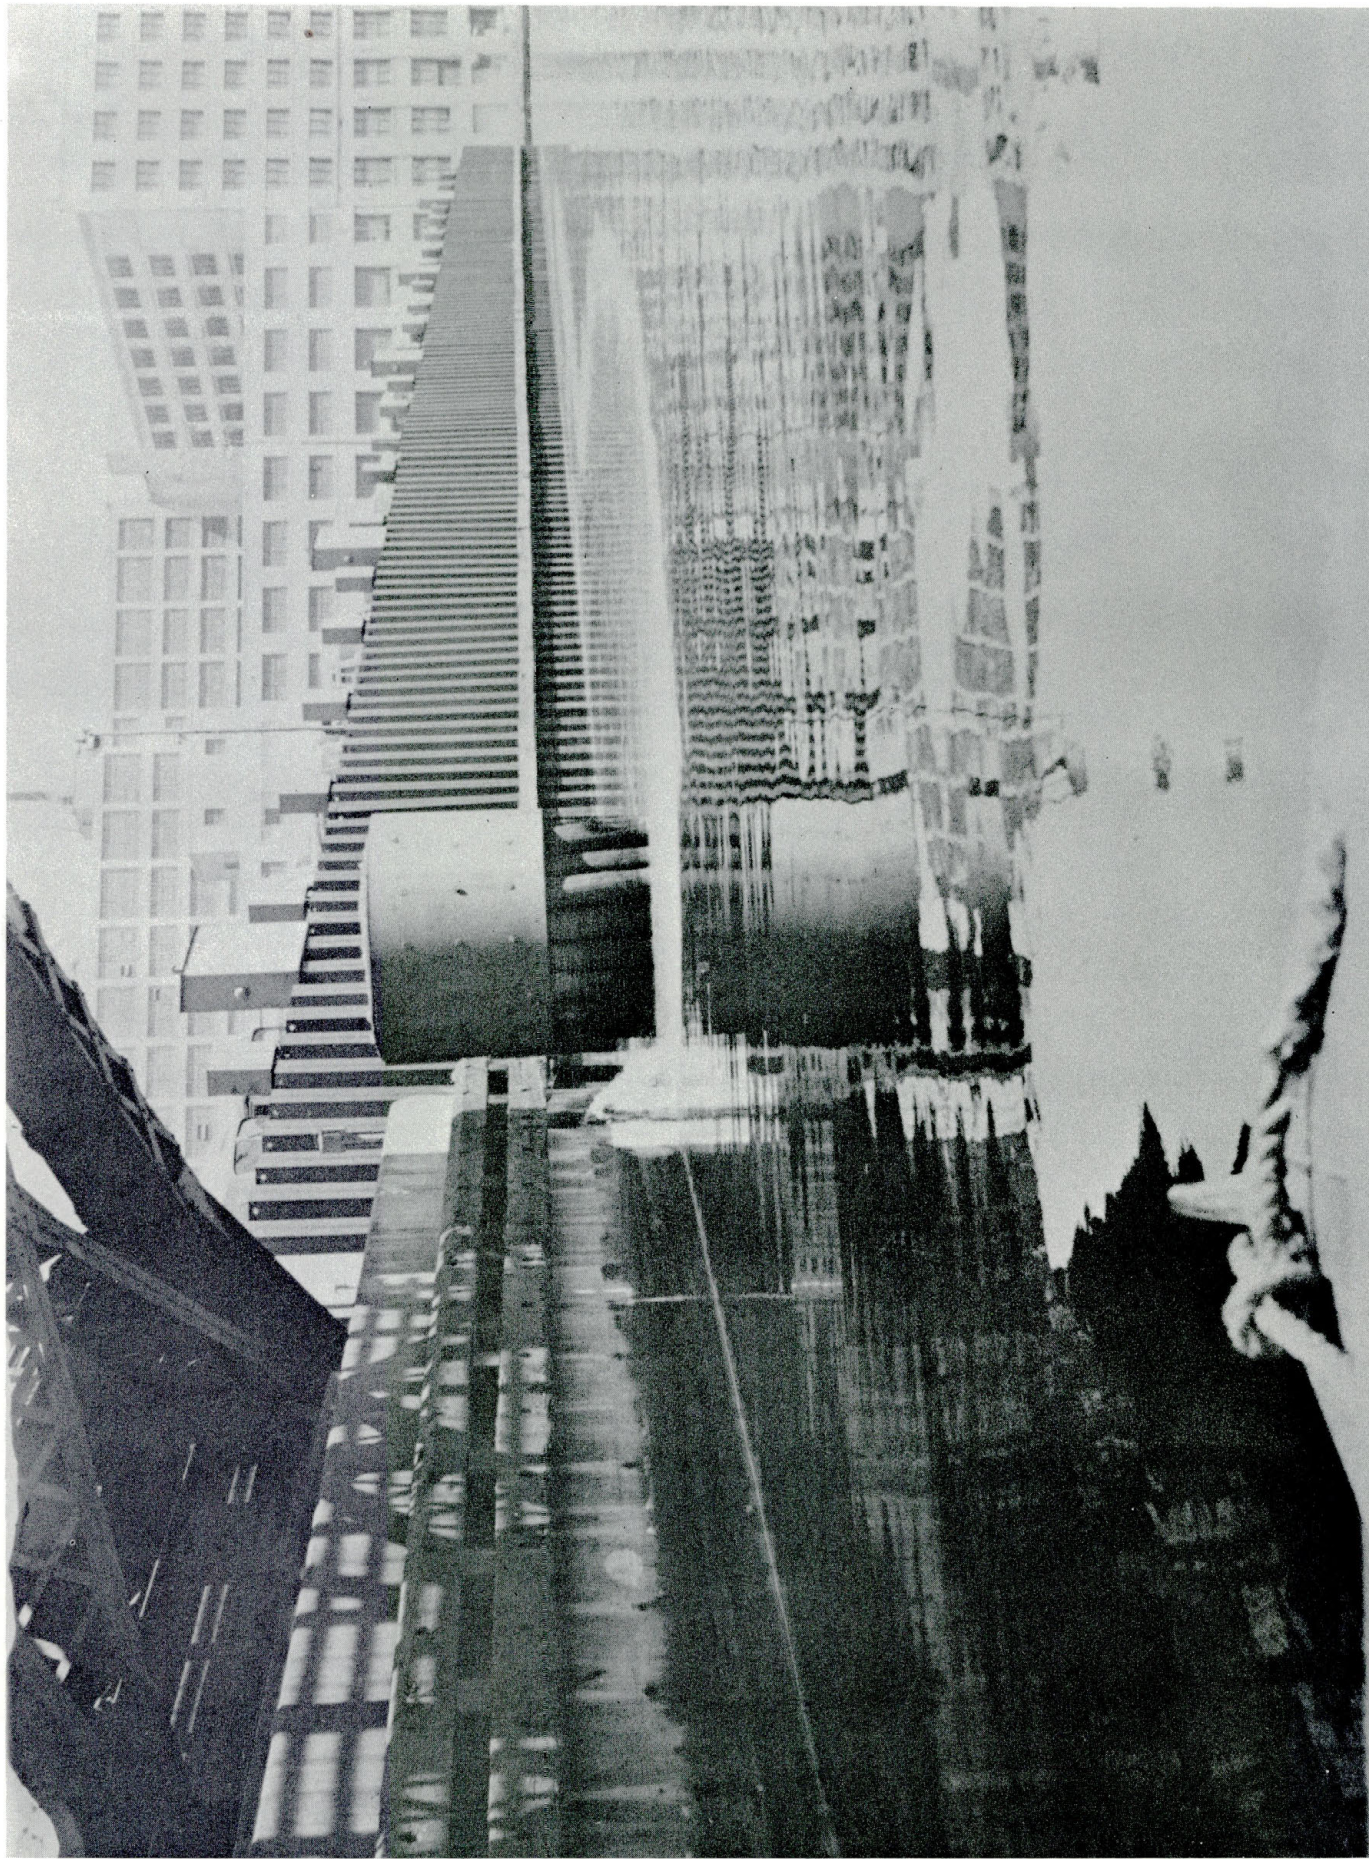
PICTURES 22, 23, 24 show a discharging sewer under the Halsted Street bridge crossing the north branch loop, just above Chicago Avenue. In picture 22, heavy grease scum can be seen floating downstream. Pictures 23 and 24 show the discoloration of the canal, due to the high solids content of the waste. A sample of this waste showed a B.O.D. greater than 790 ppm. There is little doubt that this waste receives no treatment prior to discharge into the canal.

Sewer Outlet under Halsted Street bridge crossing North branch loop just above Chicago Avenue. Note scum floating downstream from outlet.

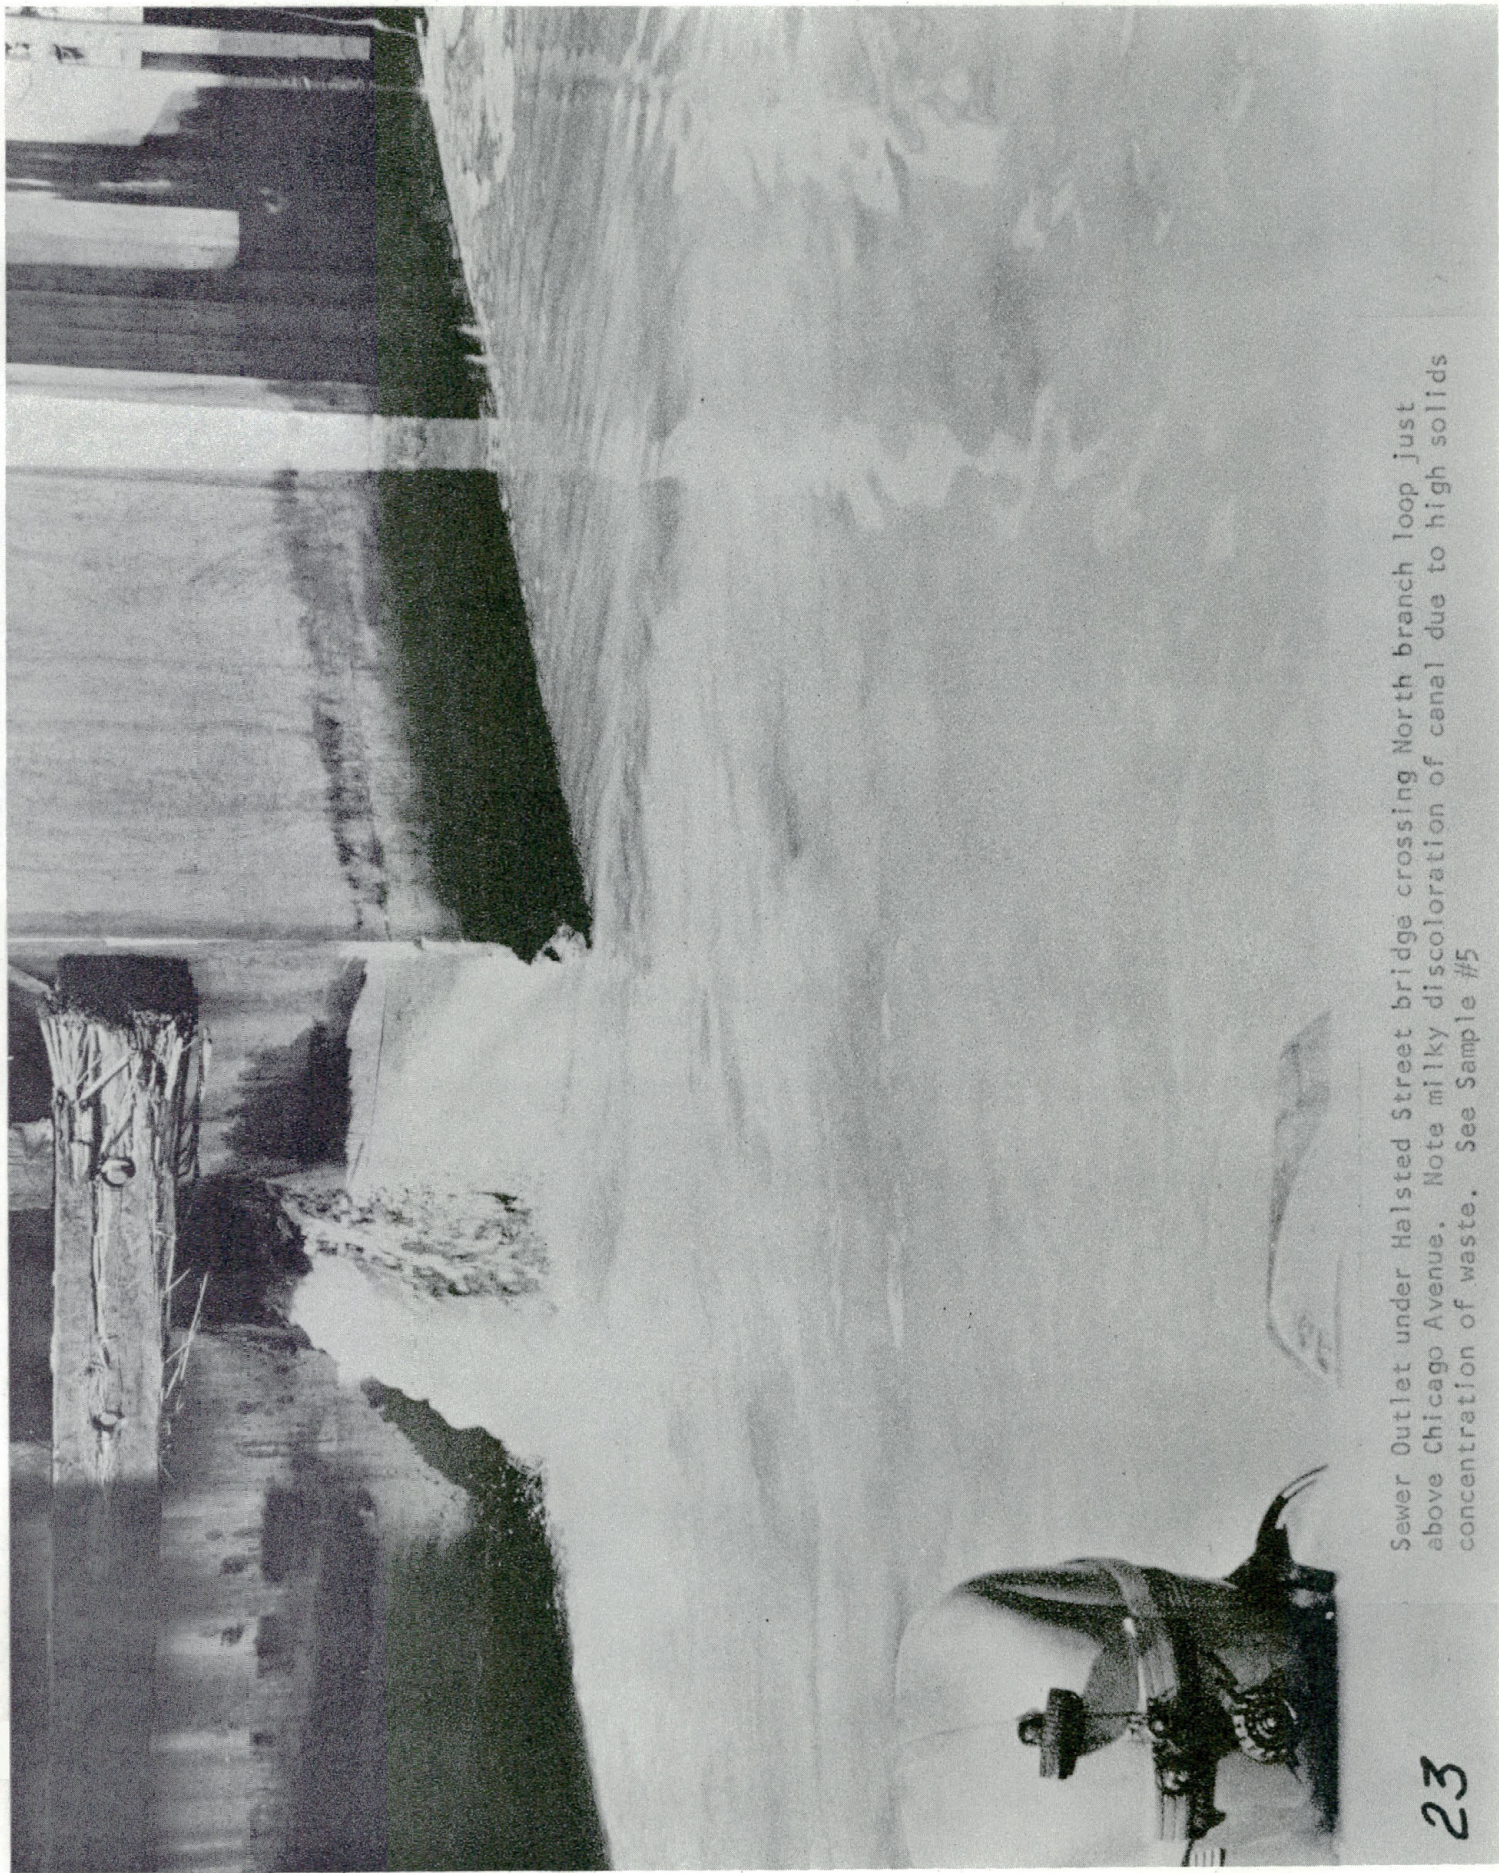
Sewer Outlet under Halsted Street bridge crossing North branch loop just above Chicago Avenue. Note milky discoloration of canal due to high solids concentration of waste. See Sample #5
