REPORT ON A SURVEY
OF THE
CHICAGO SANITARY CANAL AND THE CALUMET SAG CHANNEL

Michigan Associates
Consulting Engineers
Lansing 29, Michigan

22 April 1959

REPORT ON A SURVEY OF THE
CHICAGO SANITARY CANAL AND THE CALUMET SAG CHANNEL

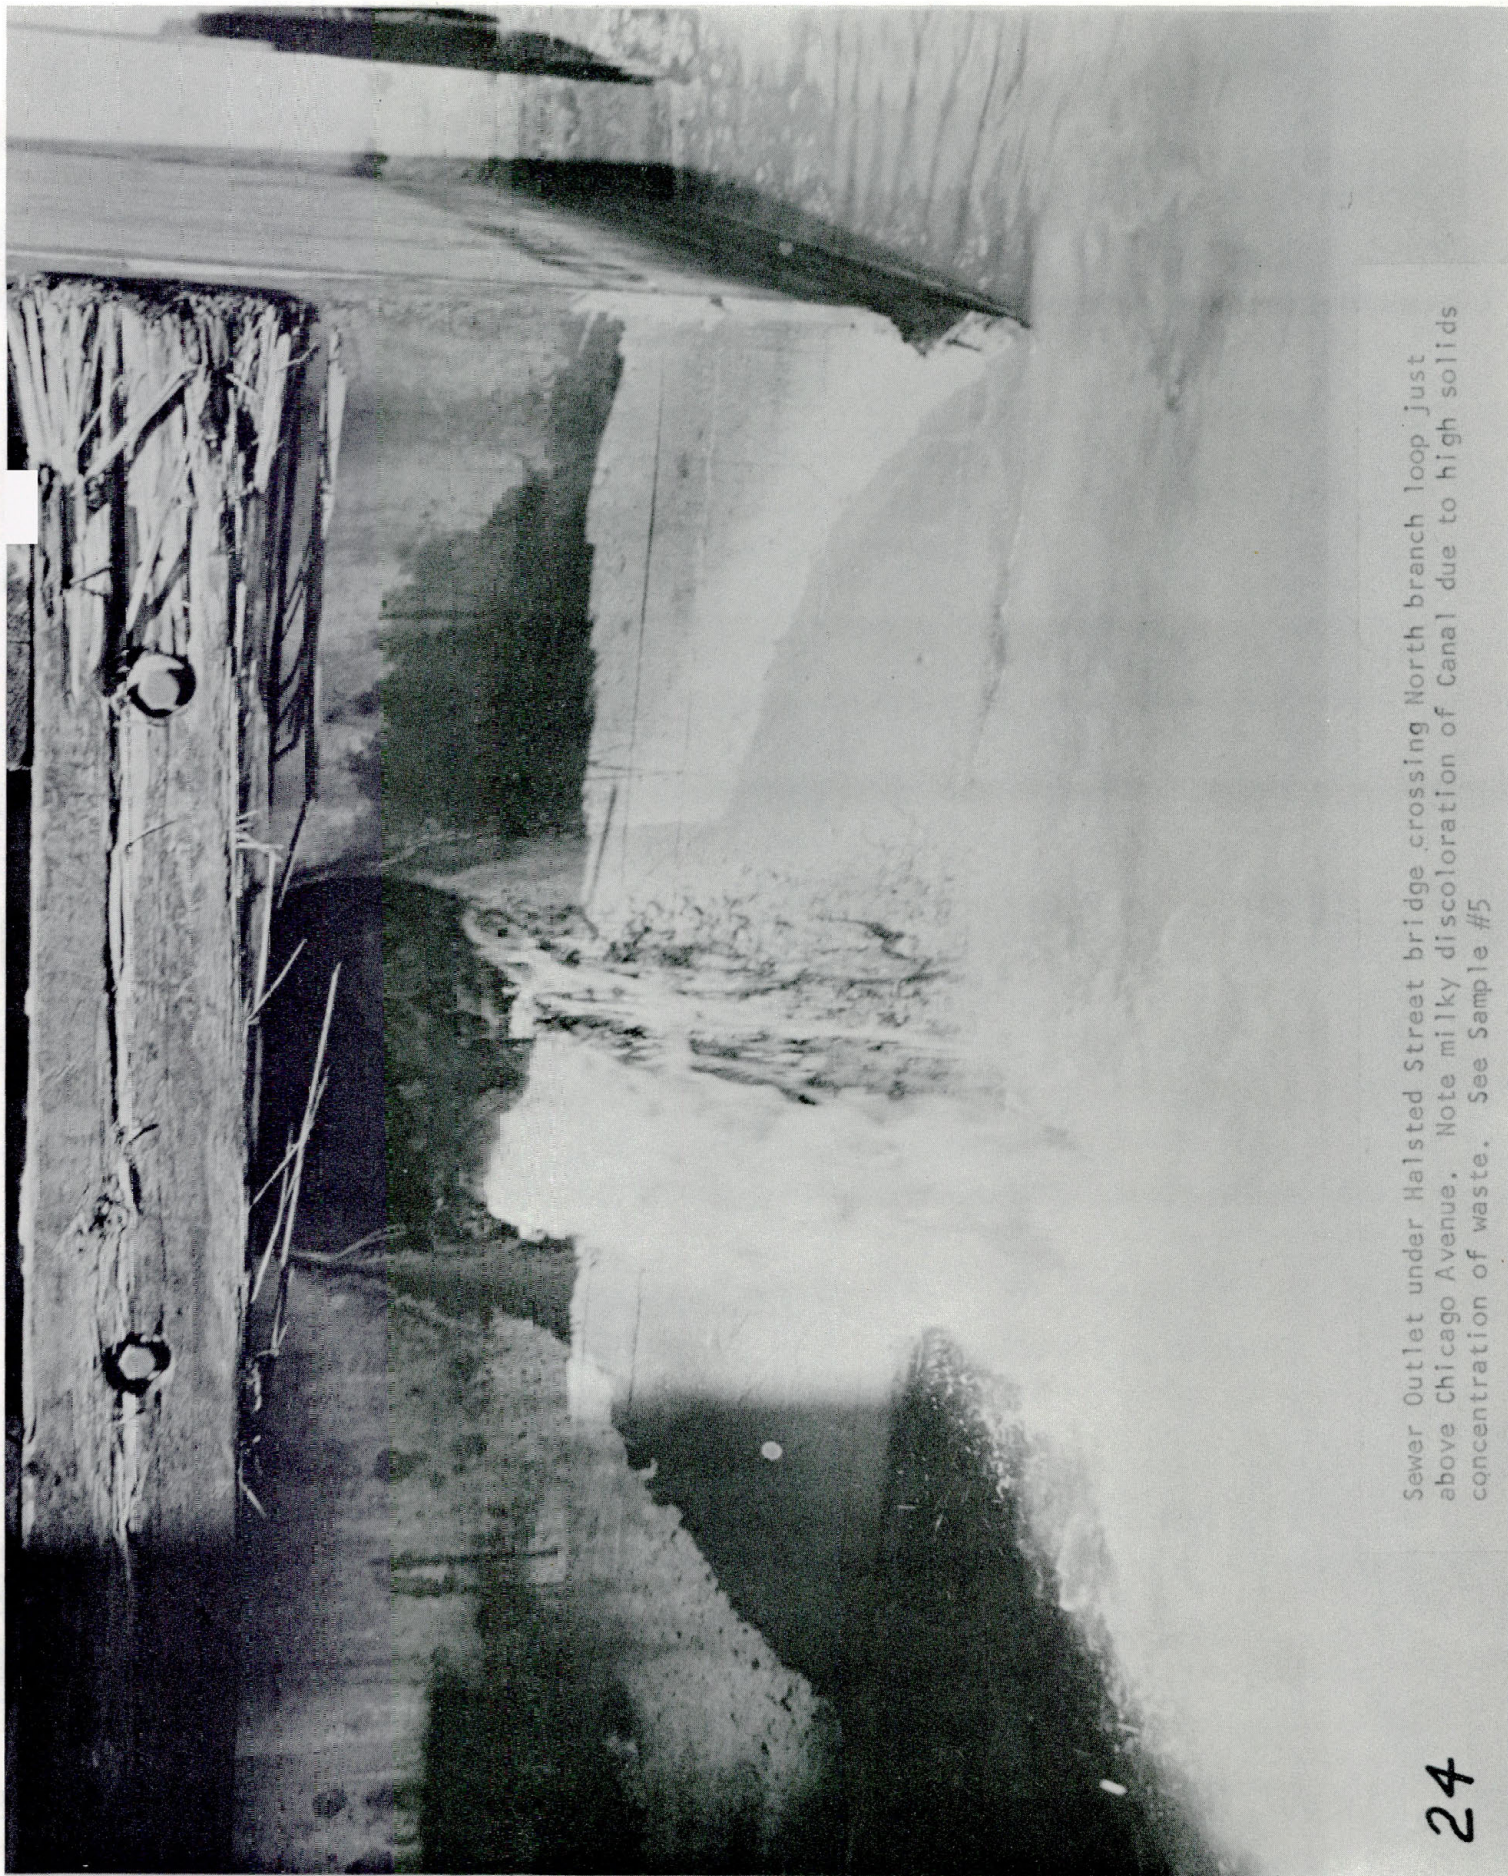
PICTURES 22, 23, 24 show a discharging sewer under the Halsted Street bridge crossing the north branch loop, just above Chicago Avenue. In picture 22, heavy grease scum can be seen floating downstream. Pictures 23 and 24 show the discoloration of the canal, due to the high solids content of the waste. A sample of this waste showed a B.O.D. greater than 790 ppm. There is little doubt that this waste receives no treatment prior to discharge into the canal.

Sewer Outlet under Halsted Street bridge crossing North branch loop just above Chicago Avenue. Note milky discoloration of Canal due to high solids concentration of waste. See Sample #5

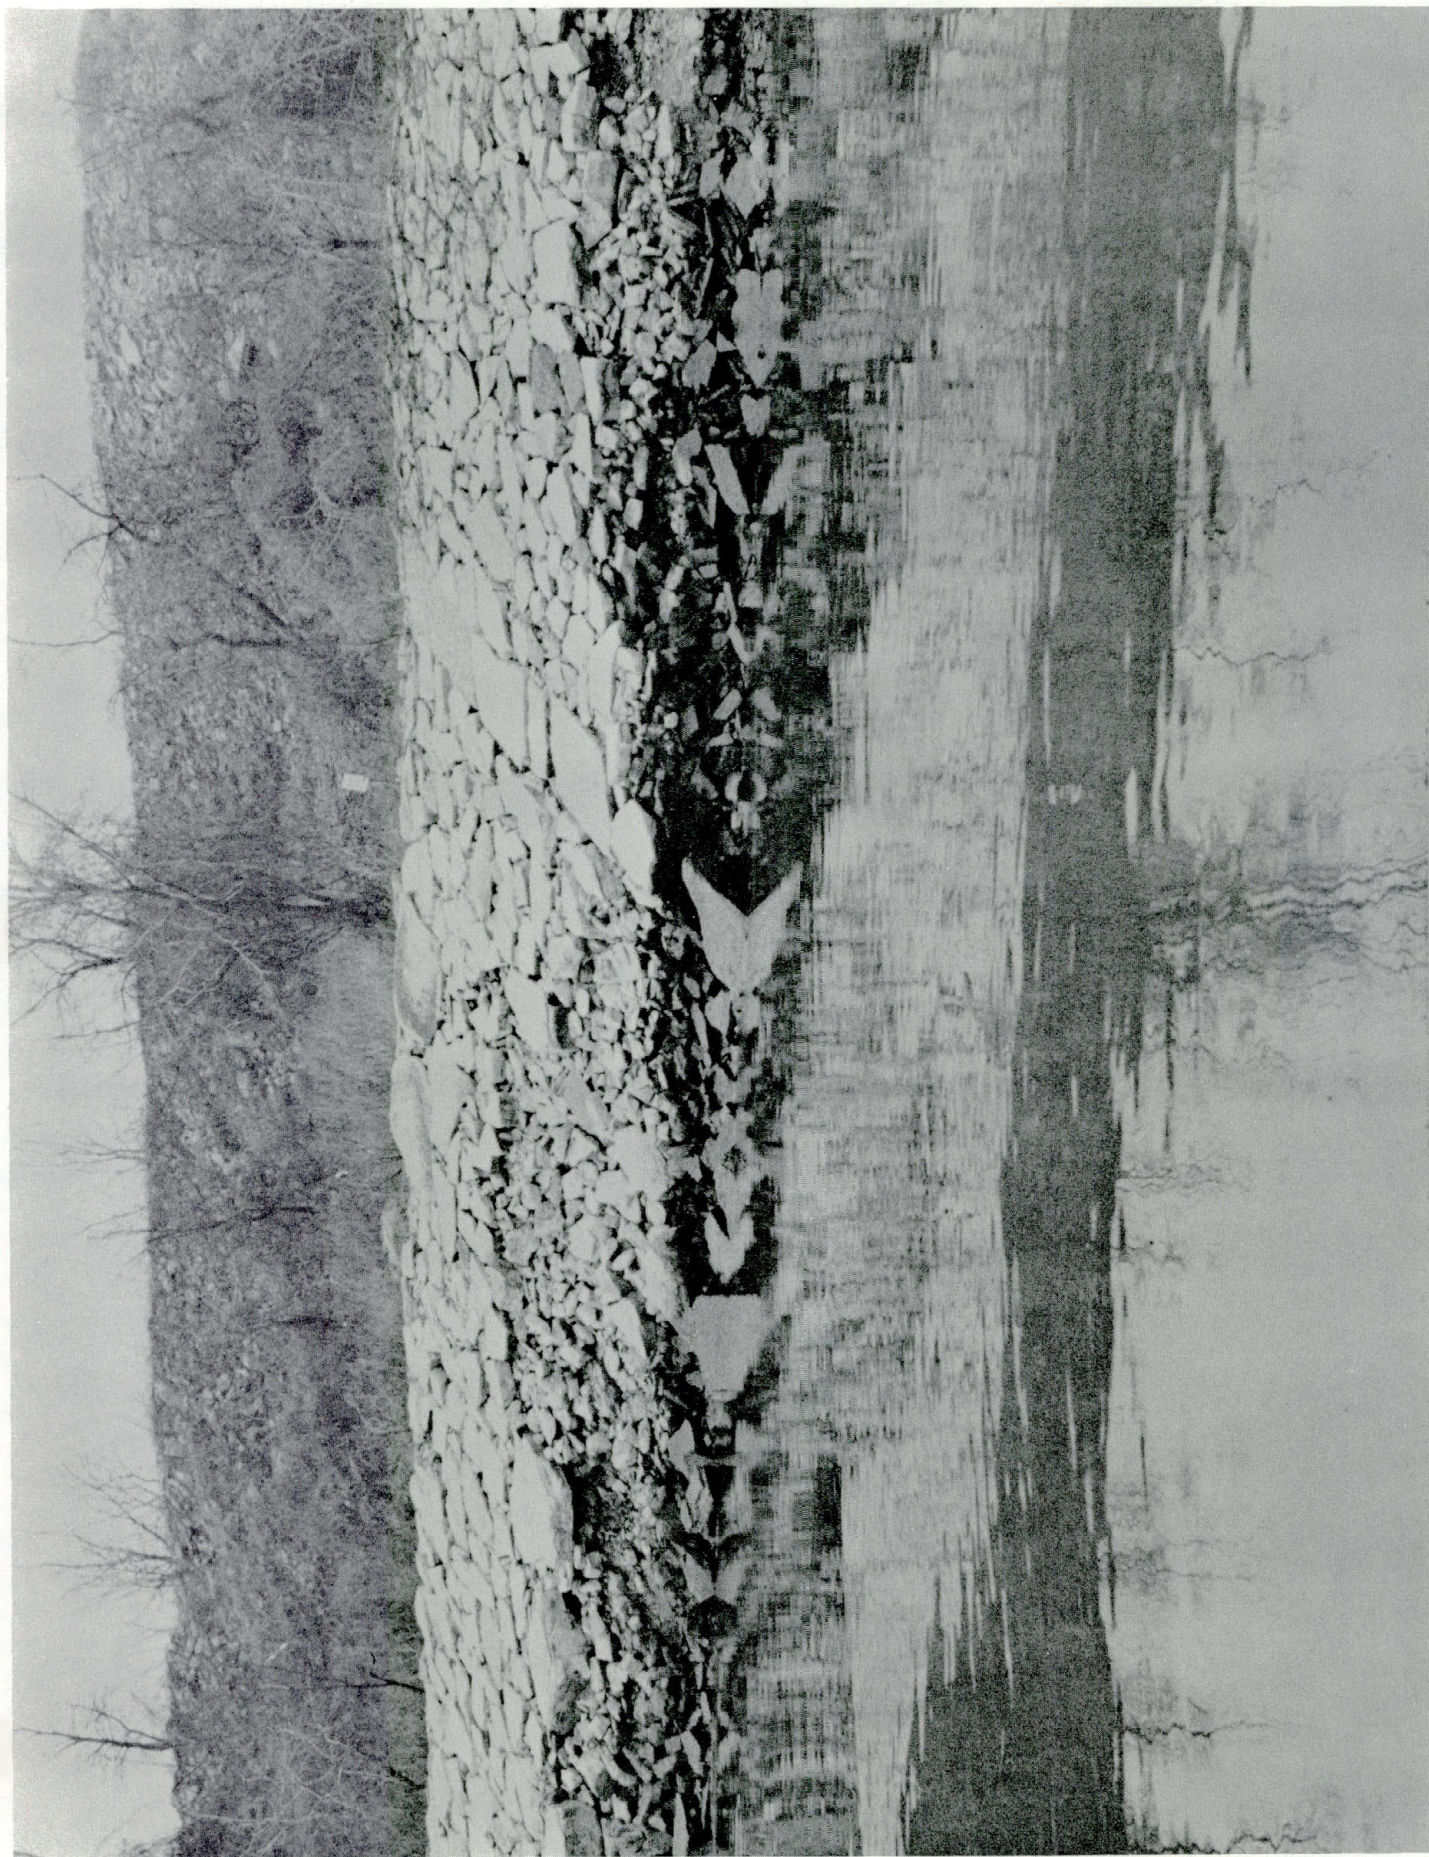
PICTURES 25, 26, 27, 28 show the oil slicks and oil scum bank deposits, and are representative of many areas along the Calumet Sag Channel.

Oil slicks and bank deposits typical of many areas along Cal Sag Canal.

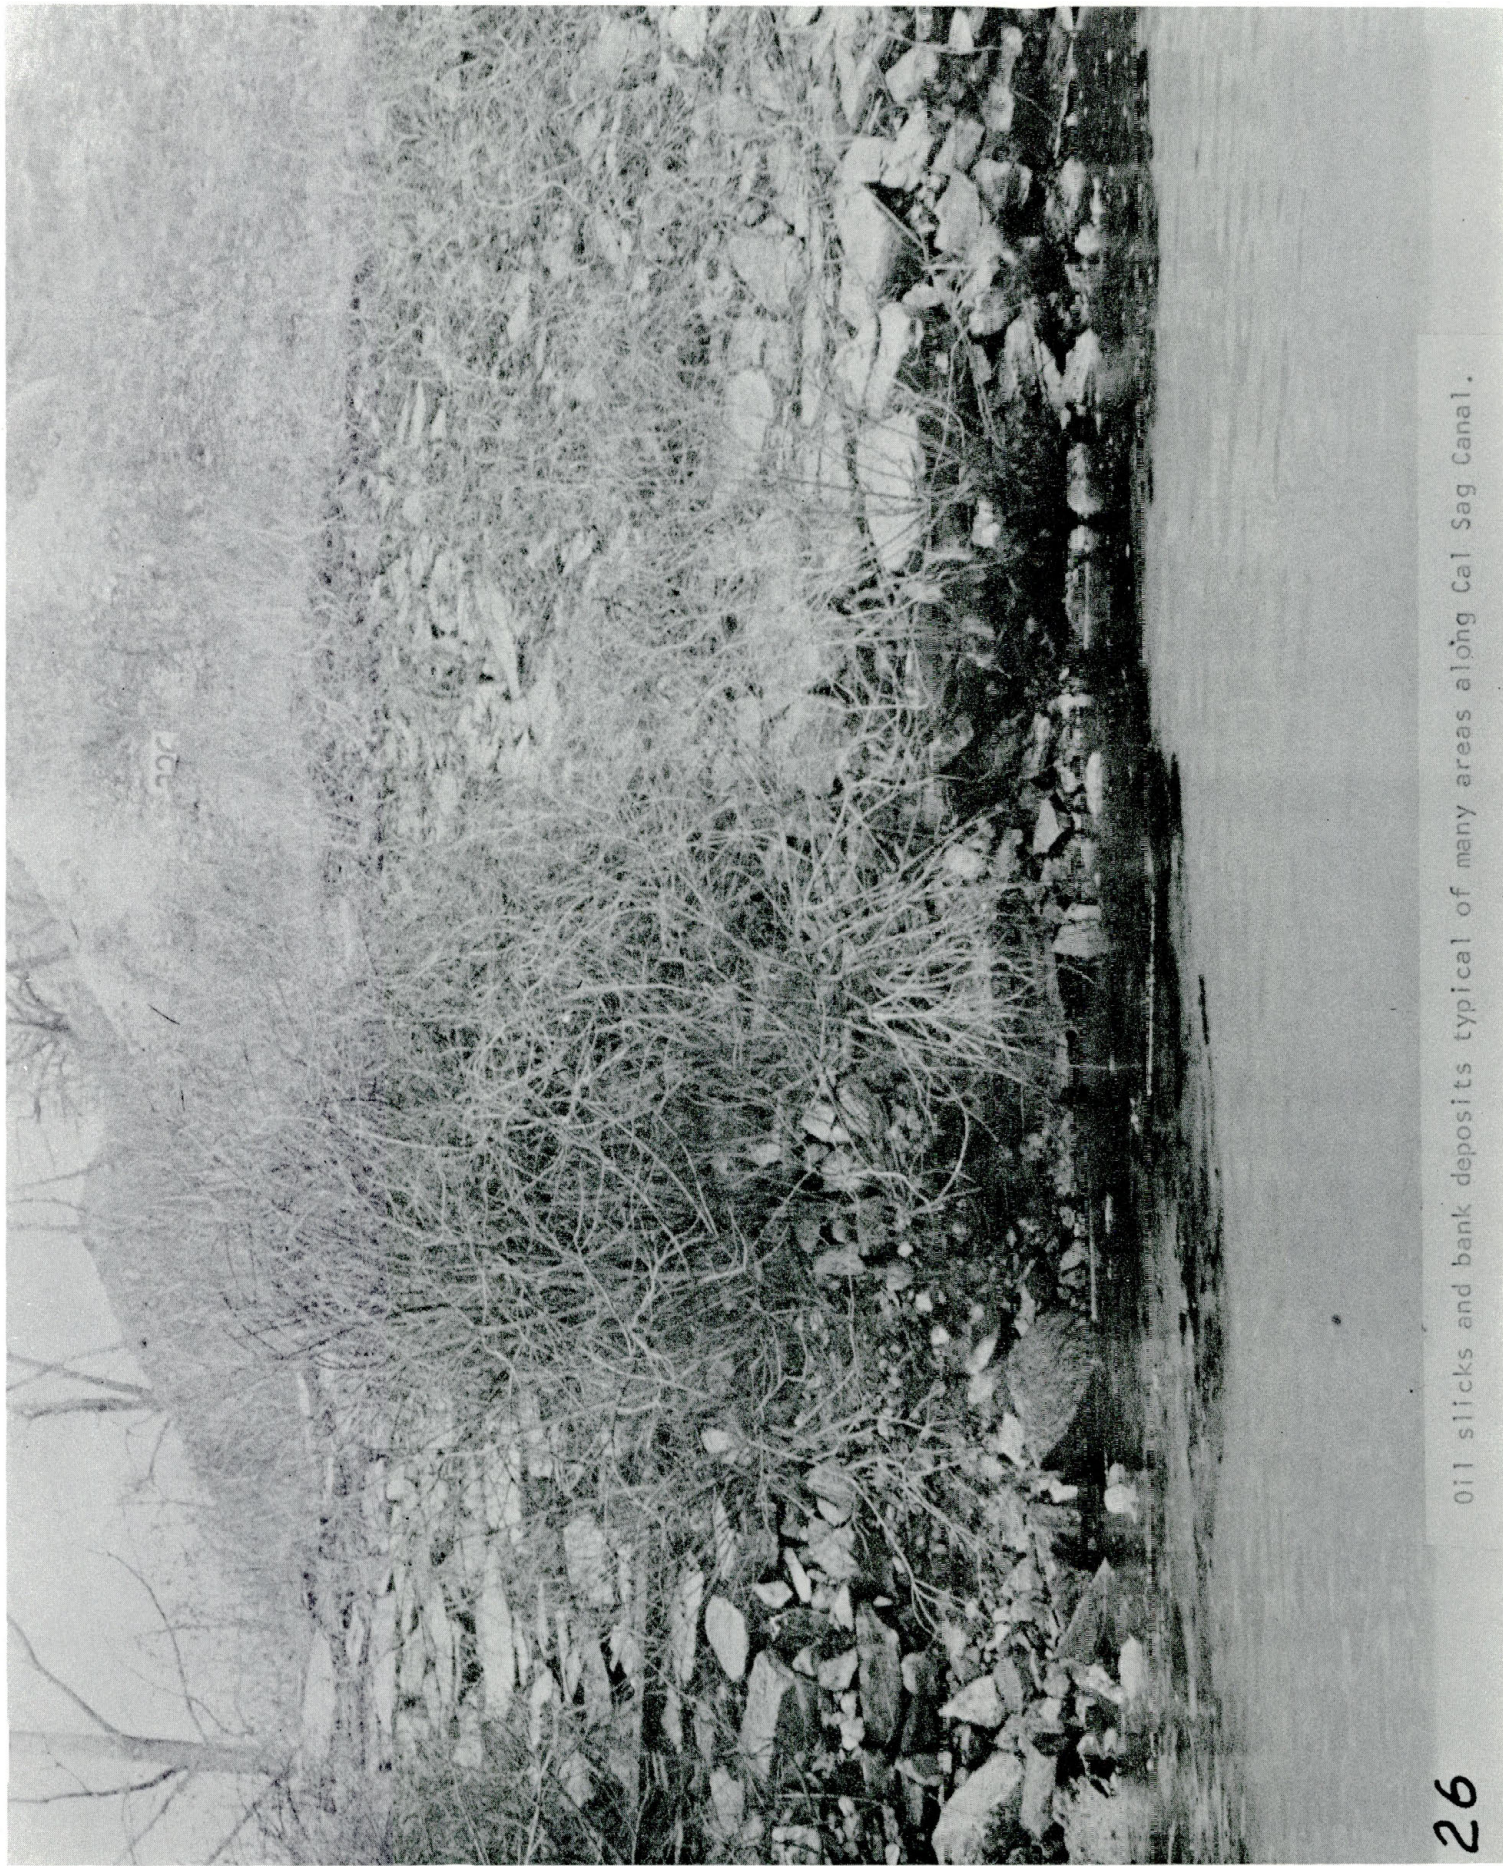
Oil slicks and bank deposits typical of many areas along Cal Sag Canal.

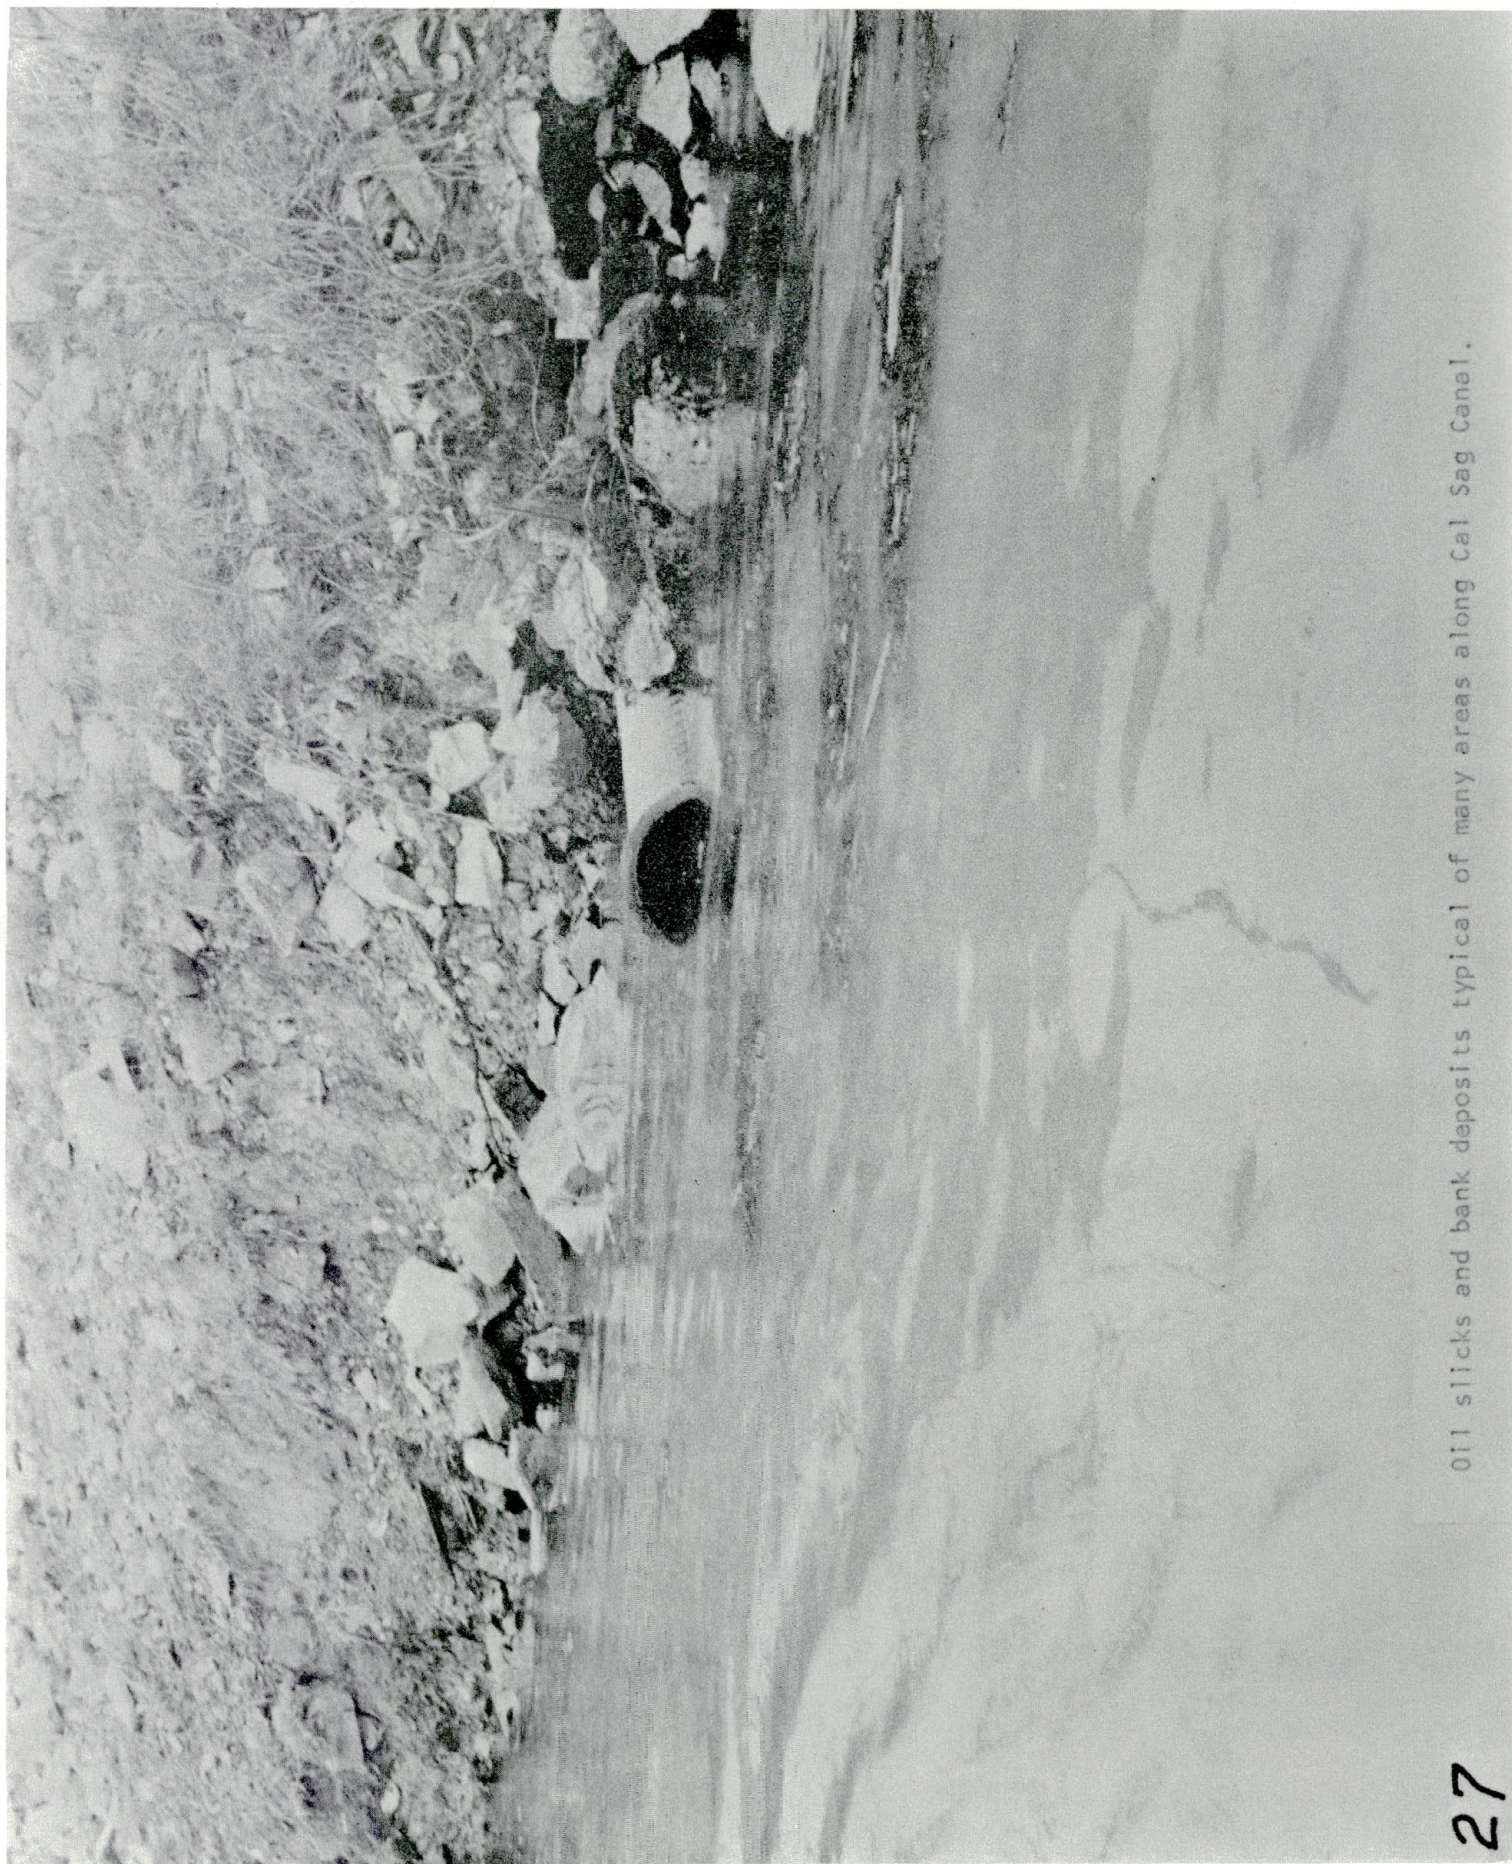
oil slicks and bank deposits typical of many areas along Cal Sag Canal.

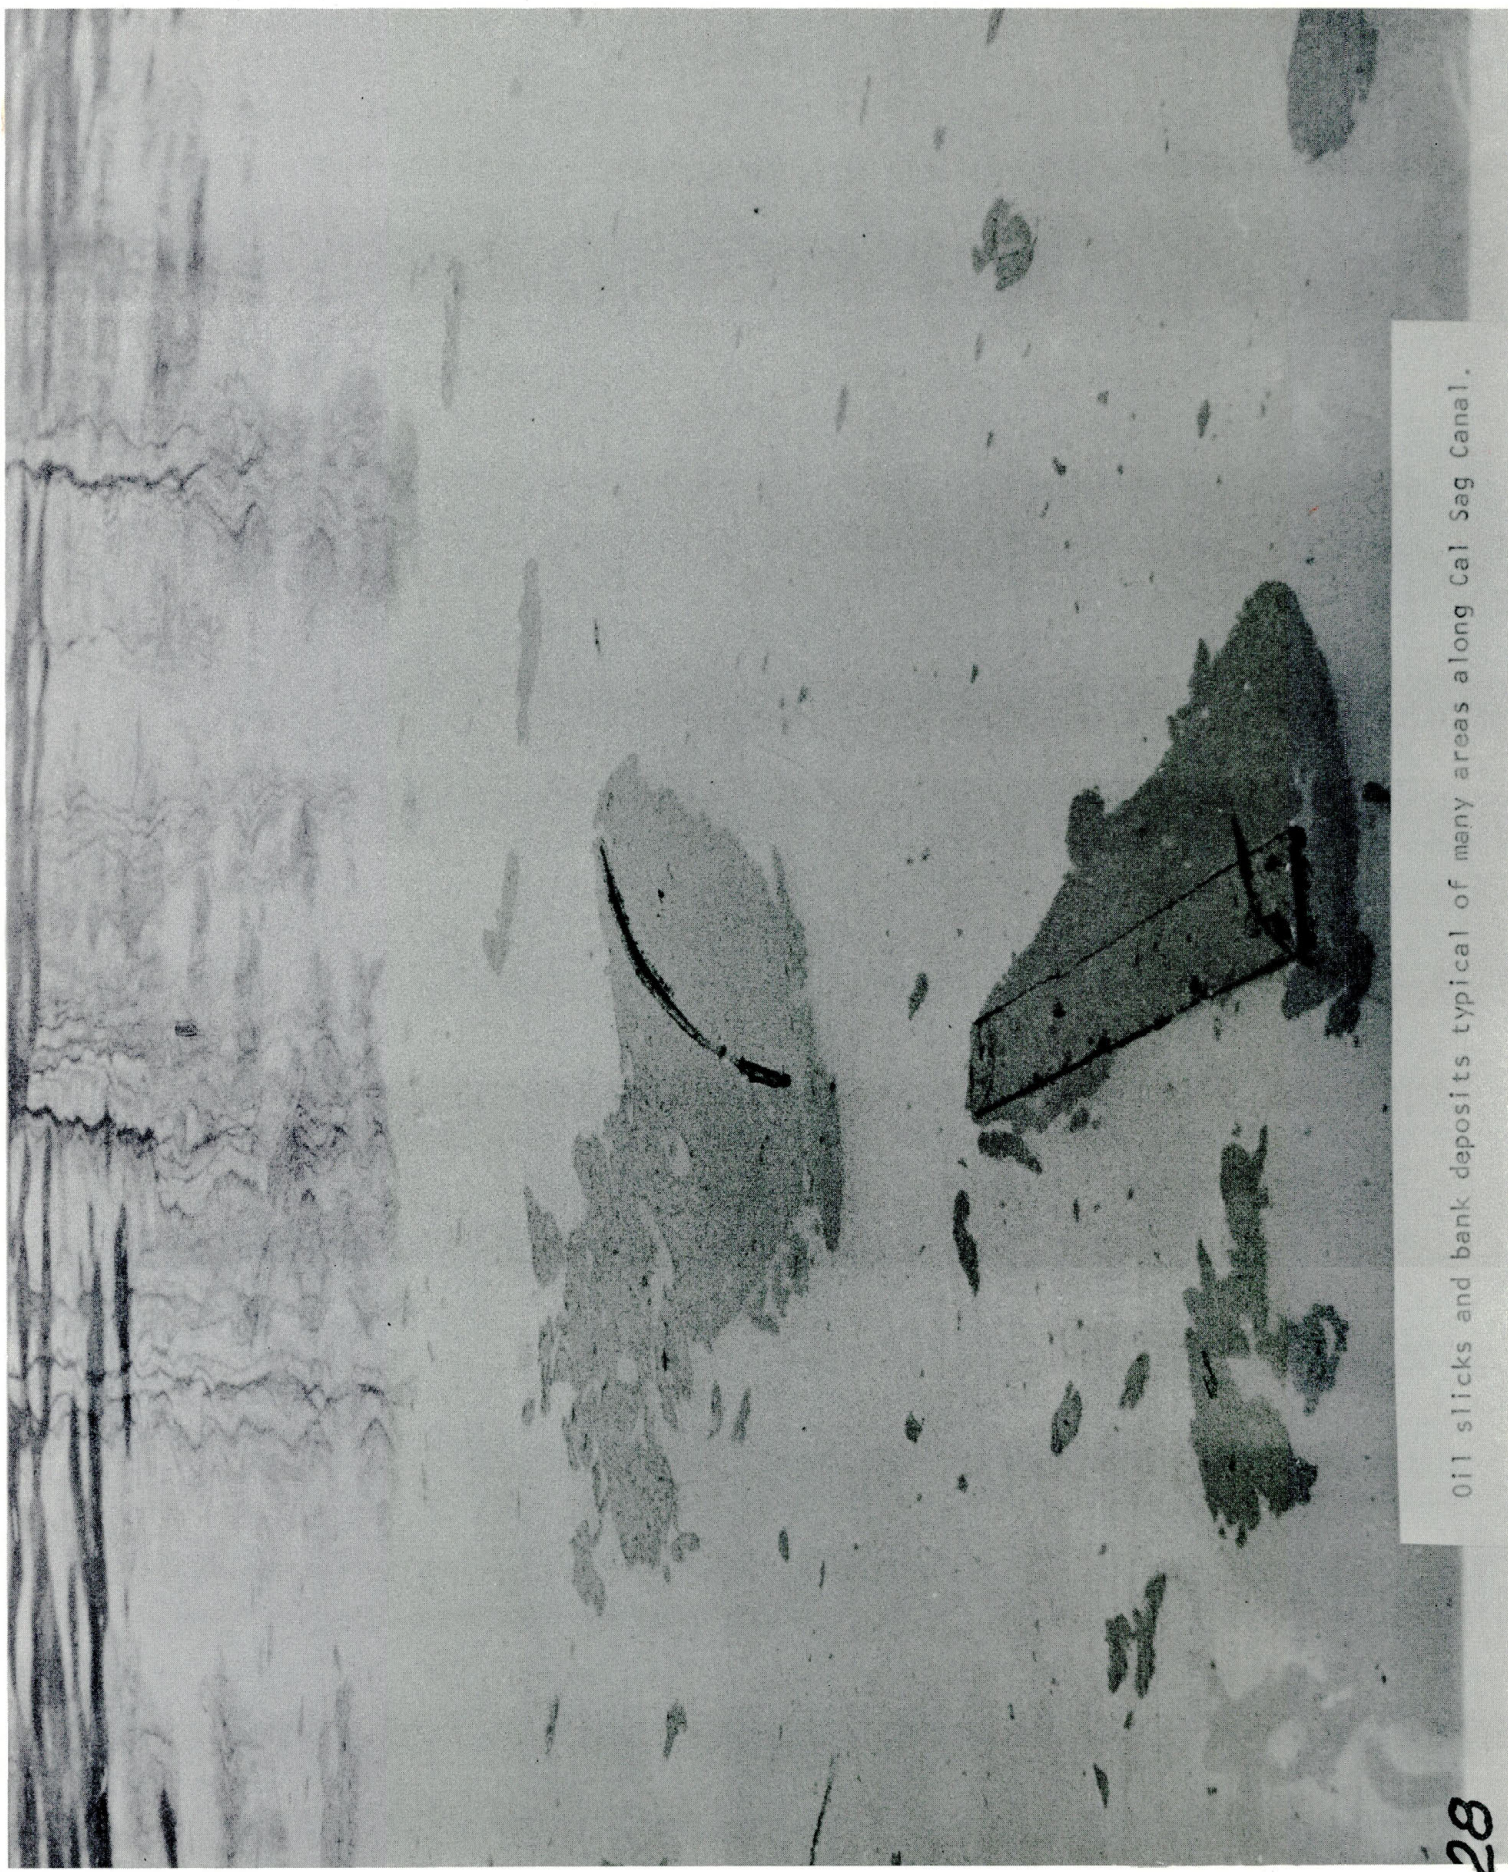
Oil slicks and bank deposits typical of many areas along Cal Sag Canal.
